Timeline of Events with Meyers High School & Memorial Stadium

Re: Meyers High School
341 Carey Ave.
Wilkes Barre, PA 18702

Re: Meyers High School Update

Re: Meyers High School Conditions

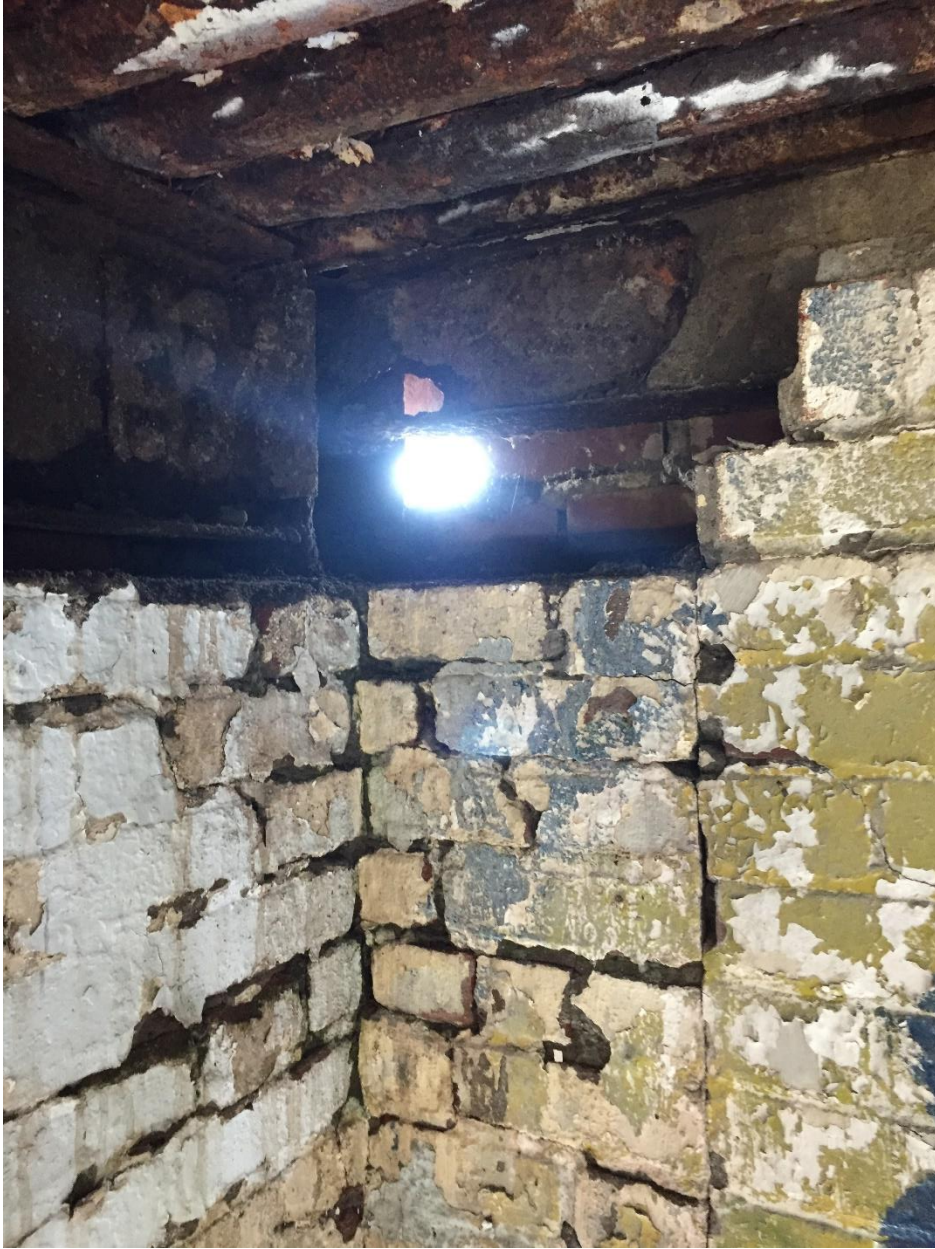
August 8th – Continuing the ongoing work at Meyers, District personnel began removing (scraping) hanging pieces of steel under the tunnel entrance to the field (locker rooms) due to the continuing deterioration of beams. During this time, as a preventative measure, Thomas Leonard had requested District personnel to remove some loose bricks which would expose a beam to assure no hidden erosion existed. Upon inspection, there was a hole in the center of the beam due to ongoing deterioration.

Picture Attached. (if you zoom in on the picture you will be able to see the light through the hole of the beam.)

August 8th - The entrance was closed and an alternative entrance to the field was utilized through the equipment room (located around the 20-30 yard line).

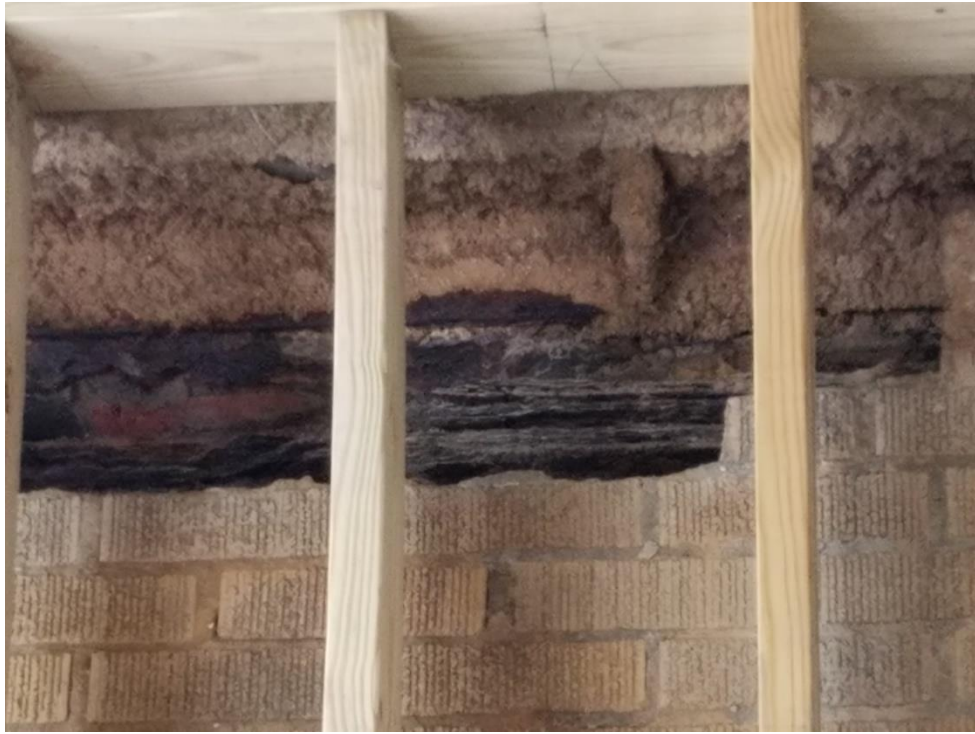
The above picture details the delamination of the structural steel that is supporting the concrete surface of the walkway. A temporary support wall constructed of wood 2" x 6" structural members was added recently in order to prevent catastrophic failure. This condition appears to have deteriorated further since these walls were installed.

In conclusion it would be my recommendation to close the elevated walking surface as it has deteriorated to a condition that is unsafe. The closure of the elevated walking surface will reduce the egress components to below the required amounts for the cafeteria and the gymnasium. Both of these areas will be required to comply with the reduced occupant load. The cafeteria will still be able to use the secondary egress stairs that egress to the football field, which will reduce the burden on the interior corridor. Further analysis of the occupancy of the classrooms, library, etc. would be required to be completed in order to determine the maximum occupant load.

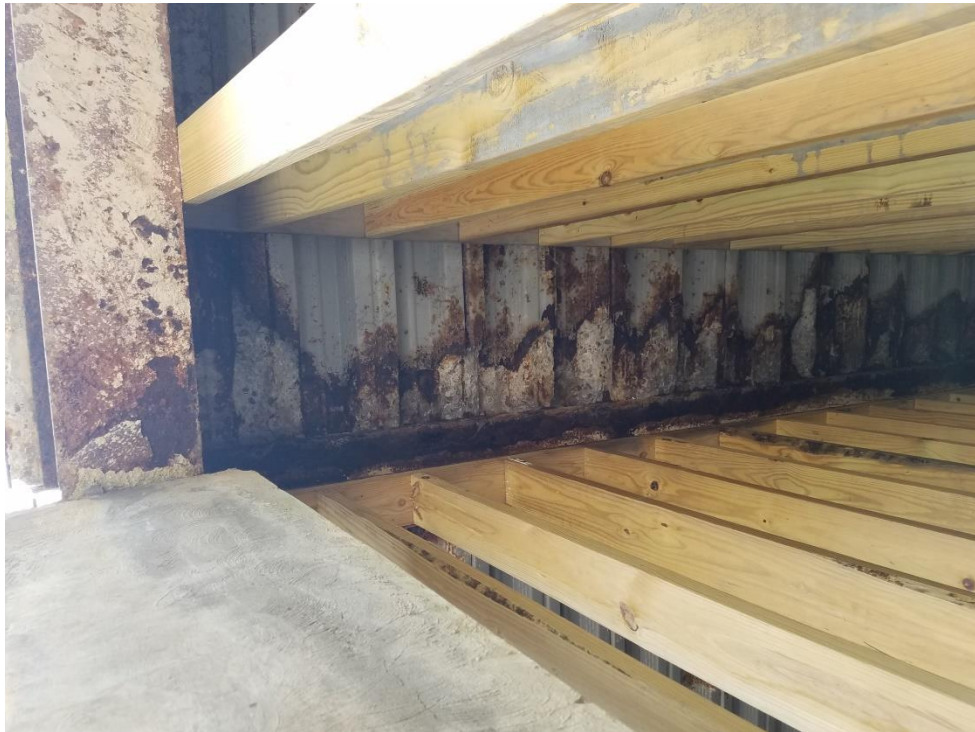
This structural steel beam supporting the concrete surface above is delaminating and is deteriorating. The steel concrete decking that is supporting the concrete surface above has deteriorated beyond its usability and was also recently supported with 2" x 6" temporary supporting walls in order to prevent catastrophic failure.

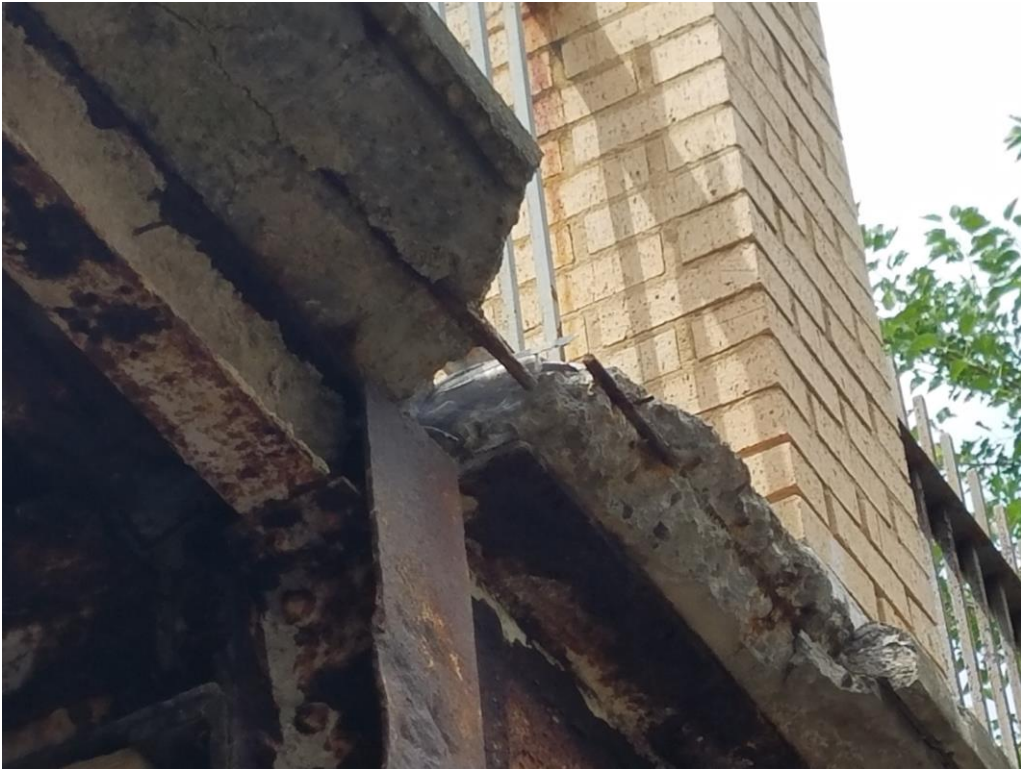
The above picture further details the deterioration of the structural steel elements and also further clarifies the condition of the concrete above the structural steel elements. The exposure of the rebar embedded in the concrete indicates that the level of deterioration has reached its limit state.

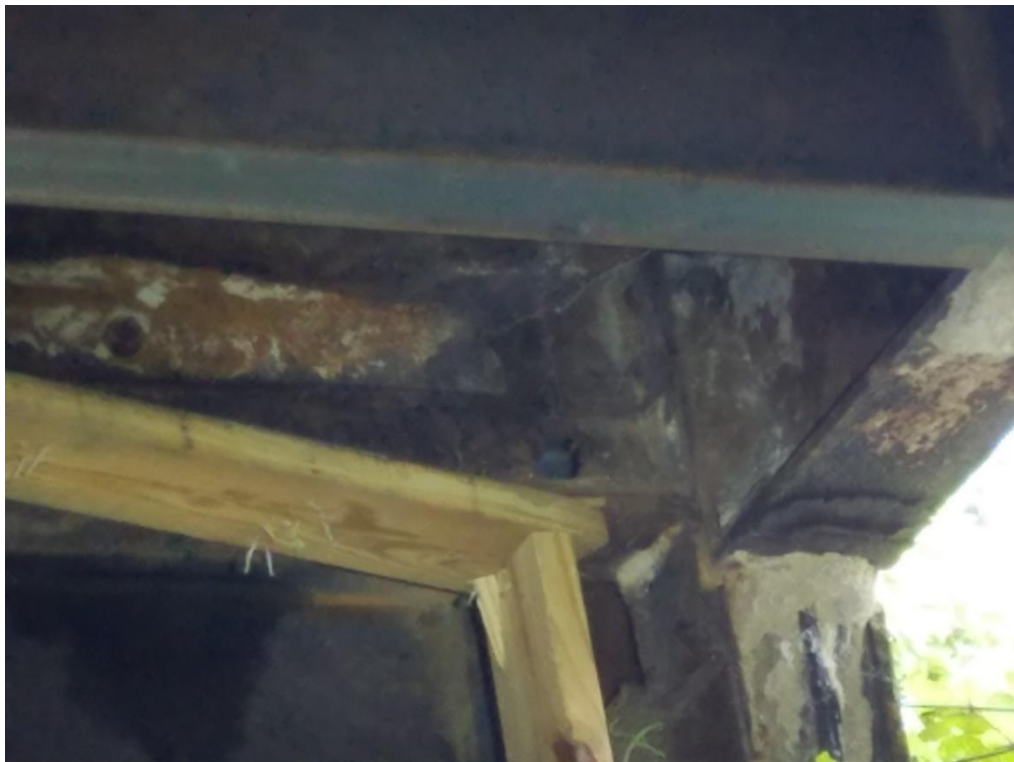
Directly above the 2" x 6" temporary support there is a hole in the structural beam that is supporting the concrete walkway above. The beam to the right of it has also delaminated.

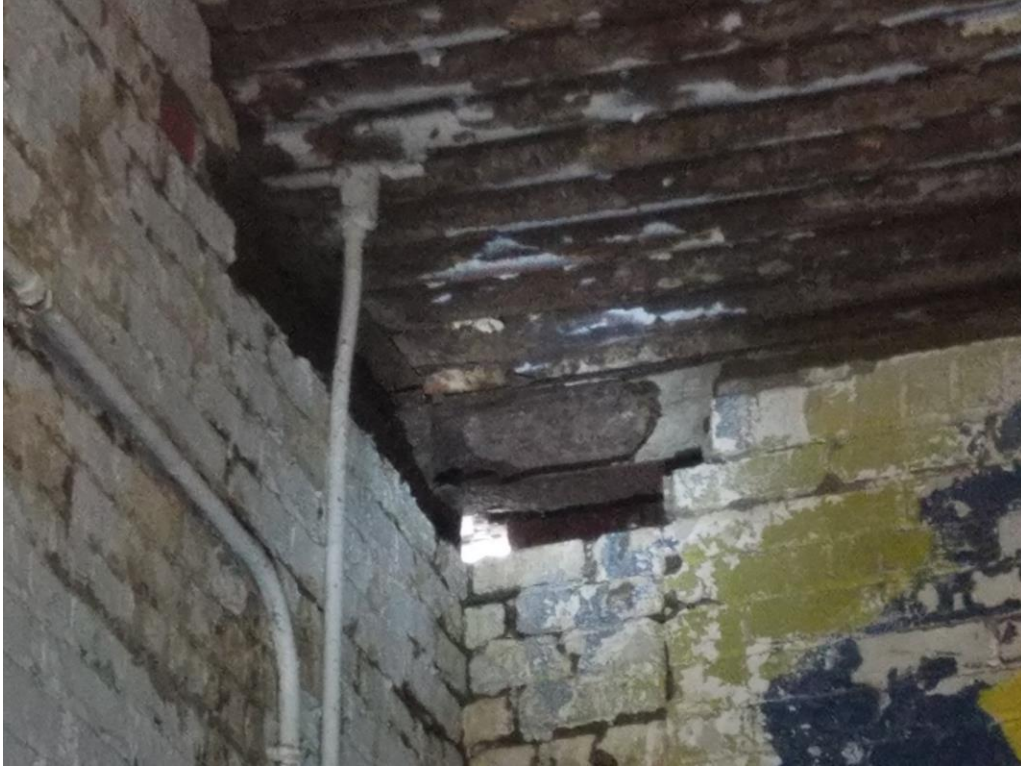
This photograph indicates the condition of the structural steel above the central access point from the locker rooms to the football field. Directly below the structural steel beam the bricks are separating from each other and becoming hazardous. The daylight that is visible through the beam location is an opening in this wall.

- Due to recently discovered steel corrosion and loose bricks in the area above the field entrance door (locker room tunnel), this area should be immediately closed. A protective wood shed can be constructed in the hazardous area to allow continued access to the field.

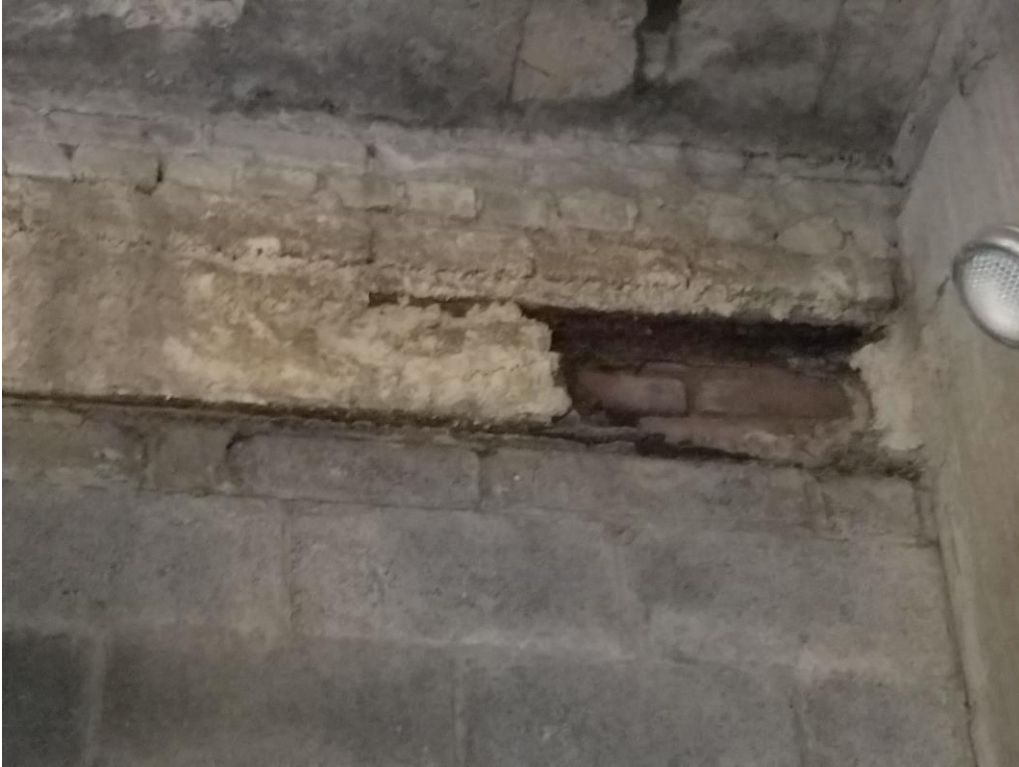
The structural steel beam above a concrete masonry wall that is supporting a concrete walking surface above has deteriorated to a point that the center web of the beam is no longer there.

The equipment room and the shared locker room corridor to the football field should also be closed. The condition of the steel beams in those areas are also in a deteriorated condition that would qualify as unsafe.

- Due to a deteriorated perimeter steel beam and loose concrete on the underside of the second floor, the equipment room adjacent to the home locker room should be closed to all students and coaches. Since this area contains a generator and other mechanical equipment, it is recommended that access by maintenance personnel be limited to an "as-needed" basis with protective headgear/eyewear required.

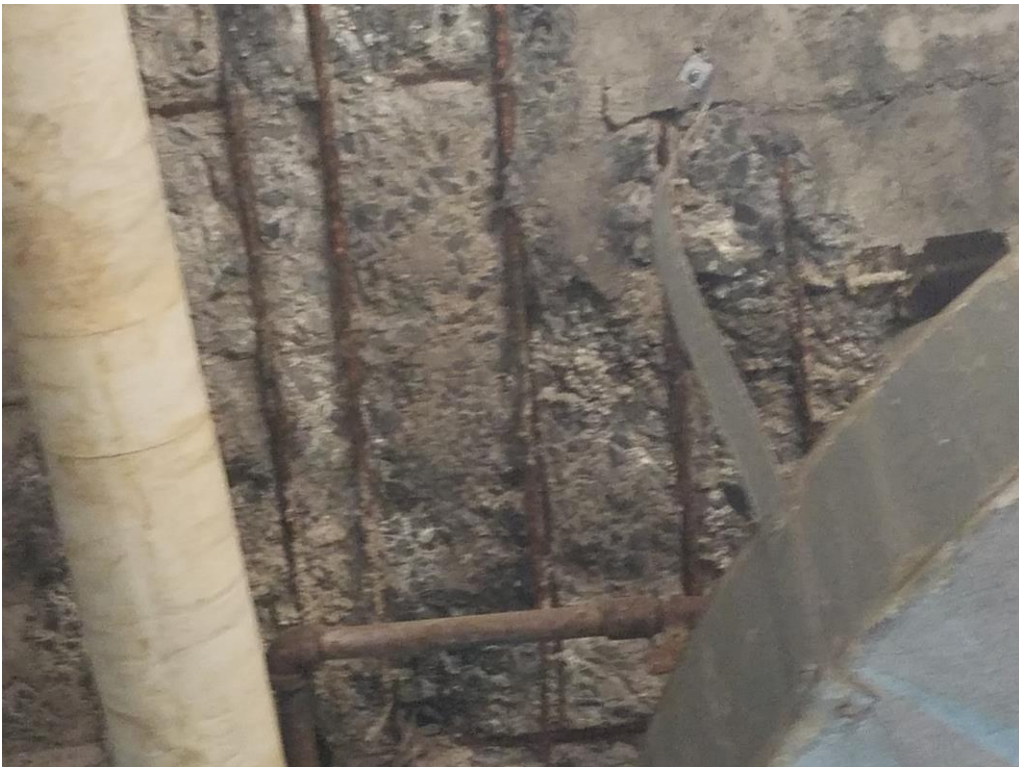
The deterioration of the concrete has reached a condition that the rebar installed within the concrete is now exposed.

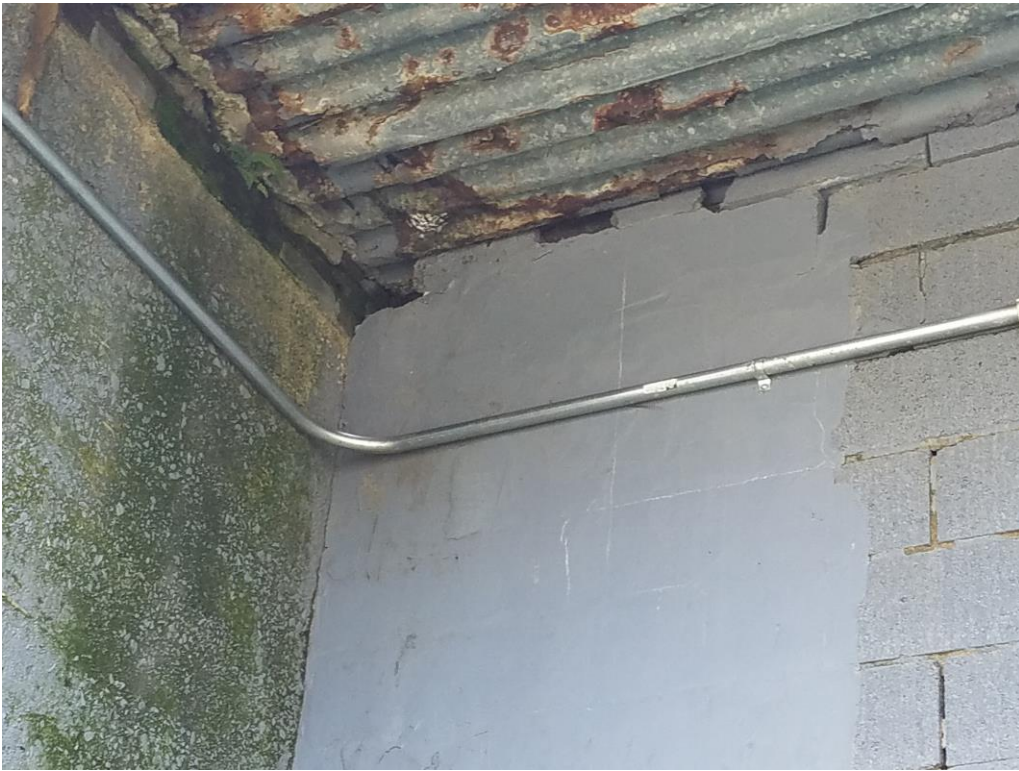
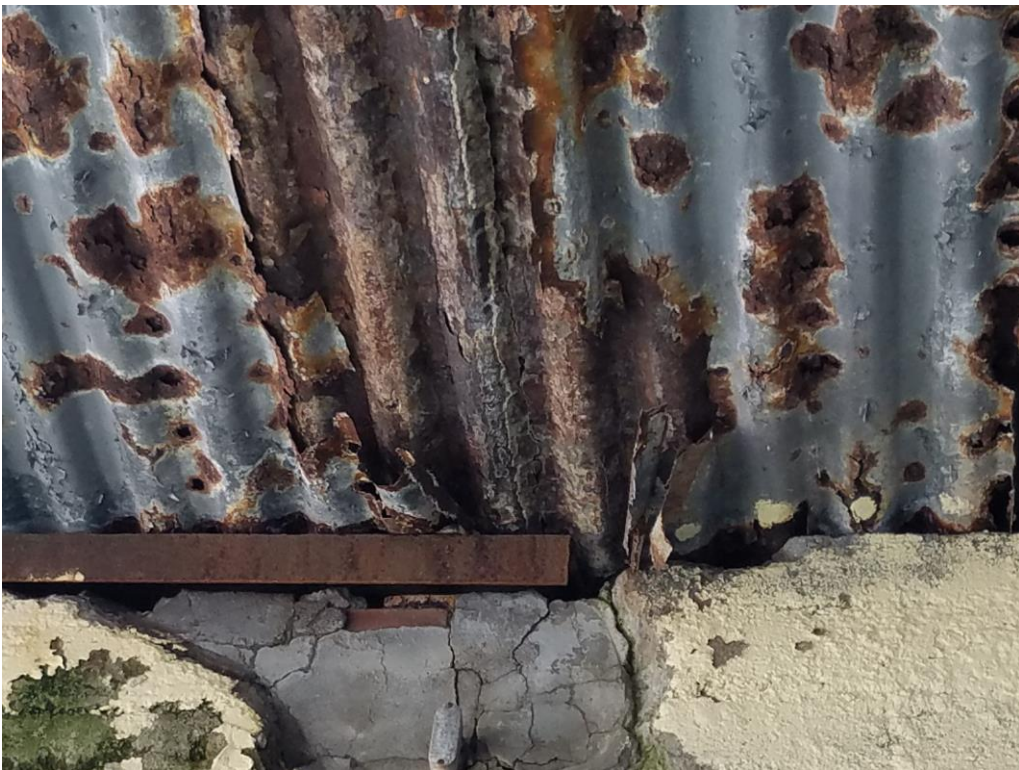
Rear First Story Cafeteria Egress

The first story egress from the cafeteria has deteriorated to a condition that has become unsafe. The steel decking supporting the concrete above has deteriorated and the structural supporting wall below it is crumbling. The steel decking has deteriorated and is now falling away from the concrete that it is designed to support.
