WILKES-BARRE AREA SCHOOL DISTRICT STRUCTURAL EVALUATION OF JAMES M COUGHLIN HIGH SCHOOL

December 8, 2014

Re: Structural Evaluation of Coughlin High School

Coughlin High School Structural Evaluation

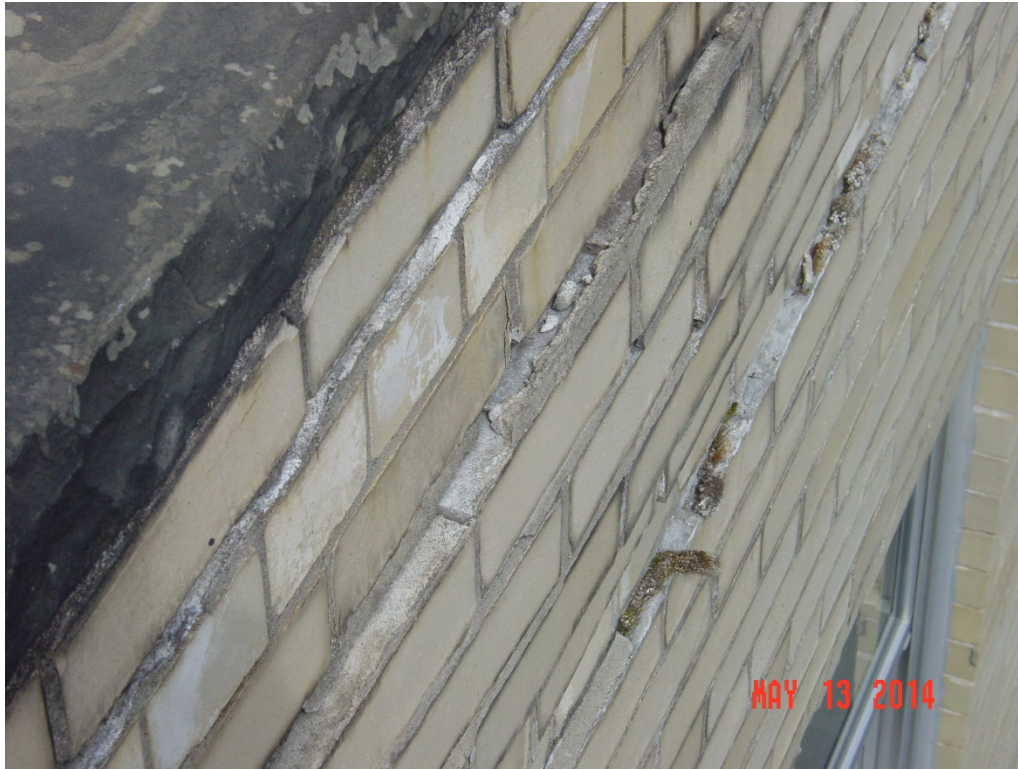
**Brick at top of
southeast corner
of Courtyard wall
prior to repairs**

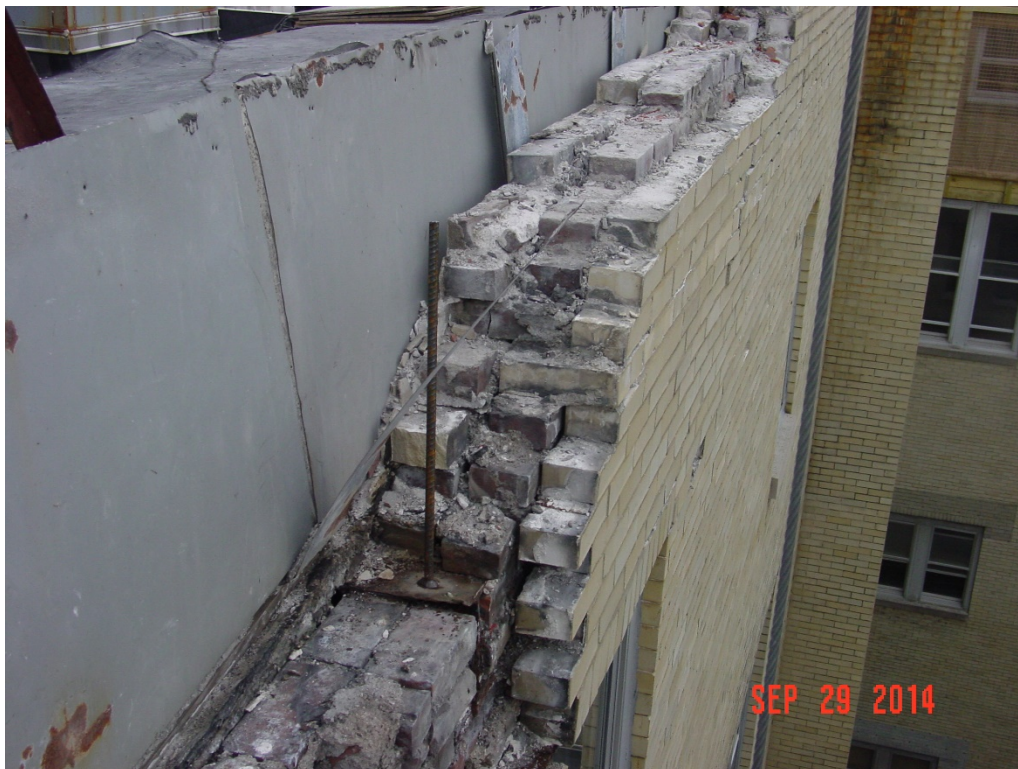
**Parapet Steel
Reinforcing Bars
Added During
Courtyard Wall
Repairs.**

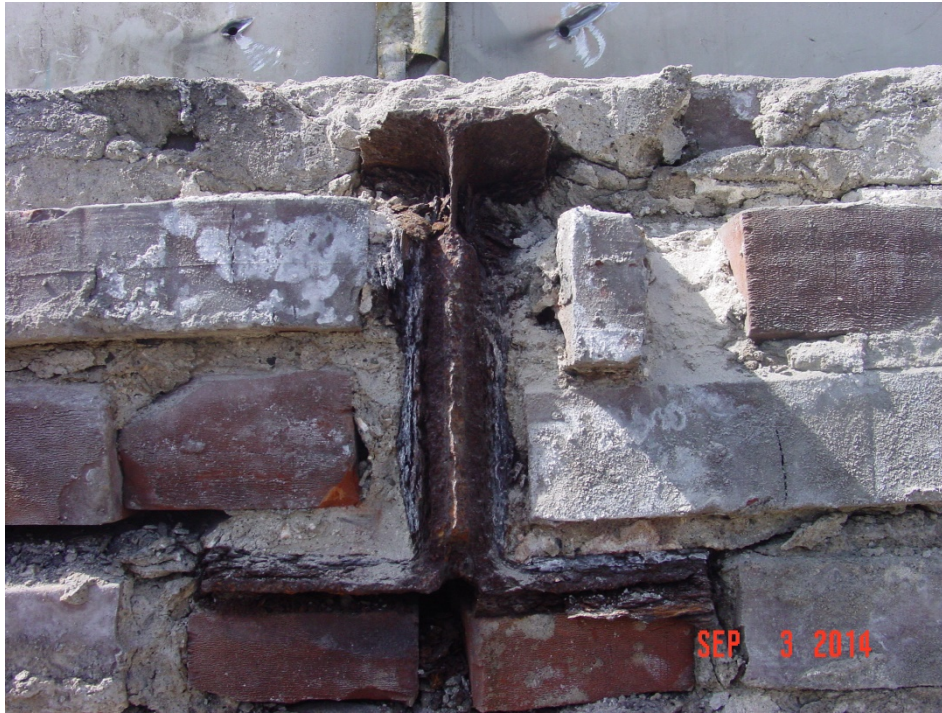
The partial removal of the parapet revealed that the ends of the steel roof beams, which bear on the inner two wythes of brick, had corroded similarly to the exposed window lintels. In some areas the outermost portion of the beams and their steel bearing plates were severely corroded and delaminated. The expansion of these members produced jacking forces in the brick walls, resulting in movements and cracking. This, in turn, has created more paths for storm water to infiltrate the wall and accelerate the deterioration process. The potential damage of the roof beams was noted during the containment design process and the affected beams were shored with built-up wood studs bearing on the attic slab. This was done to protect the roof from localized failure.

Exposed End of typical roof beam at courtyard wall.

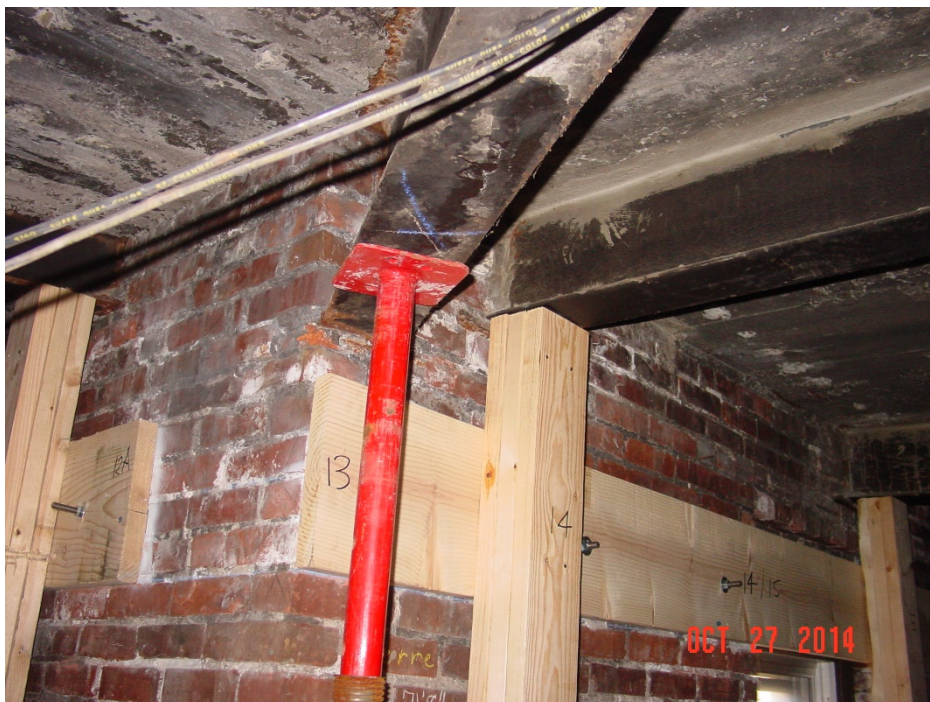
Roof shoring installed in Attic during 2014 courtyard wall repair and containment project

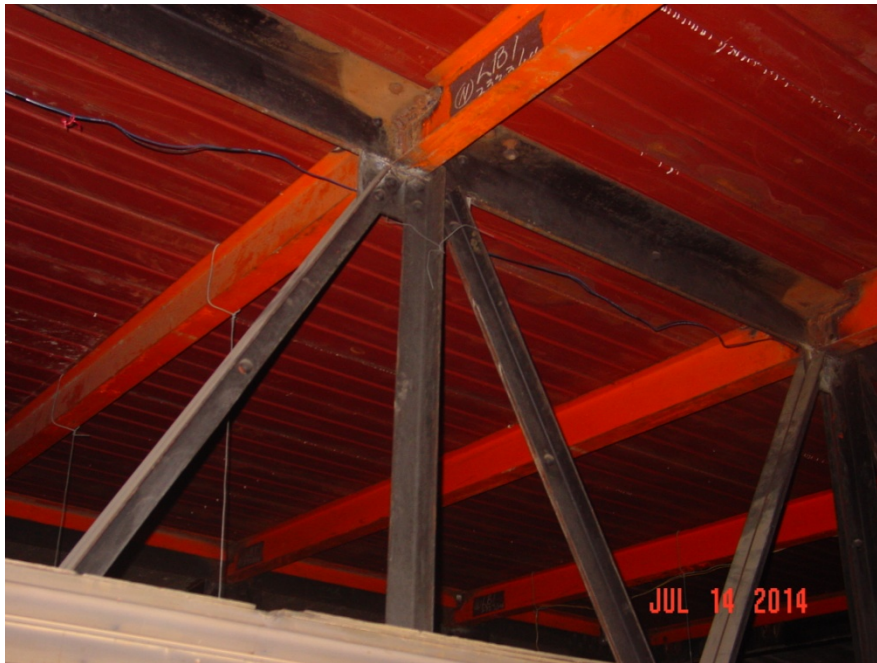
View above library ceiling showing steel framing (orange) in-filled above original skylight.

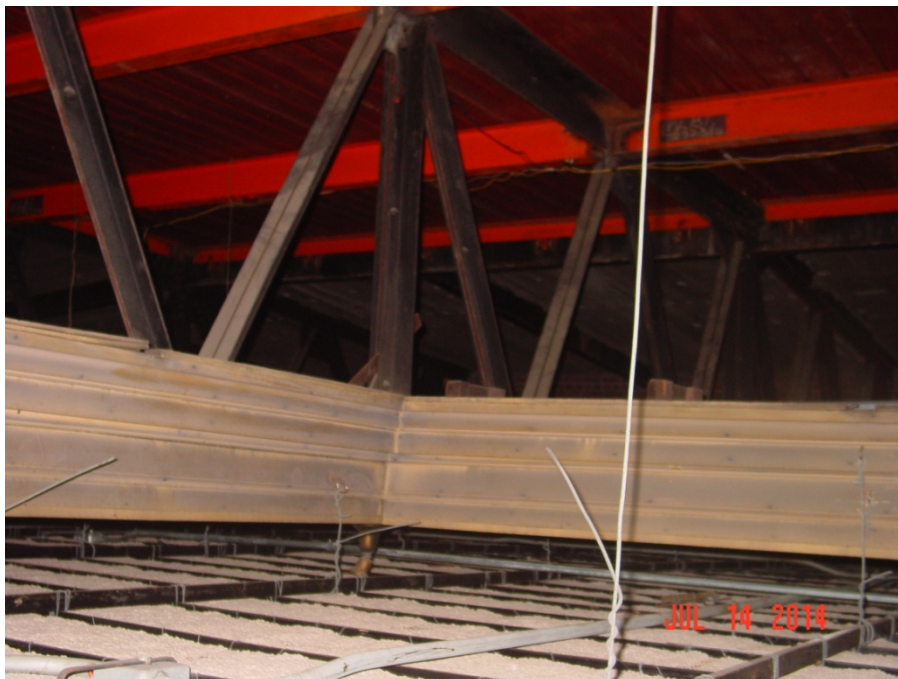
View of former Library skylight window frames and the replacement plaster ceiling hung below.

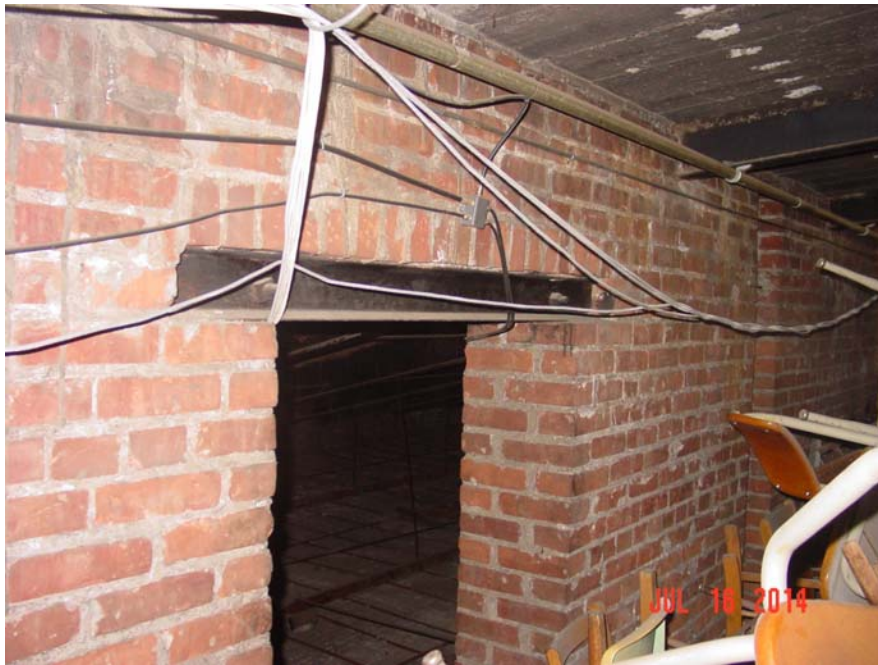
Existing interior Attic brick walls and steel lintels are in sound condition.

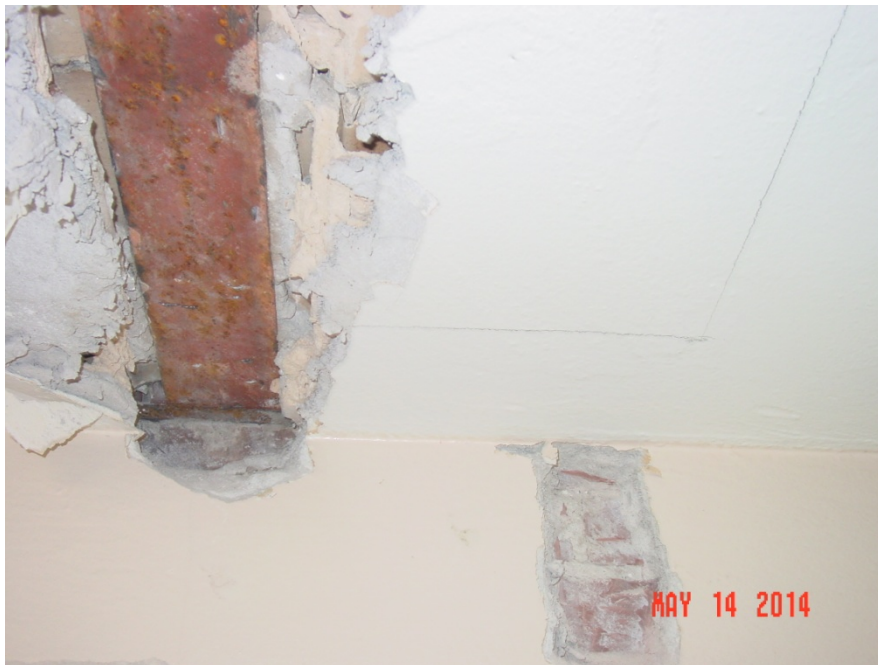
Interior 4th floor beam bearing on Courtyard wall was exposed and found to be in sound condition.

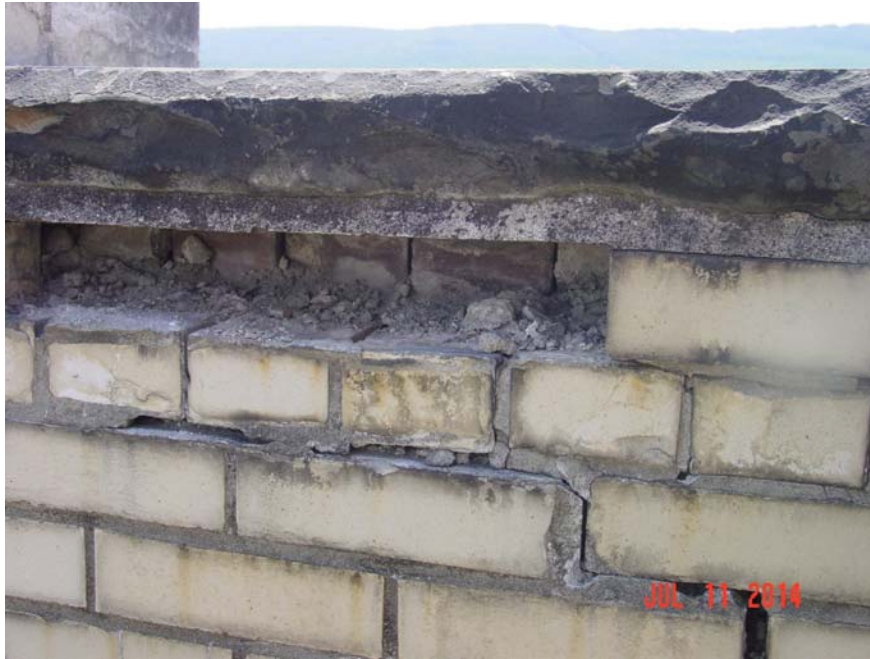
Top of Courtyard parapet prior to repairs in Summer of 2014. Note the deteriorated mortar. The missing bricks were easily removed by hand.

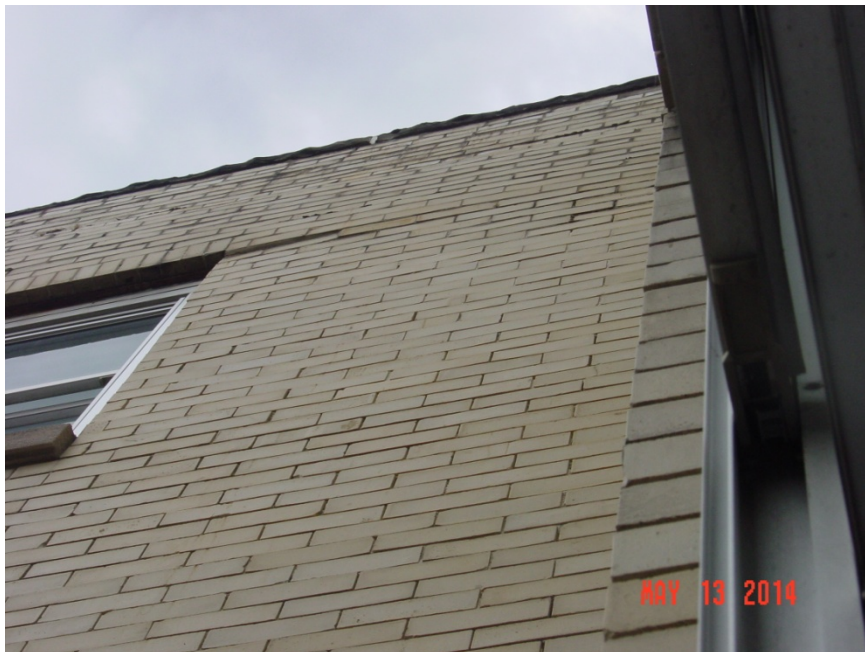
The long-term moisture exposure has also taken its toll on the steel lintels above the numerous courtyard windows. The lintels have corroded, delaminated and expanded to the extent the face brick bearing on them has begun to bulge away from the backing courses. Because the water likely entered the walls through deteriorated joint seals in the stone caps, this condition is most severe in the attic windows and becomes less pronounced at the lower levels. Upon discovery of the precarious condition of the brick and the potential for displaced sections to fall, the library was closed and the second floor windows were covered with plywood. The plywood was installed because the bases of the windows are located only a few inches above the library roof, and therefore brick falling from the roof area had the potential to bounce and break the glass.

Courtyard wall prior to 2014 repairs. Note top corner of window where heavy corrosion in steel window lintels caused the steel to delaminate, expand and push the brick outwards.

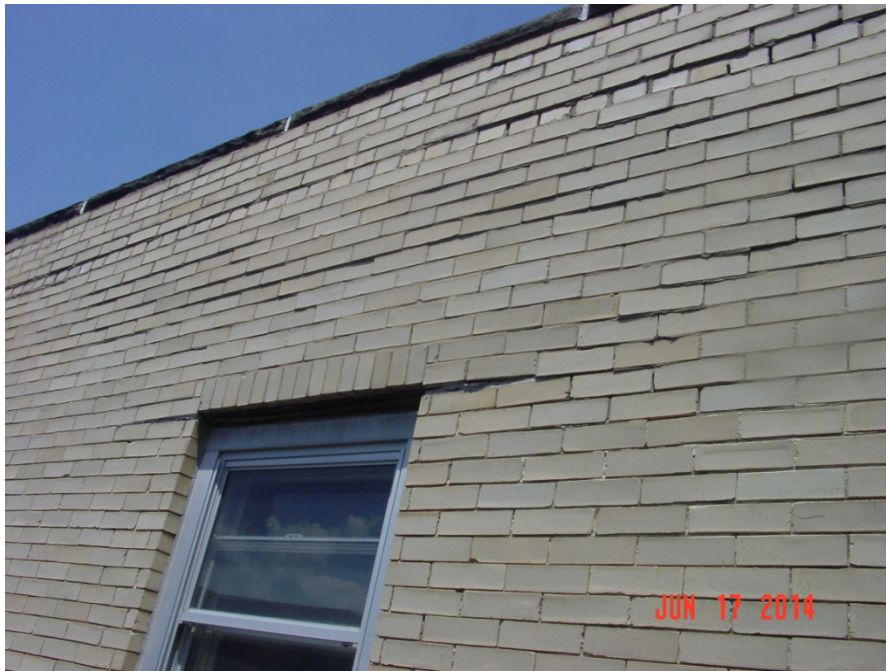
Bowing of brick above an Attic window due to corrosion and expansion of the steel lintel.

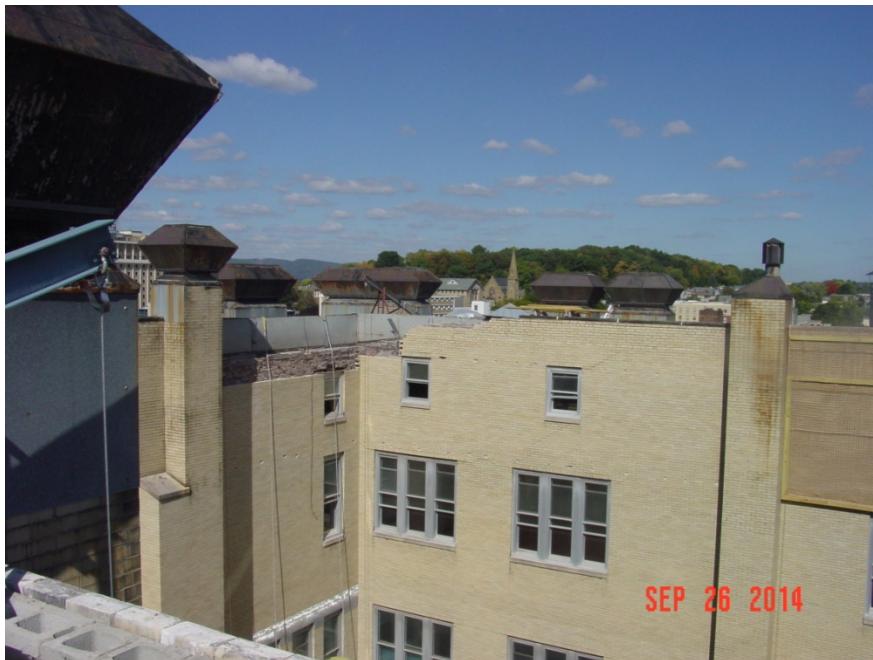
Badly damaged sections of the Courtyard parapets were removed and rebuilt in the 2014 repair/containment project.

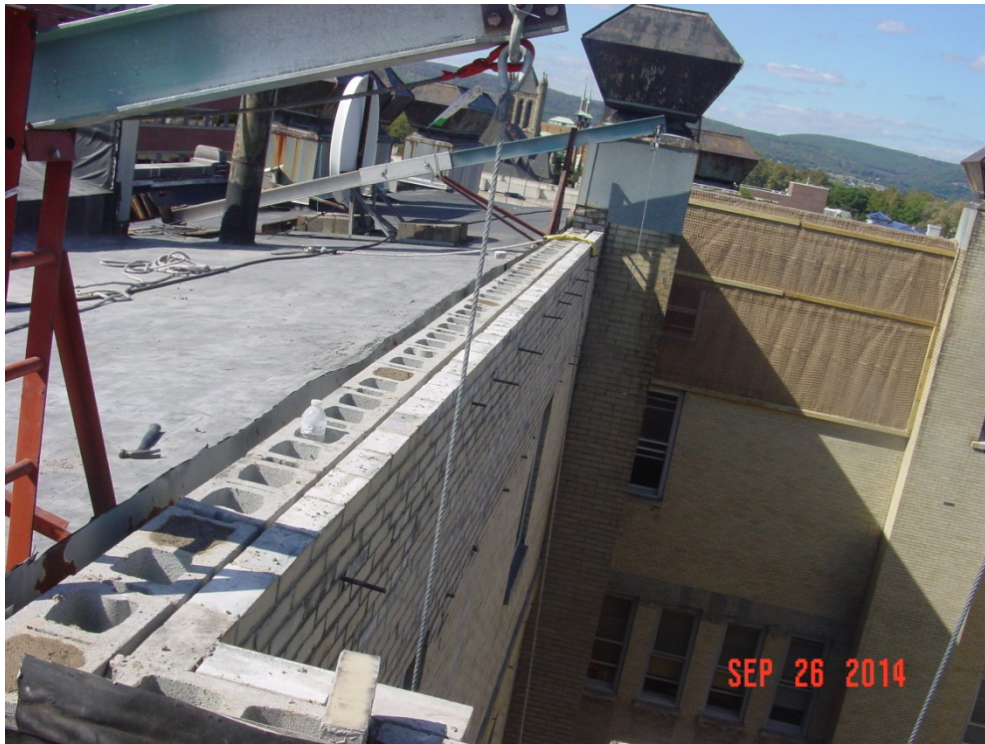
**View of re-built
section of parapet
during 2014
repair/containment
project.**

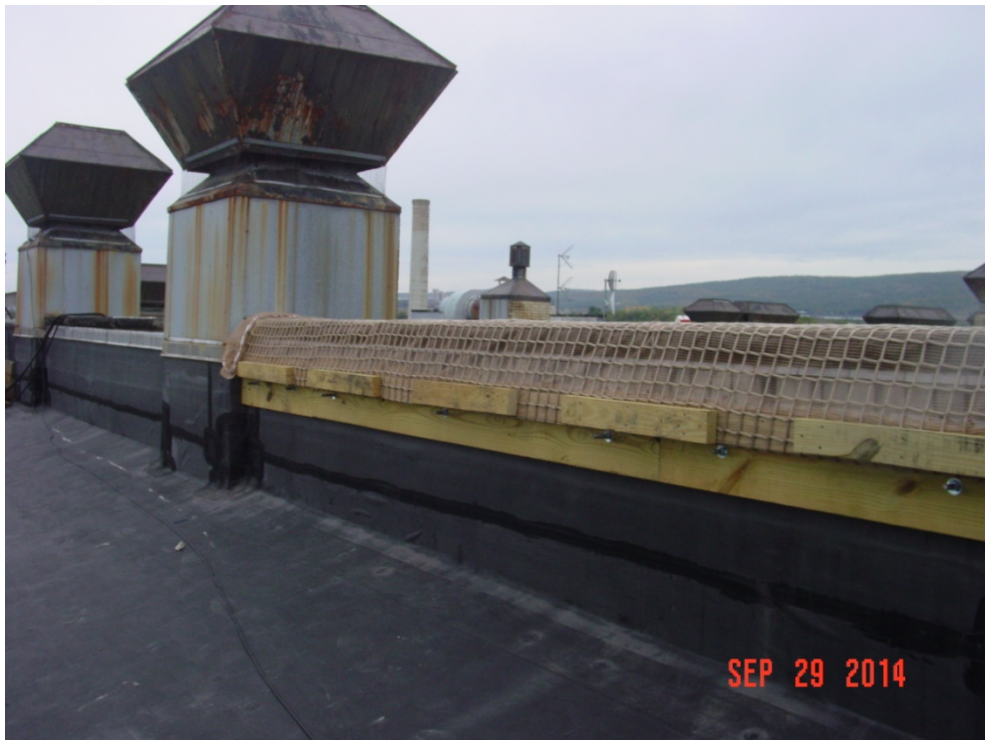
**Anchorage of
containment netting
on rear of existing
parapet.**

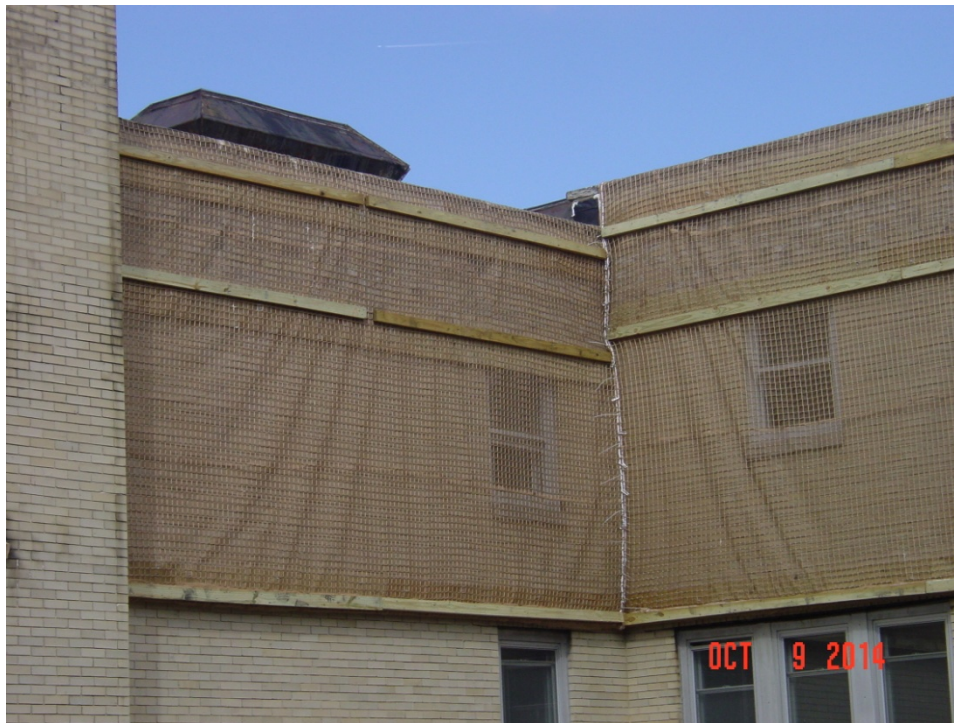
**View of completed
repair/containment
netting in northwest
corner of Courtyard.
Existing parapet was
rebuilt at lower
elevation on west side
where roof elevation
drops above
Auditorium stage.**

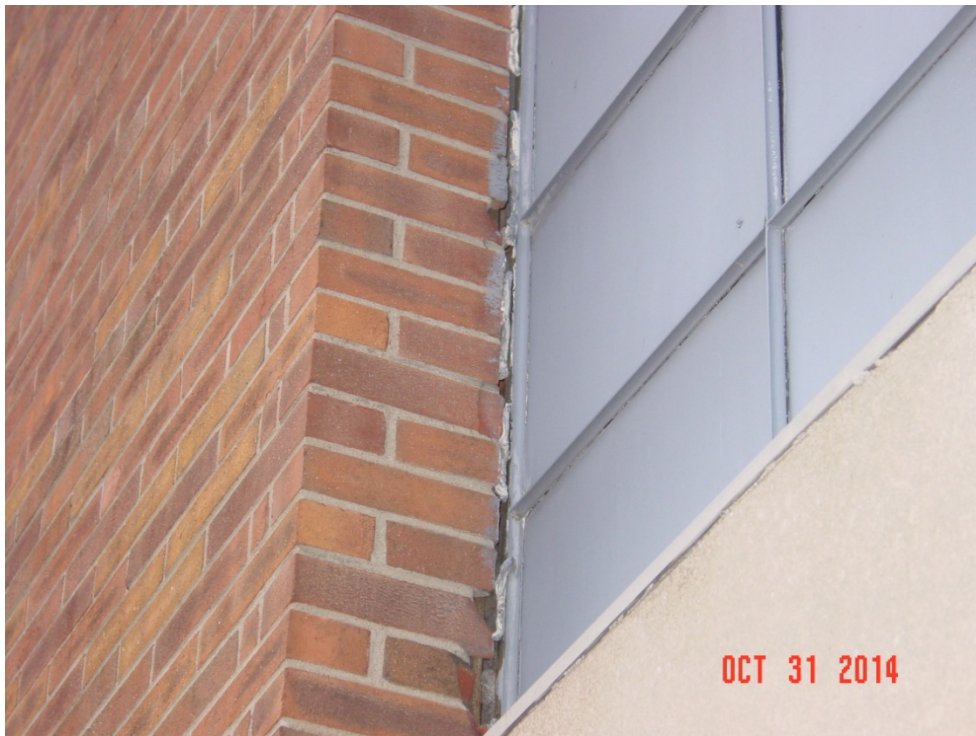
Brick / window joint on south wall of Gymnasium. Joint is failing and allow water to infiltrate which may be initiating internal corrosion. The Annex façade should be maintained if short or long-term continued occupancy is anticipated.

If the Annex is to be occupied for another 2 to 5 years, it is recommended that a façade maintenance program is implemented as soon as possible. This will include the repointing of the brick and re-grouting of the stone panel joints. Maintaining the exterior façade will greatly improve the lifespan of the building and will maintain its future value should the District sell the Annex upon completion of the short-term occupancy. Estimated cost: \$250K

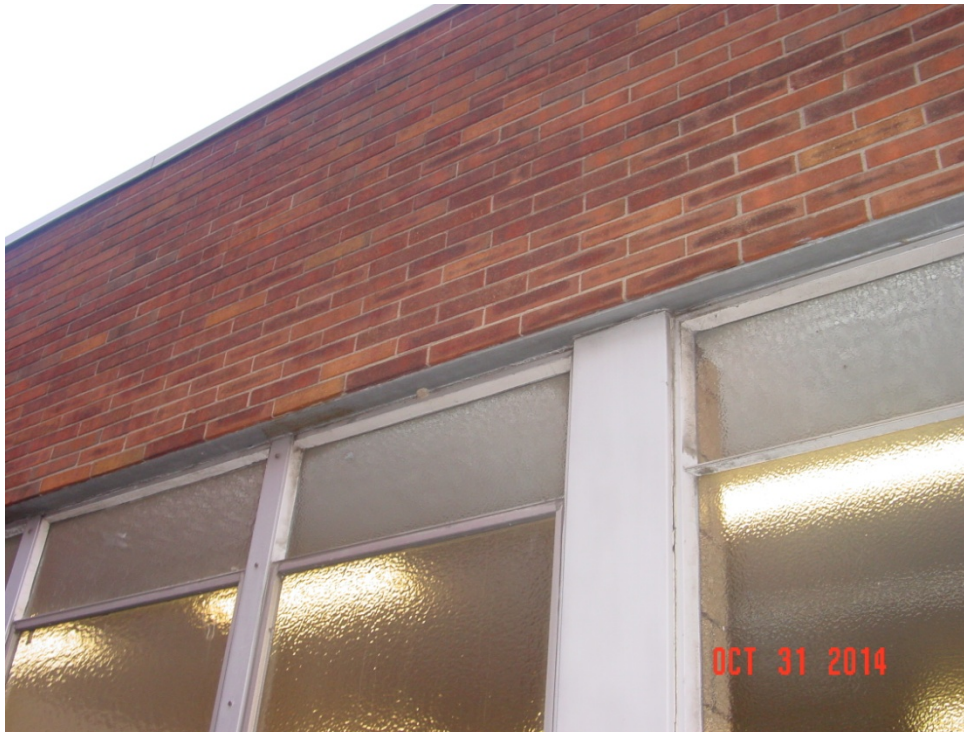
West wall of Annex is in fair to good condition. There is currently no visible lintel corrosion. Brick re-pointing is recommended to maintain the condition of the joints and supporting steel.

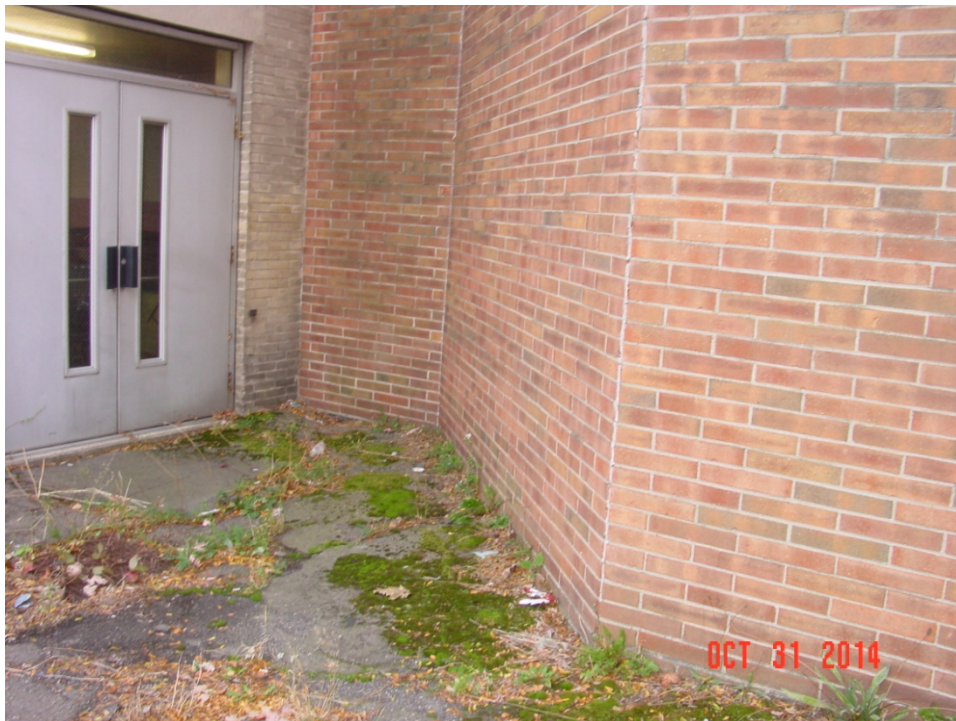
Single story tie-in of Annex and original school Auditorium area. Note corner joints beginning to fail.

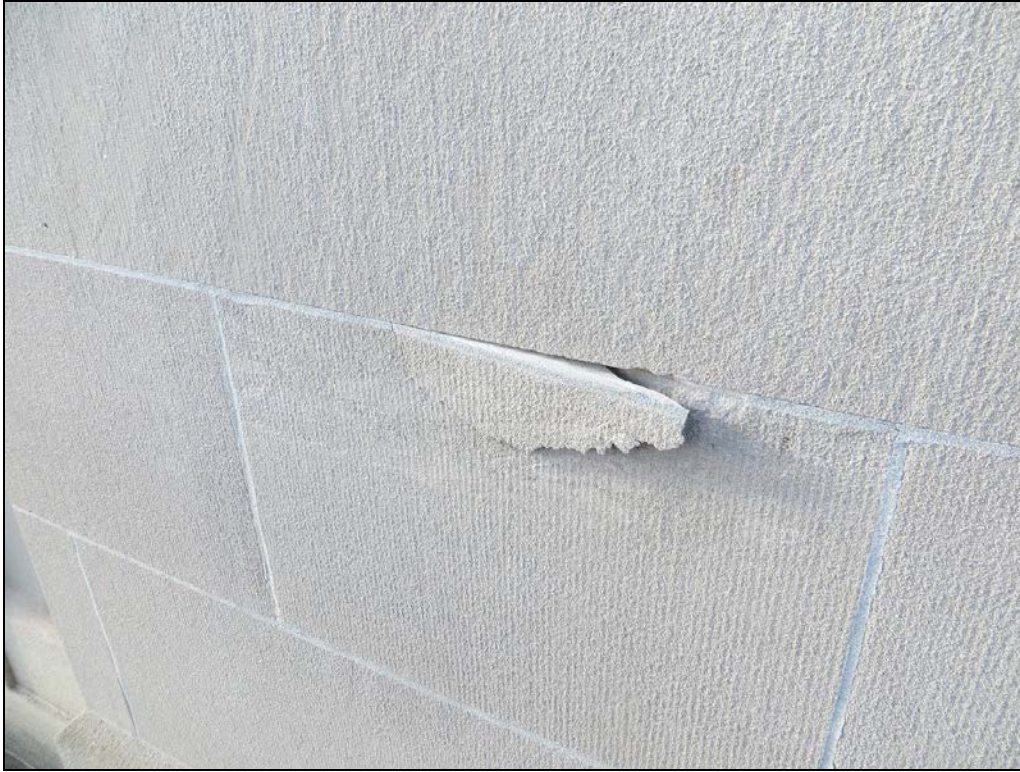
Photograph 3:

Typical crescent shaped spall ready to fall from the building.

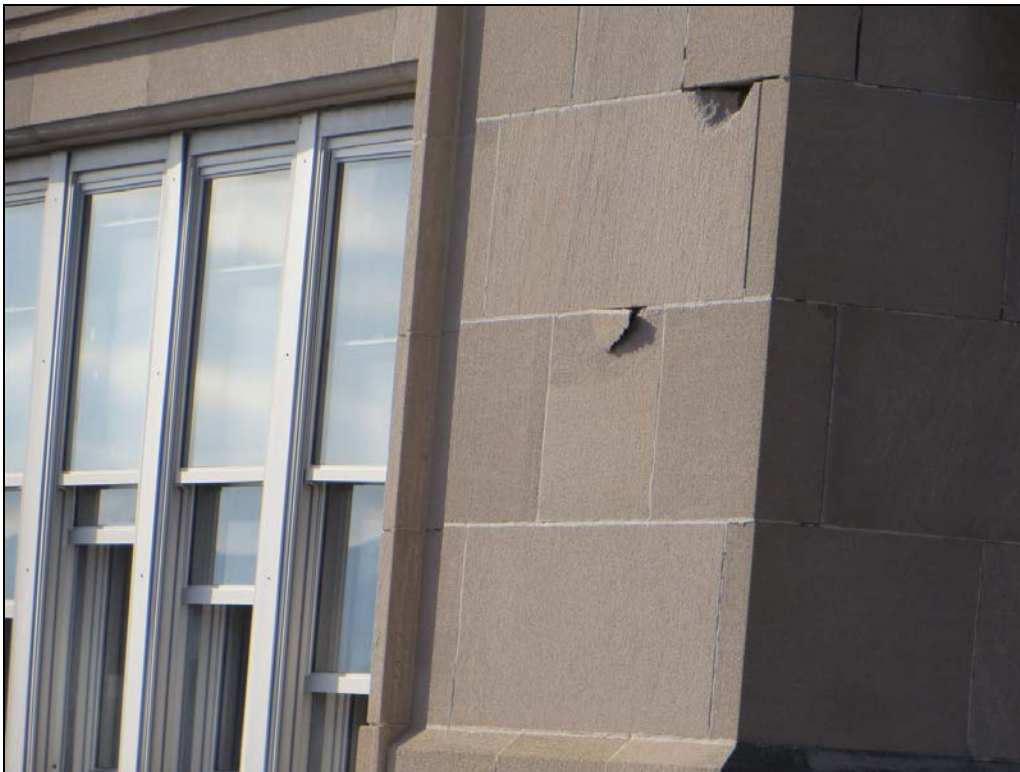
Photograph 4:

One spall that already came loose from the building and one that is ready to fall.

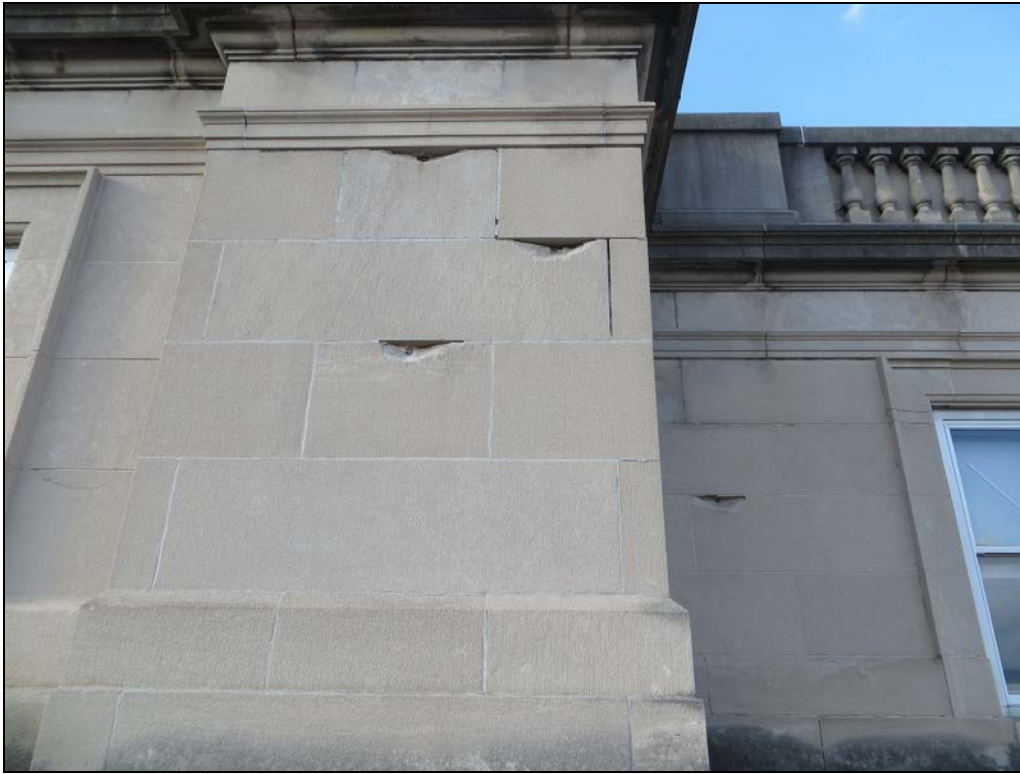
Photograph 5:
Multiple spalls in
close proximity to
each other.

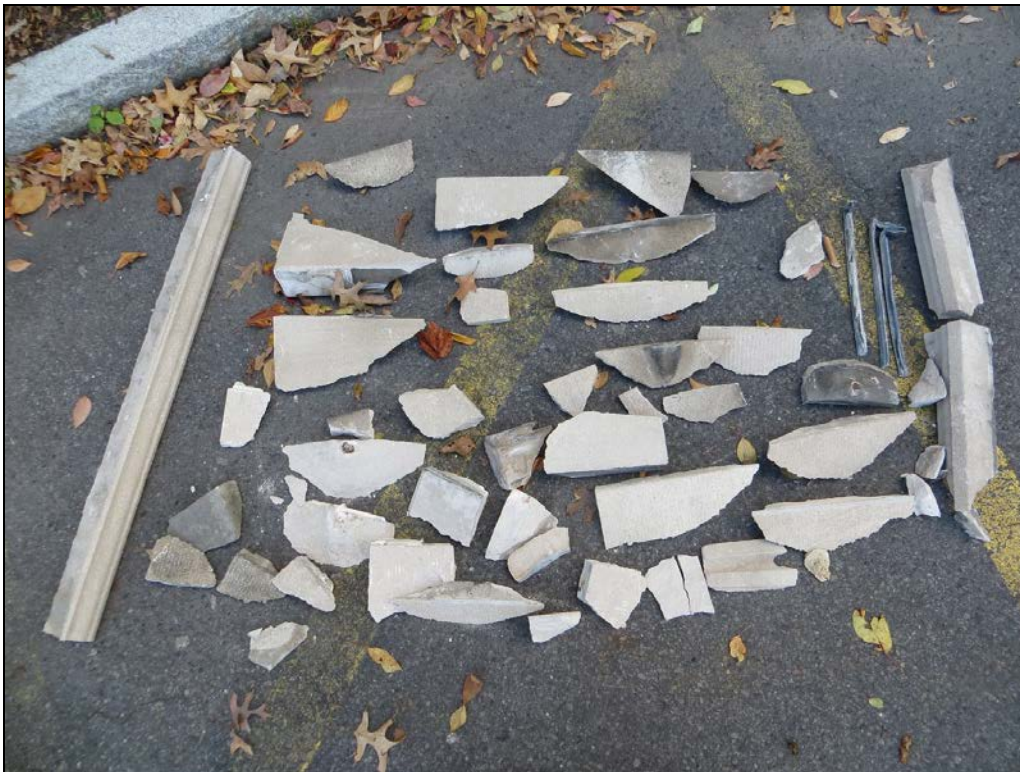
Photograph 6:
MPS removed
several pieces of
stone from the
building that were
ready to fall. This
picture does not
include the
multiple pieces of
stone that have
already fallen to
the ground. The
falling stone pieces
prompted the
installation of the
fencing and
overhead
protection.

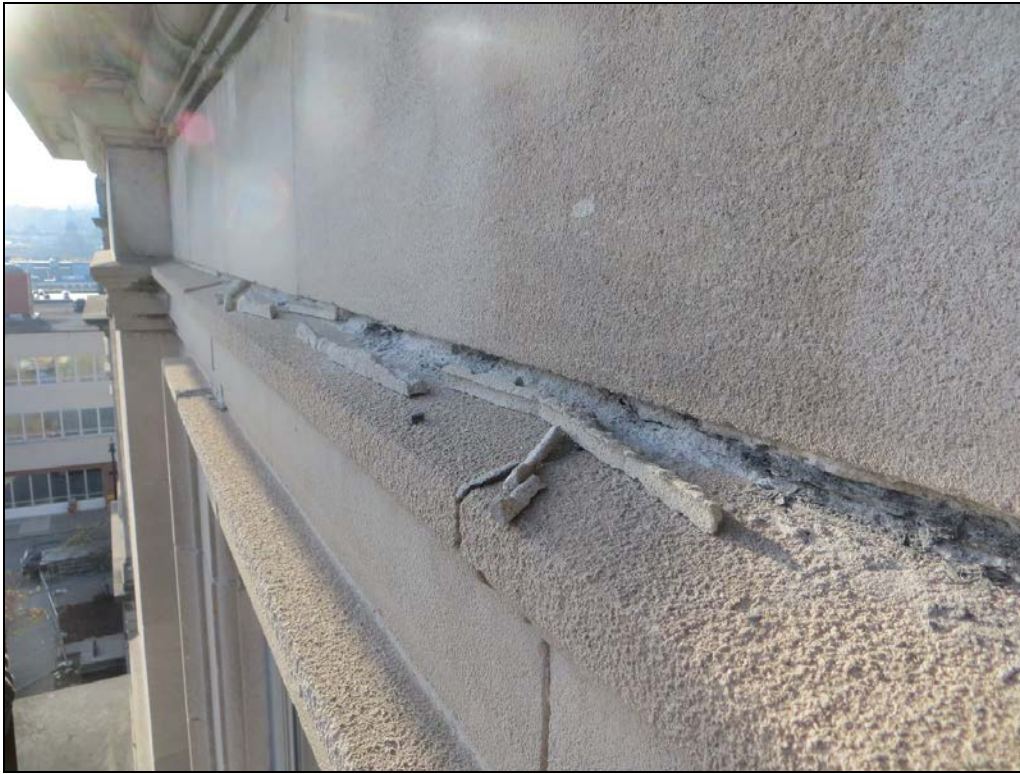
Photograph 7:

Deterioration of the mortar joints between the limestone panels is allowing excessive water to enter the wall assembly. Slate shims were exposed behind the failed mortar joint.

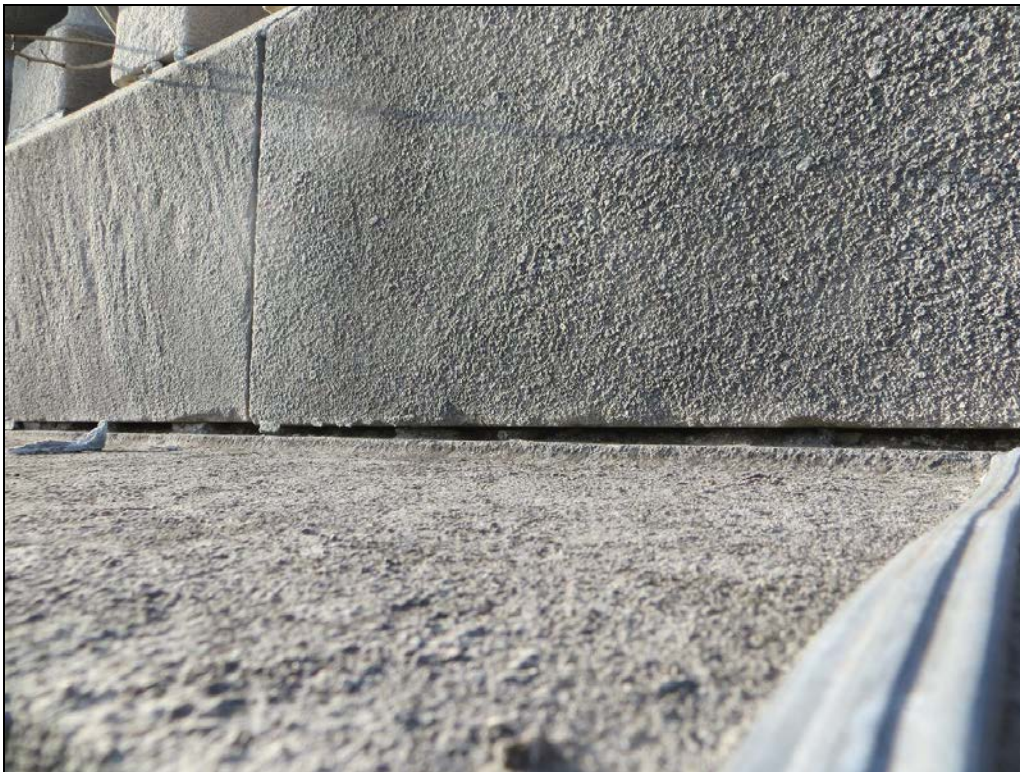
Photograph 8:

This joint with missing mortar is wide open, allowing large amounts of bulk rain water to enter the wall assembly.

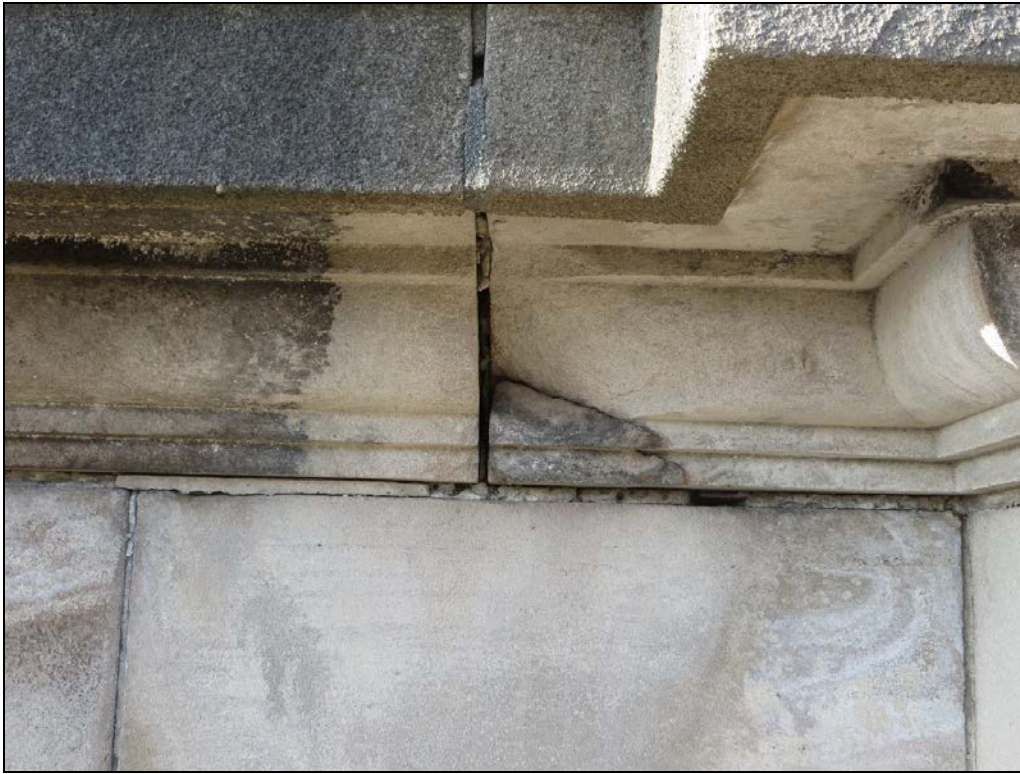
Photograph 9:

Open mortar joint
above an insipient
spall.

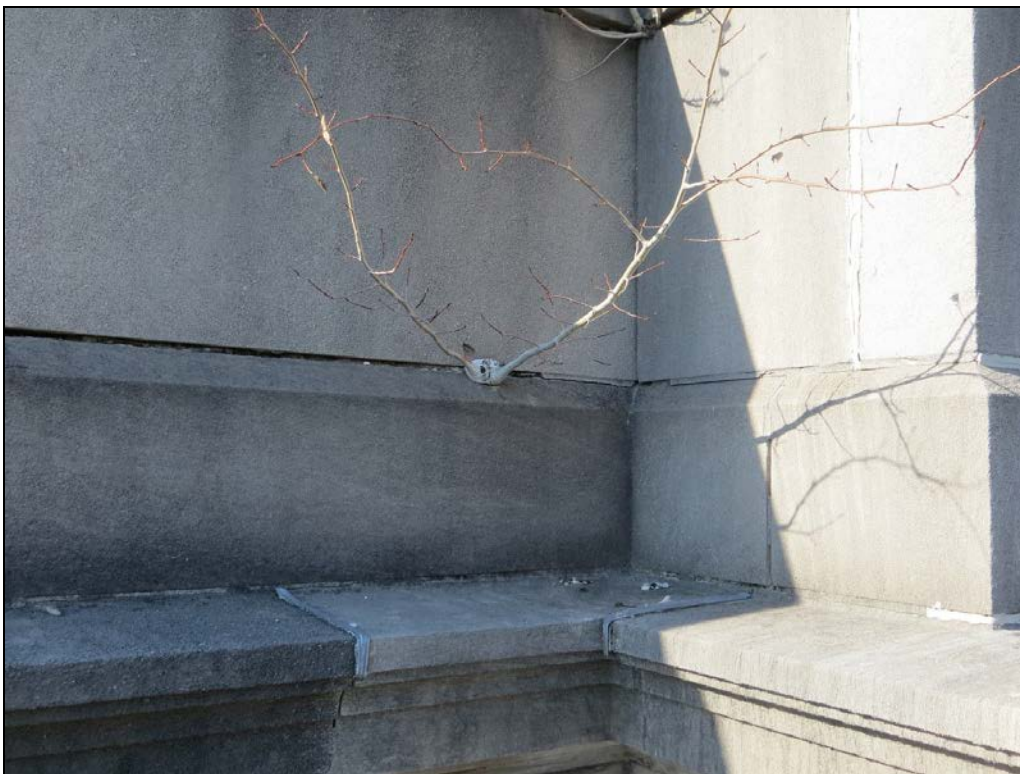
Photograph 10:

The presence of
plant growth is an
indication the wall
assembly is
saturated.

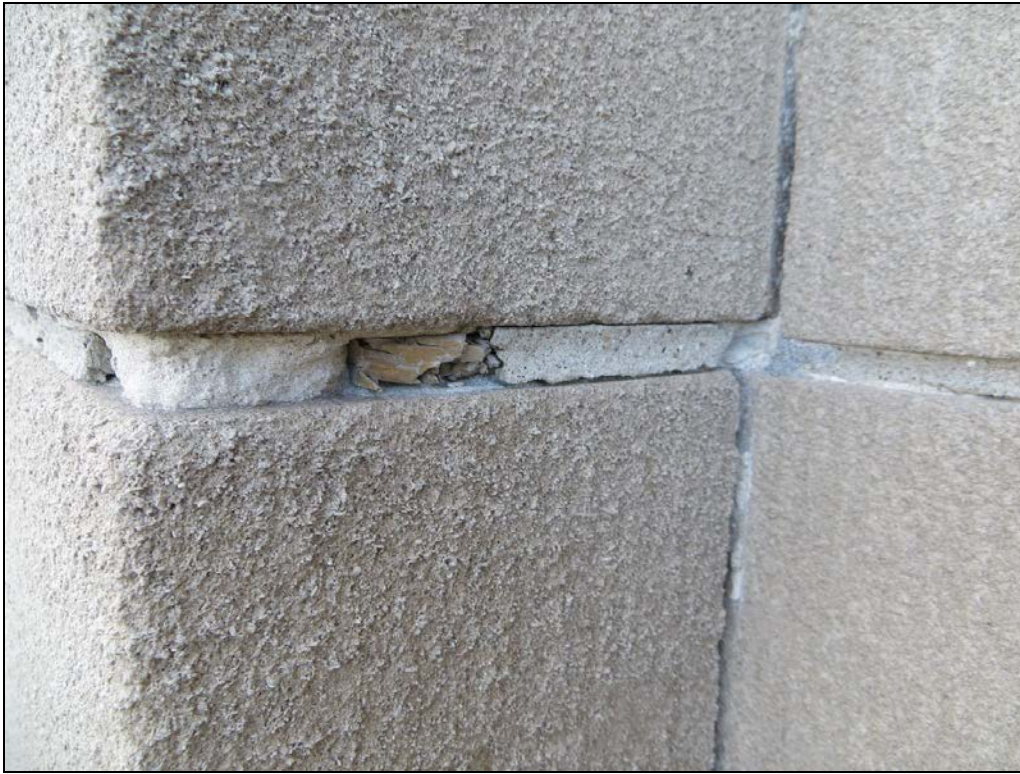
Photograph 11:
An original wood shim at a failed mortar joint.

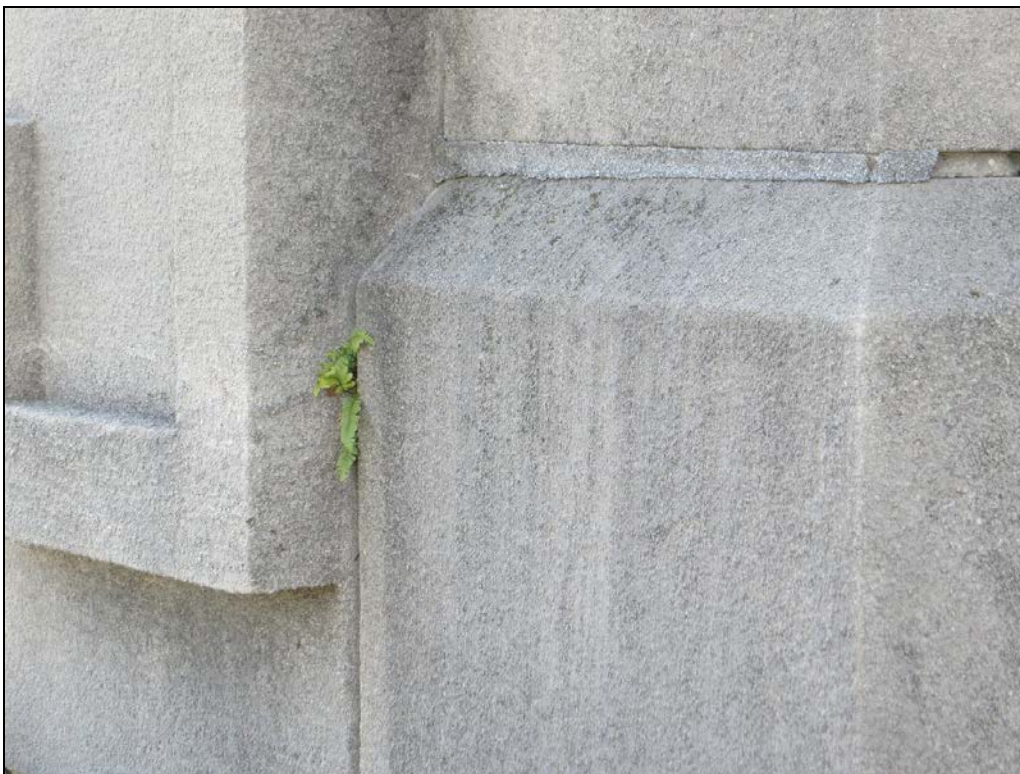
Photograph 12:
More plant growth in an open mortar joint.

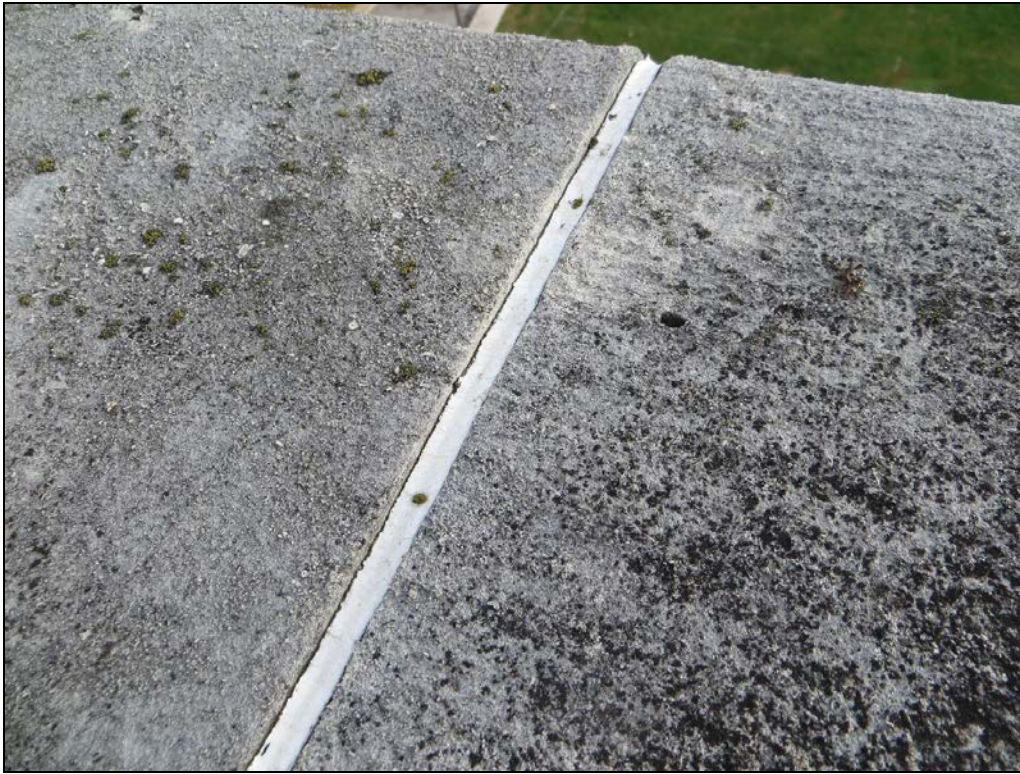
Photograph 15:
Most of the sealant joints between the coping pieces were failed.

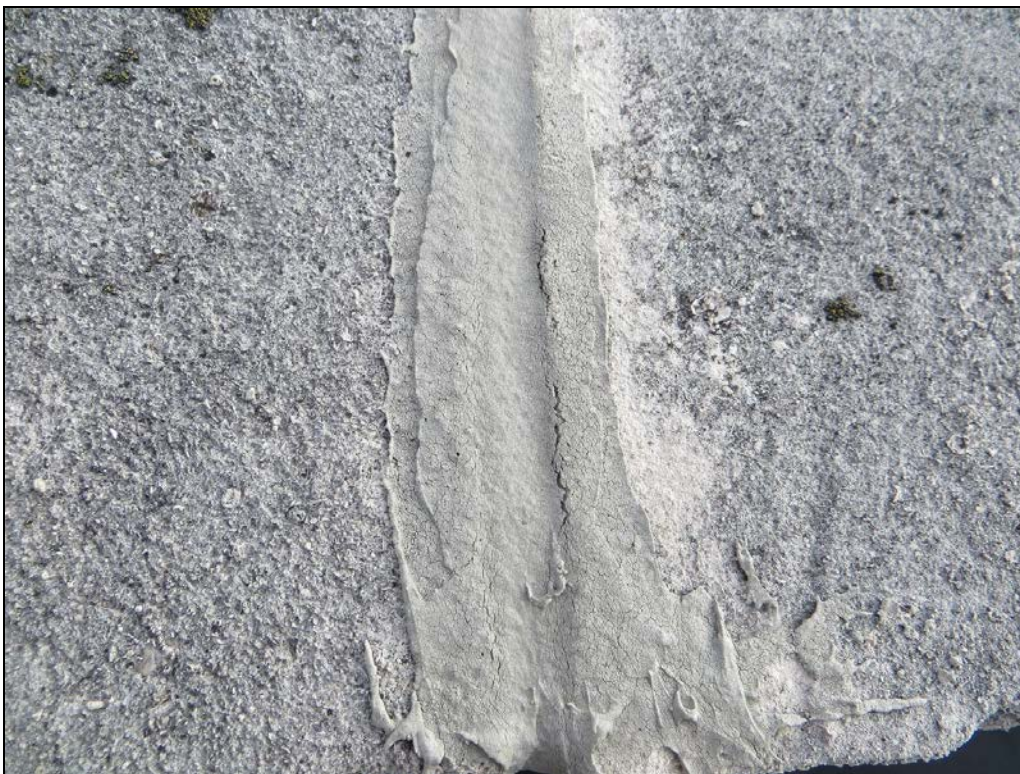
Photograph 16:
Even newly replaced sealant joints were already beginning to fail.
