WILKES-BARRE AREA SCHOOL DISTRICT STRUCTURAL EVALUATION OF JAMES M COUGHLIN HIGH SCHOOL

December 8, 2014

Re: Structural Evaluation of Coughlin High School

Coughlin High School Structural Evaluation

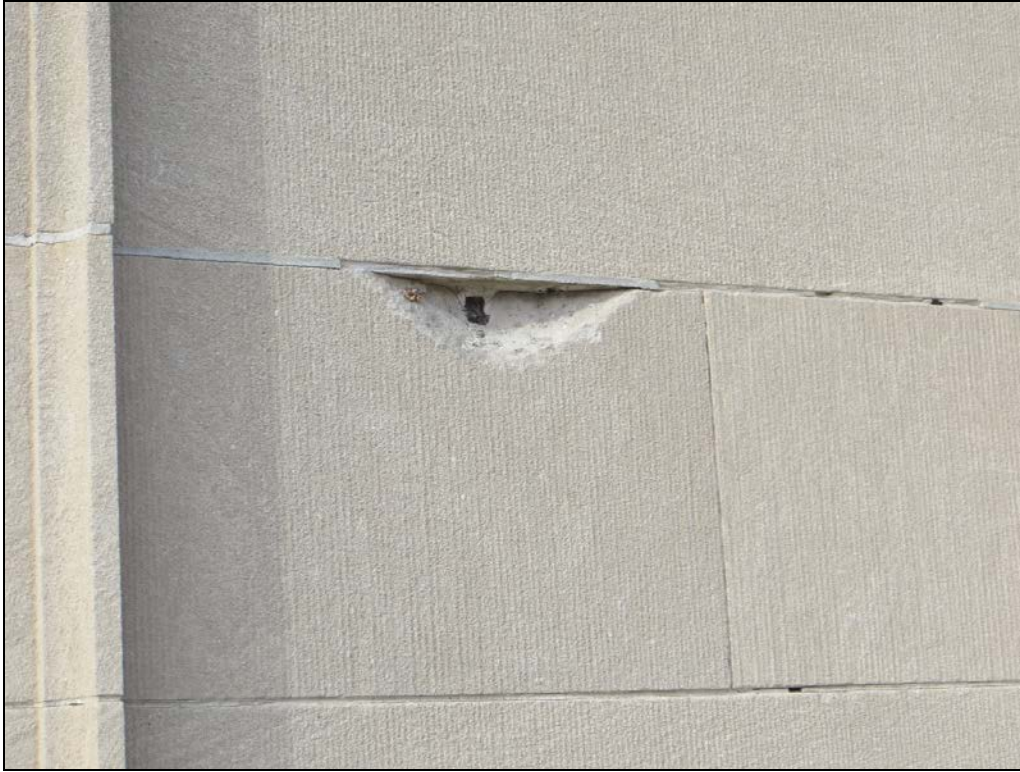
Photograph 17:

The crescent shaped spalls were typically associated with corroded cramp anchors. The cramp anchors provide lateral support to the stone.

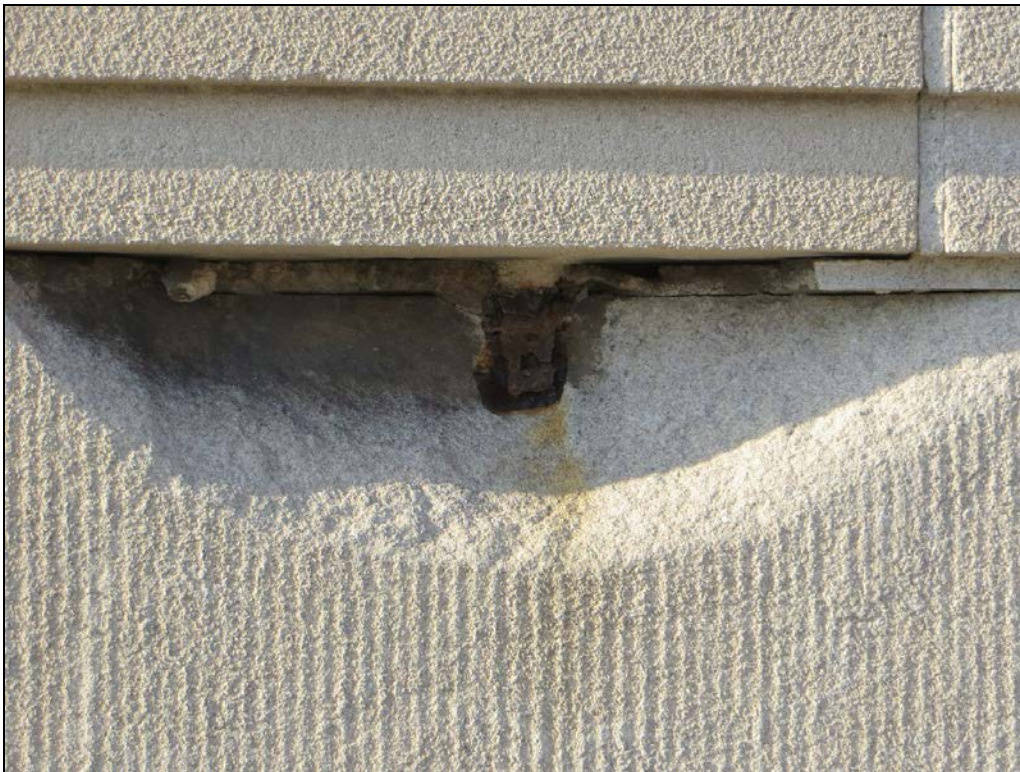
Photograph 18:

Corrosion of the cramp anchor put pressure on the stone, eventually causing the spall.

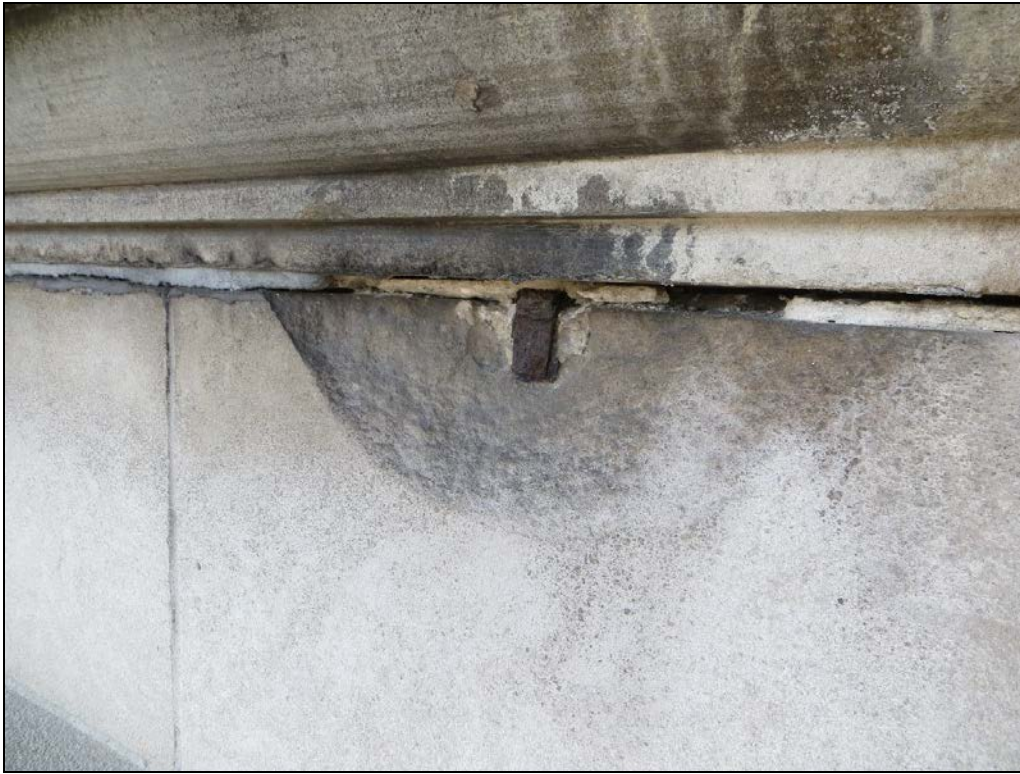
Photograph 19:
Most of the
anchors at the spall
locations were
heavily corroded.

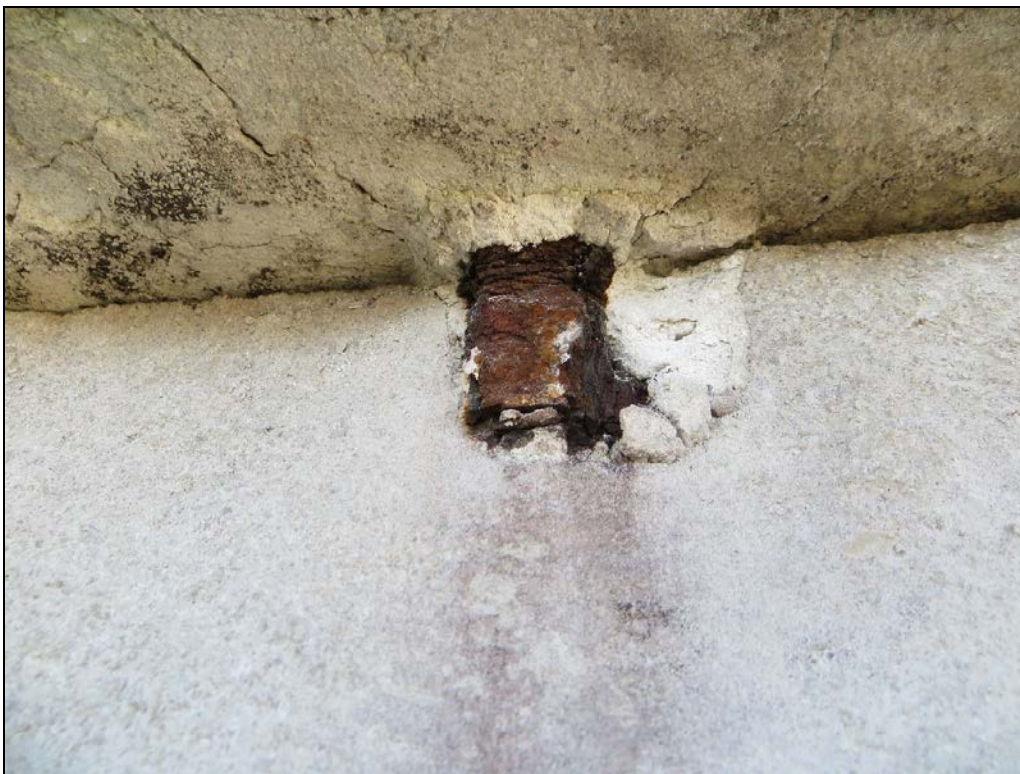
Photograph 20:
The corrosion of
the anchors is
caused by water
within the wall. As
the walls take on
more water the rate
of corrosion of the
anchors increases.

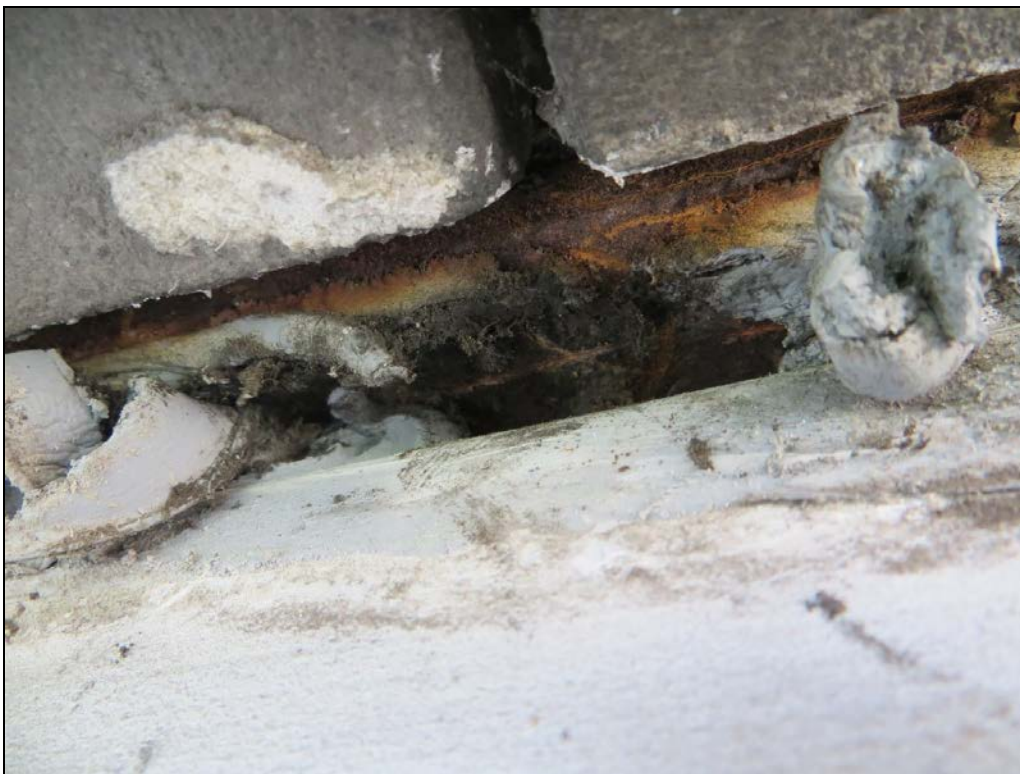
Photograph 22:

Corrosion of the steel under the massive stone pieces. Some displacement of the stone pieces was noted, which will continue as the steel continues to corrode.

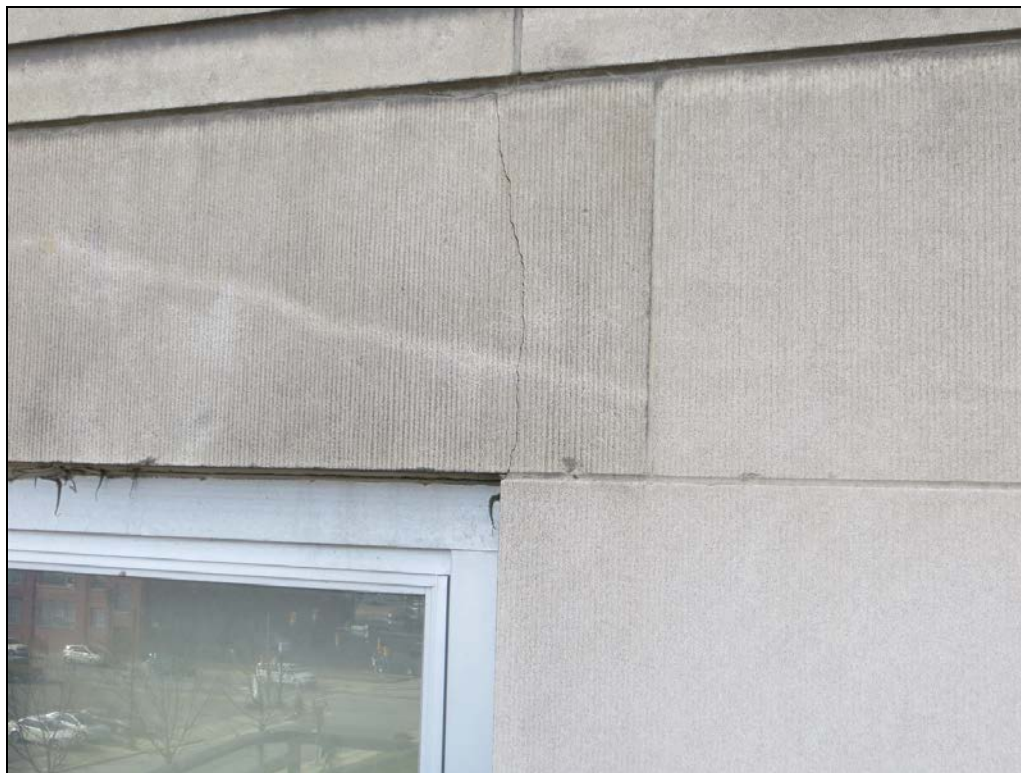
Photograph 23:
Cracked stone pieces were noted above some of the windows.

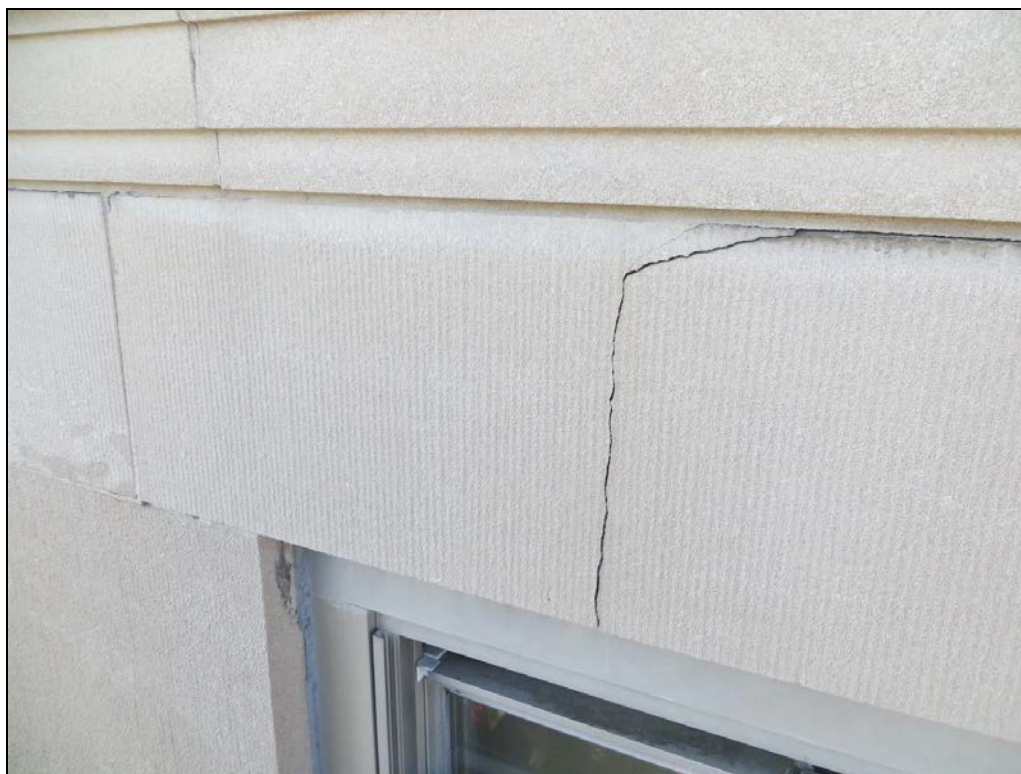
Photograph 24:
Some of the cracks were significant, indicating the stone was under significant stresses caused by the corrosion of the steel below.

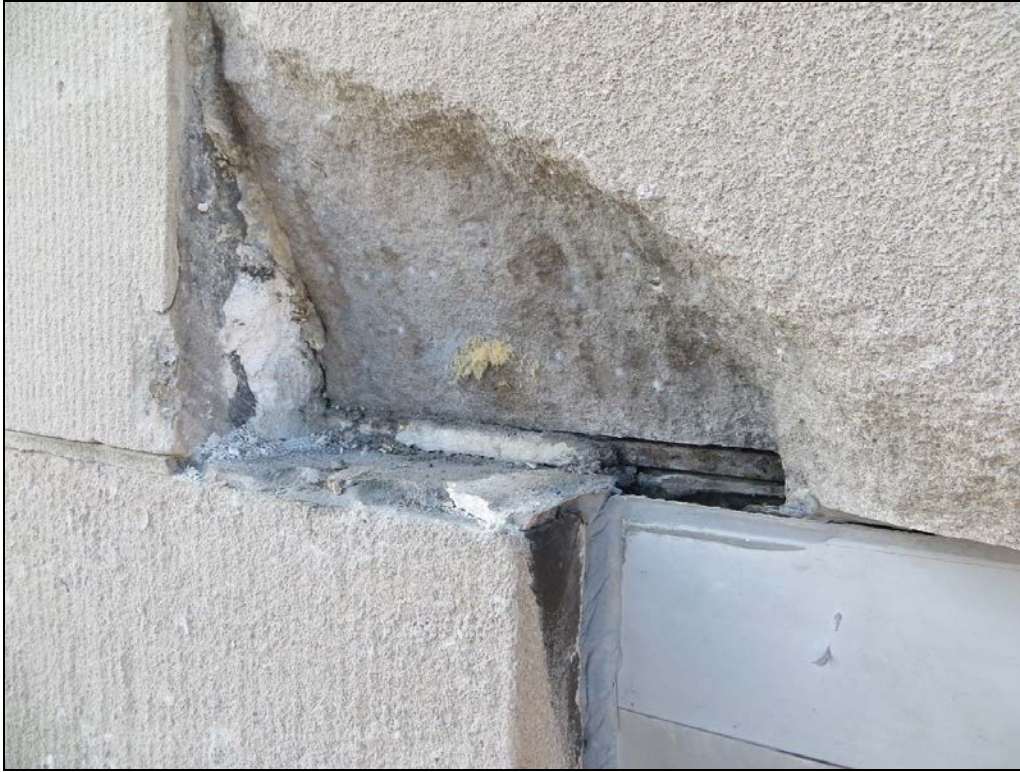
Photograph 25:

At other locations the corrosion of the steel caused the stone to spall.

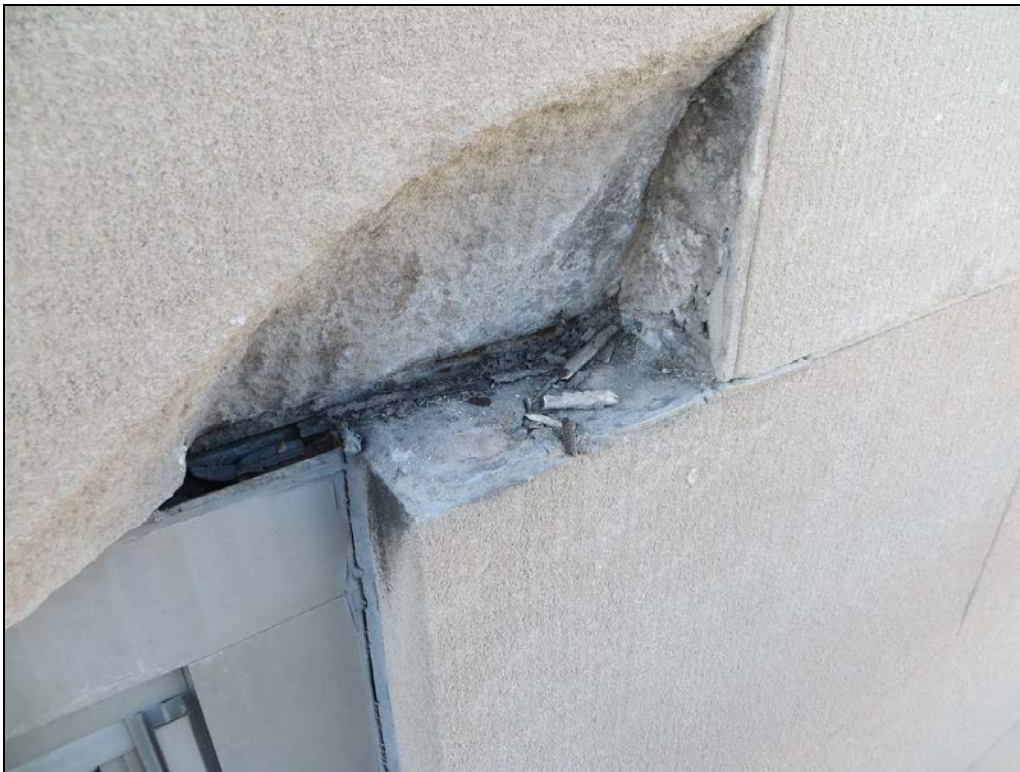
Photograph 26:

The spalls tended to occur above the window jambs, where the steel was fully embedded in the masonry, and therefore, subjected to more trapped water.

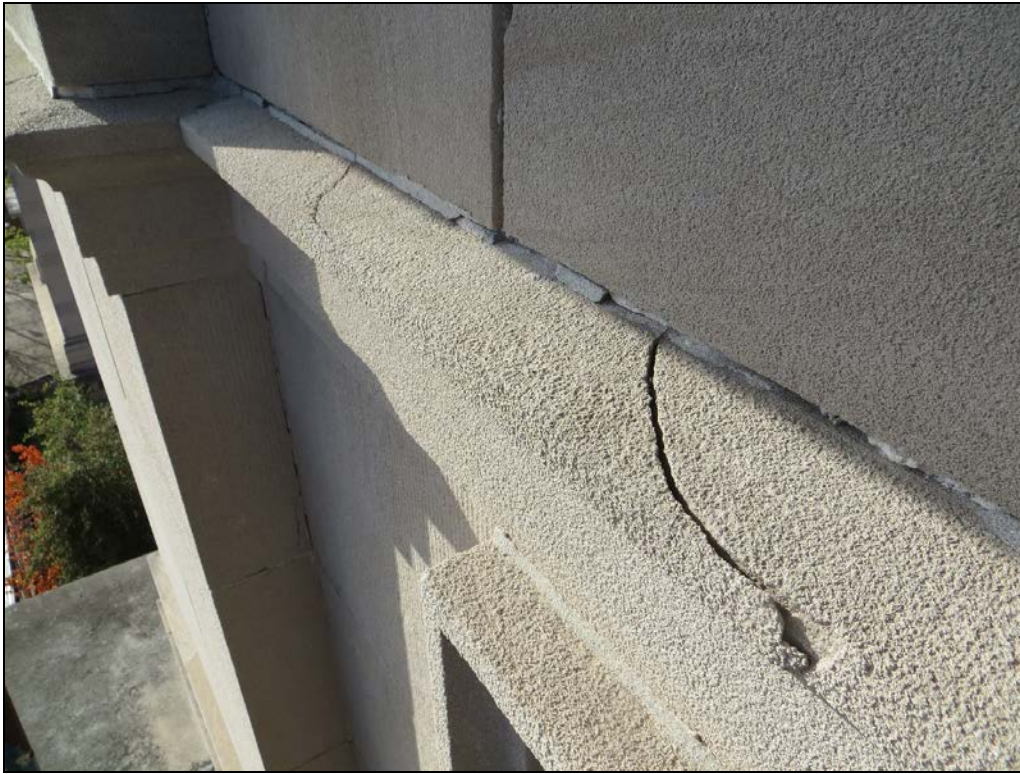
Photograph 27:

Cracks in the molding just above a window opening appeared to be caused by the same steel assembly that supports the stone above the window openings.

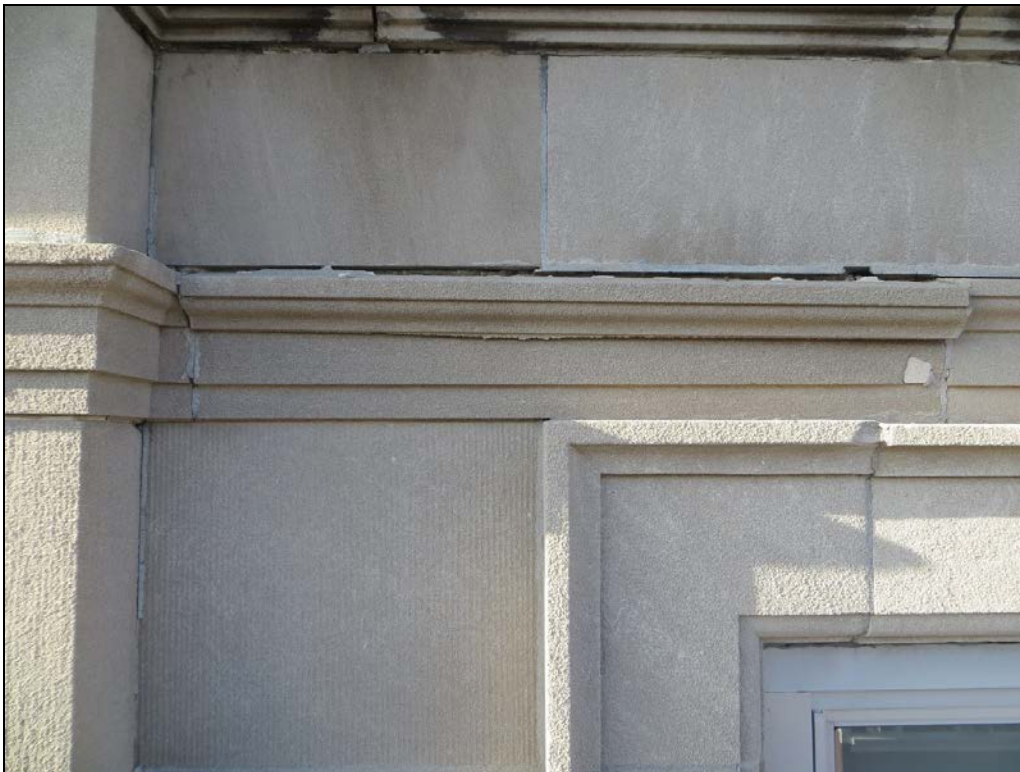
Photograph 28:

This molding piece was ready to fall. Without drawings we do not know the configuration of the steel at the window heads, but the proximity of the steel directly above the window to the steel behind the molding indicates they may be part of the same assembly.

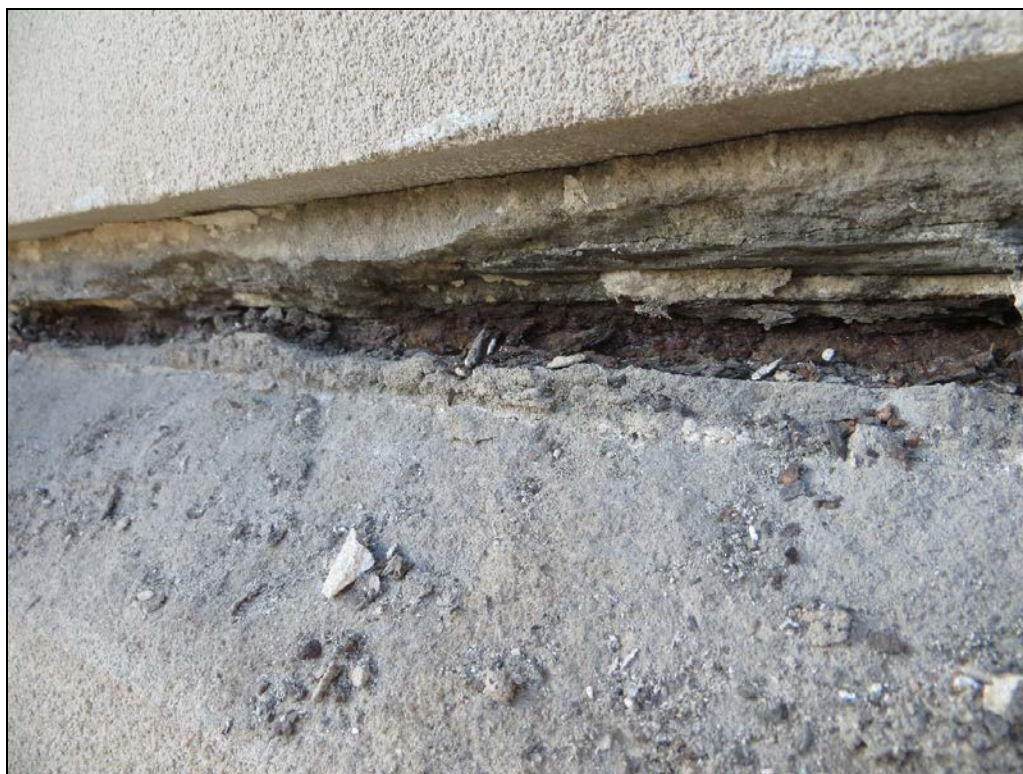
Photograph 30:
The steel behind the molding piece was heavily corroded.

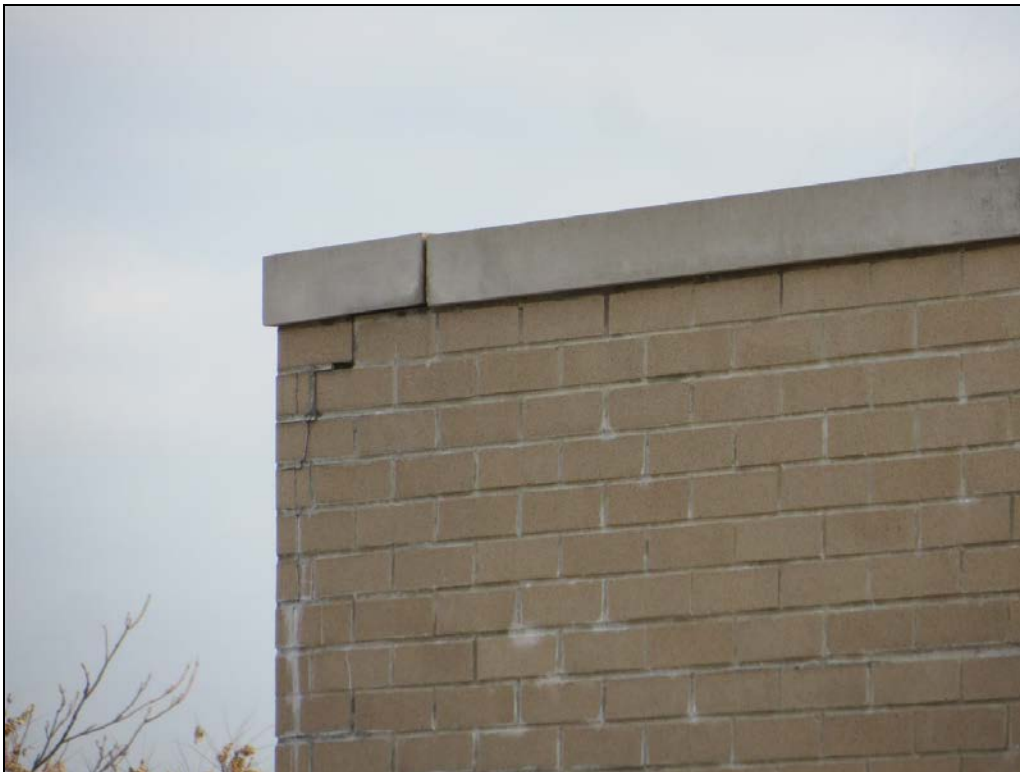
Photograph 34:
The chimney was
in fair condition,
but we did not
some cracking and
displacement at the
upper corner.

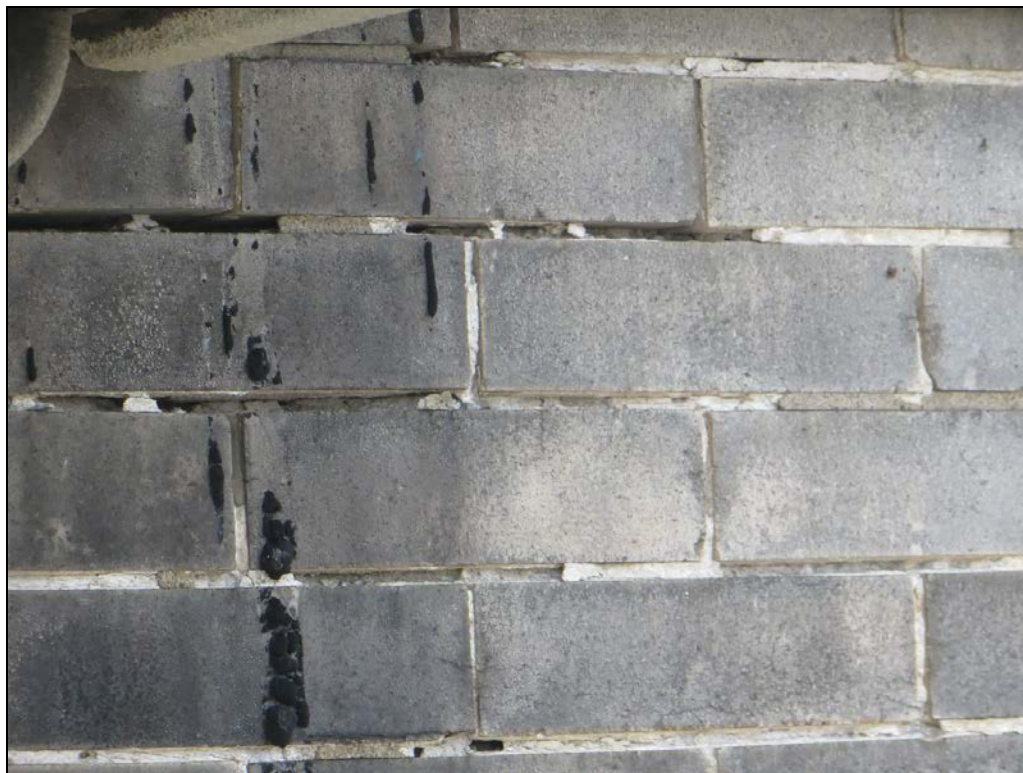
Photograph 35:
The mortar joints
on the rear of the
building were in
poor condition.

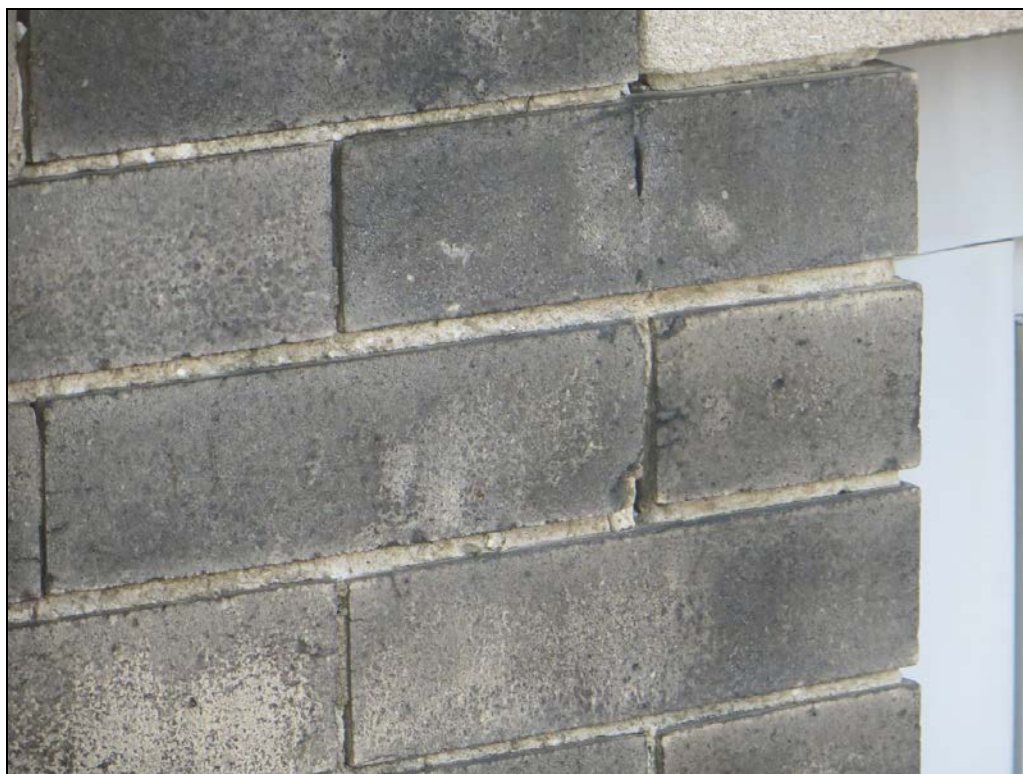
Photograph 36:
The weathered
joints expose the
tops of the brick,
which creates a lip
to catch water,
increasing the rate
of water
penetration.

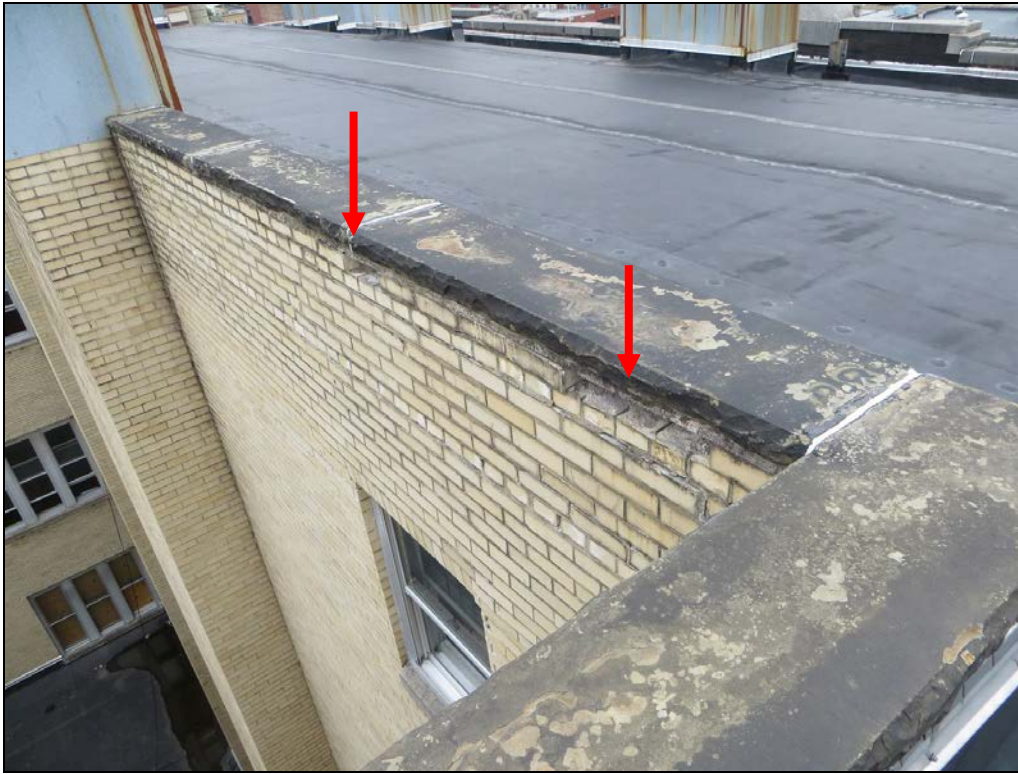
Photograph 37:
The brick veneer on the courtyard elevations was in poor condition, particularly at the parapets. Note the missing brick under the coping.

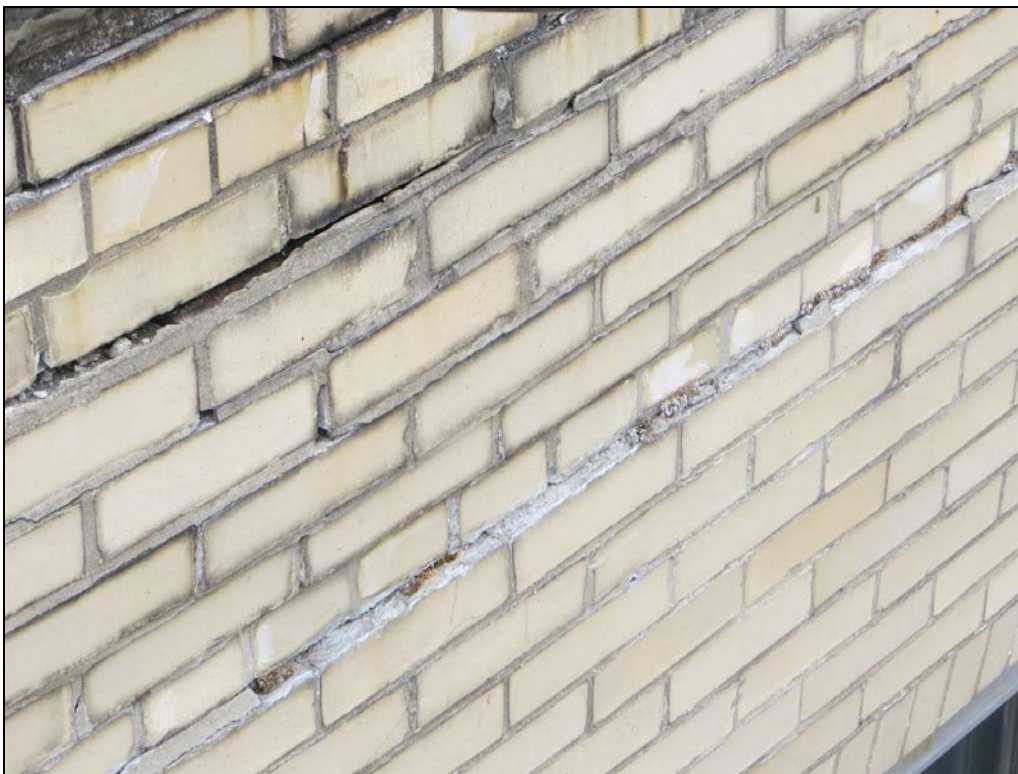
Photograph 38:
Cracked and displaced brick were observed at multiple locations.

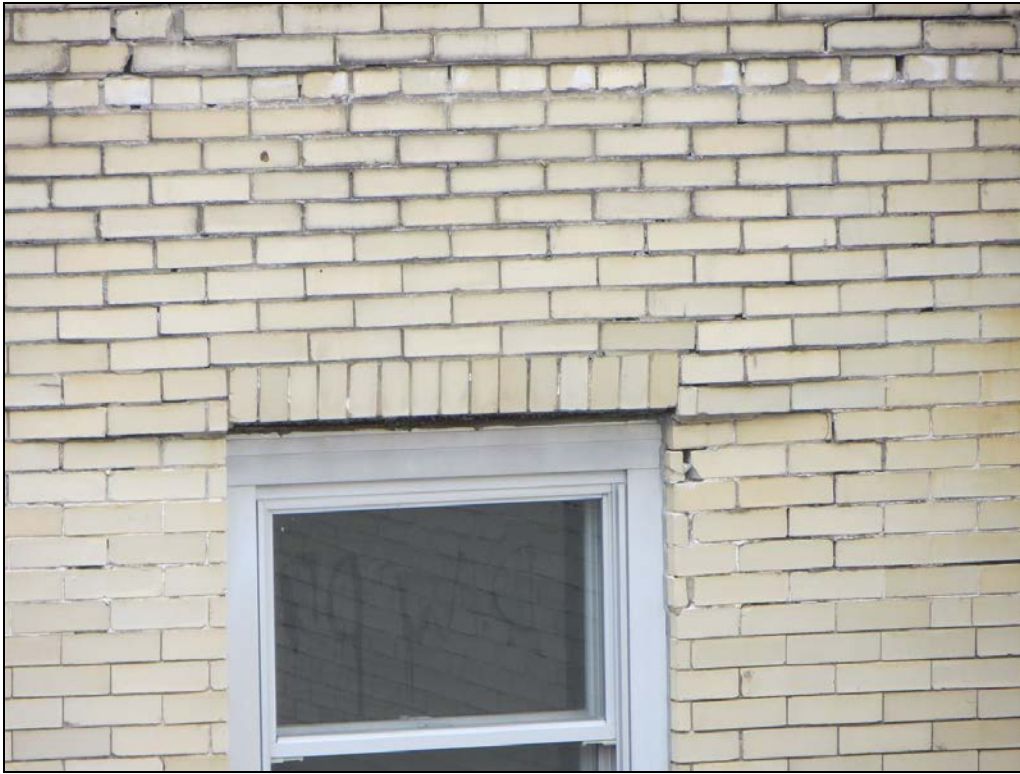
Photograph 39:
Corrosion of the
window lintels is
causing the brick
cracking and
displacement.

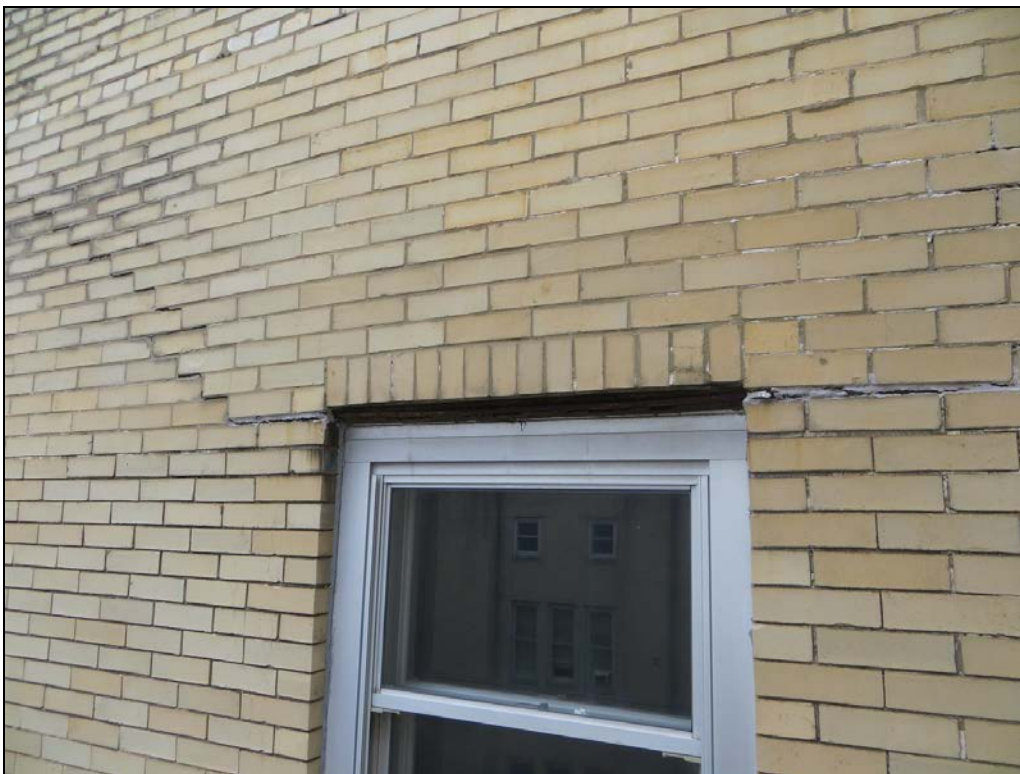
Photograph 40:
The heavy
corrosion of the
lintels caused
substantial damage
to the surrounding
masonry.

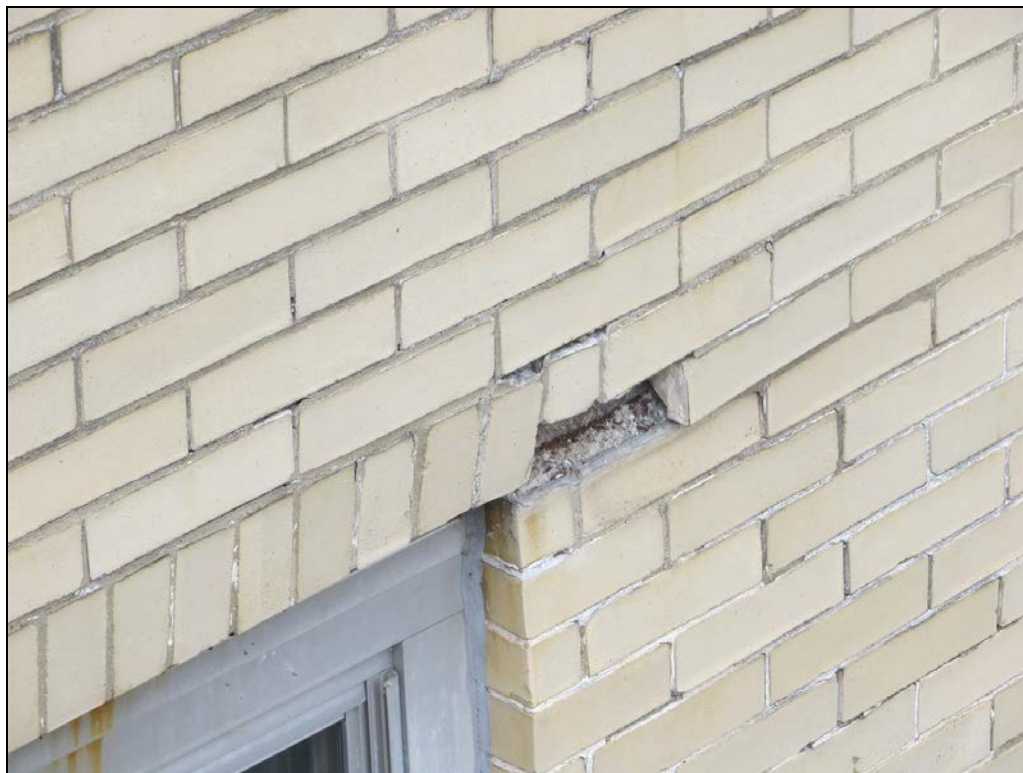
Photograph 41:
At this lintel a brick was pushed off the wall from the corroding lintel.

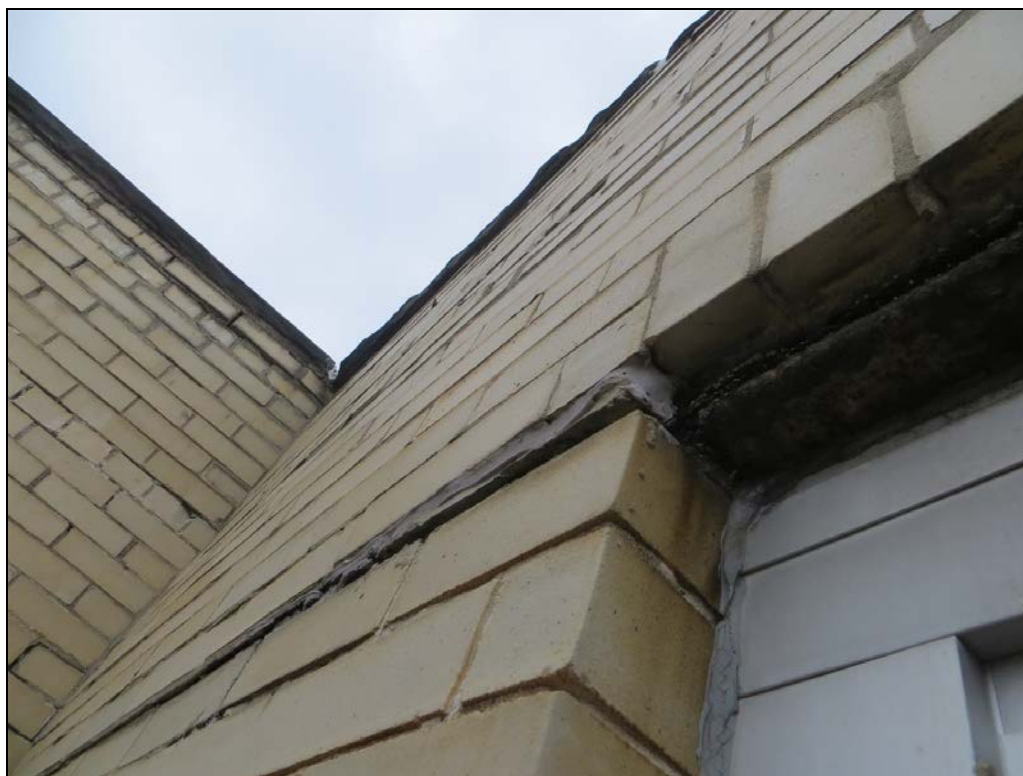
Photograph 42:
The brick above the lintel has displaced outward.

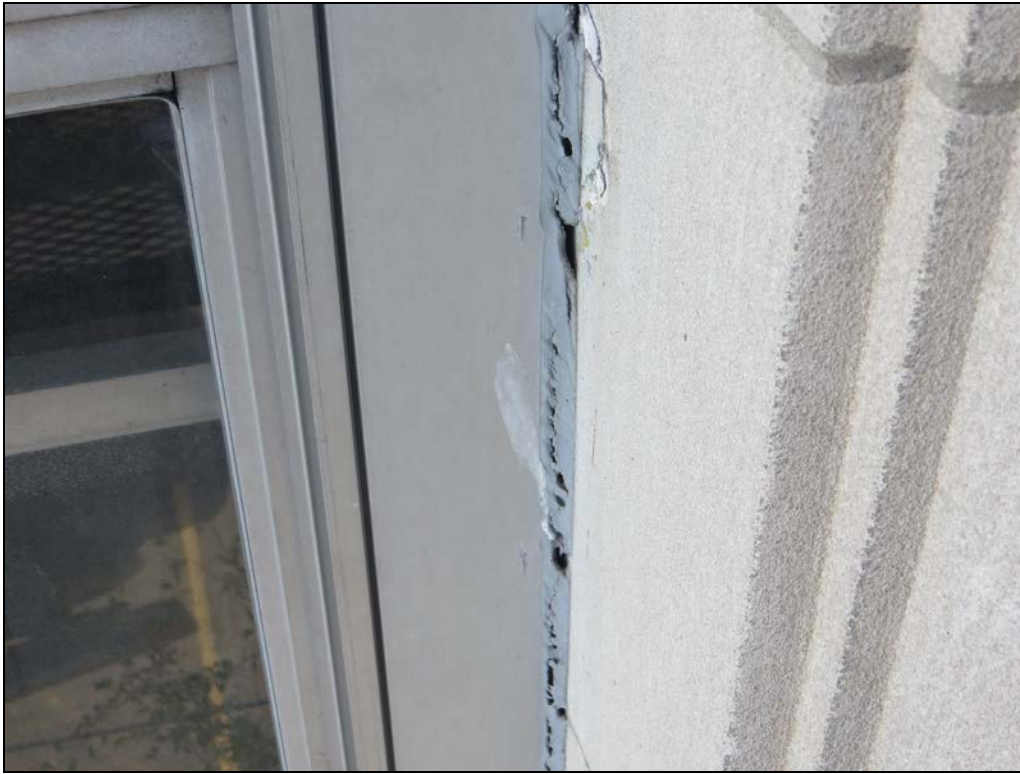
Photograph 45:
Failed sealant at
the window
perimeter.

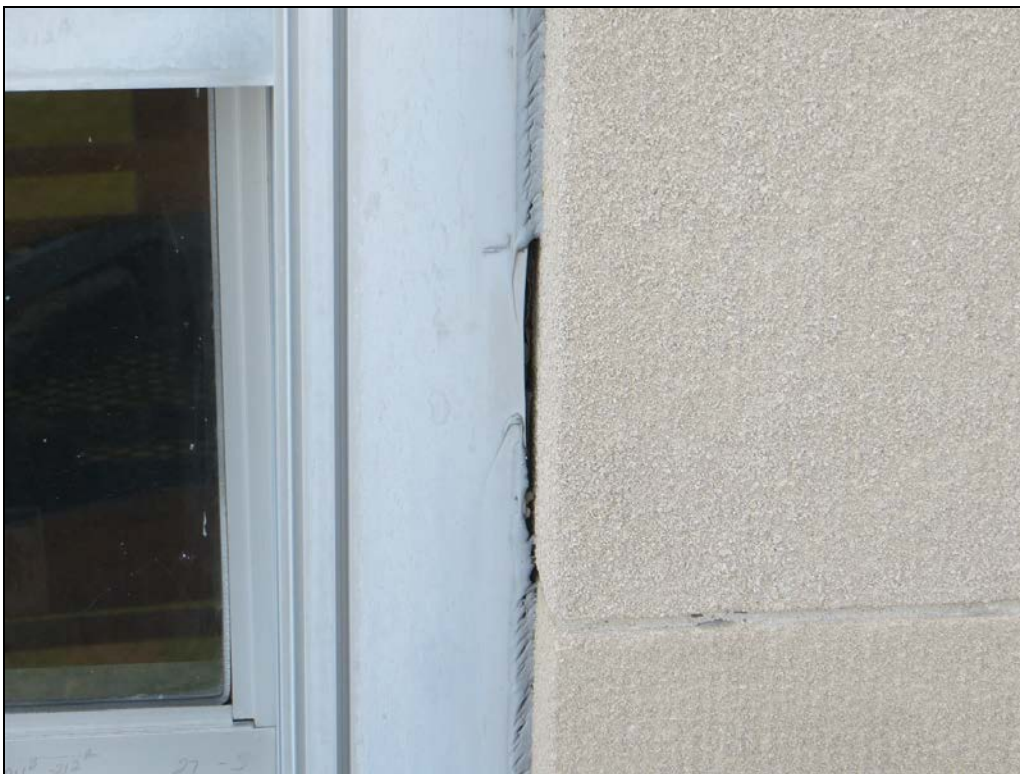
Photograph 46:
Sealant was not
installed at a
section of the
window perimeter.

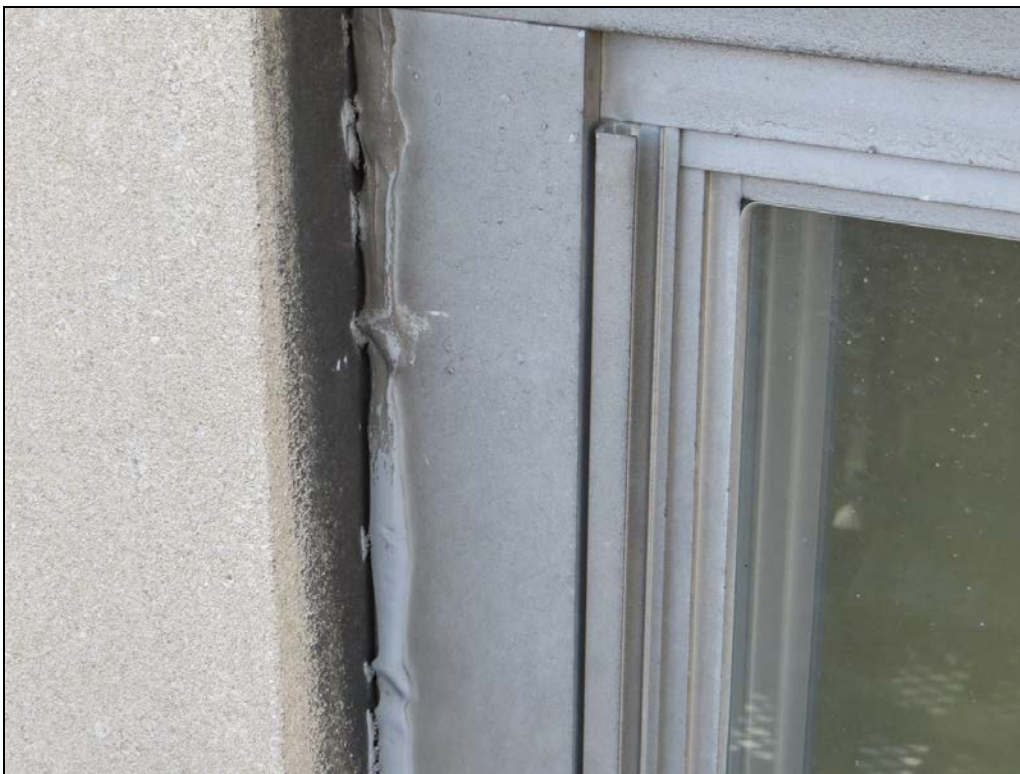
Photograph 48:
Sealant has failed the entire height of the window jamb.

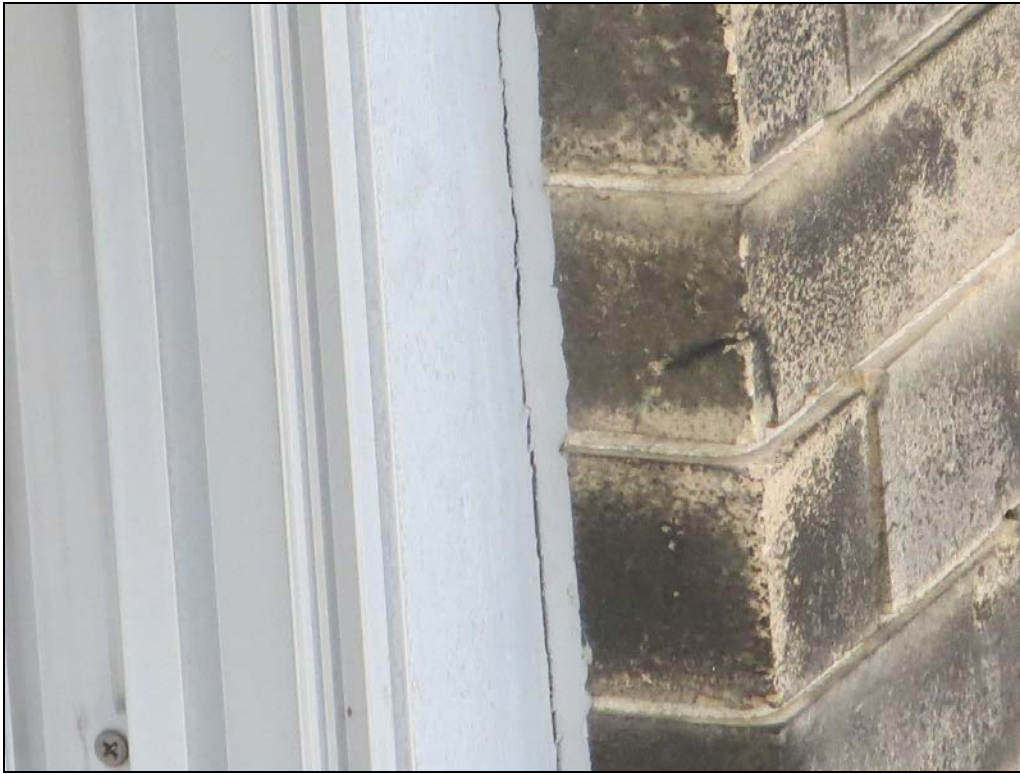
Photograph 49:
Failed sealant on
the rear elevation
of the building.

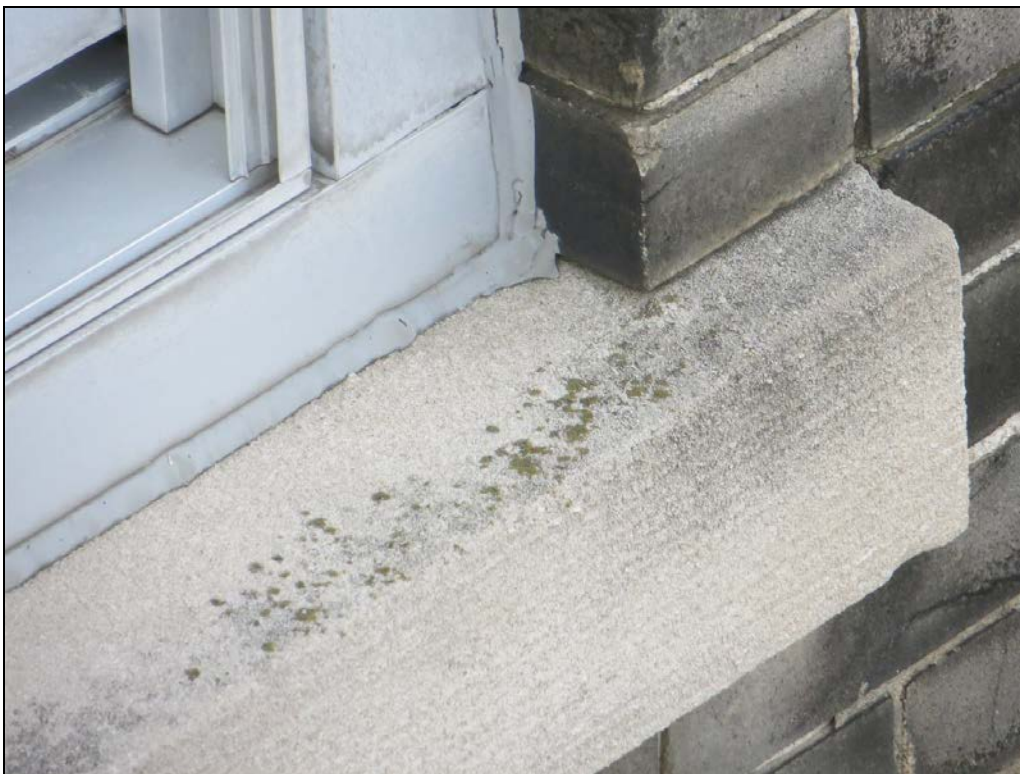
Photograph 50:
Sealant on the
window sill was
never properly
tooled, greatly
reducing the
performance of the
sealant.
