## WILKES-BARRE AREA SCHOOL DISTRICT STRUCTURAL EVALUATION OF ELMER L. MEYERS HIGH SCHOOL

December 8, 2014

**Re: Structural Evaluation of Meyers High School**

# Meyers High School Structural Evaluation

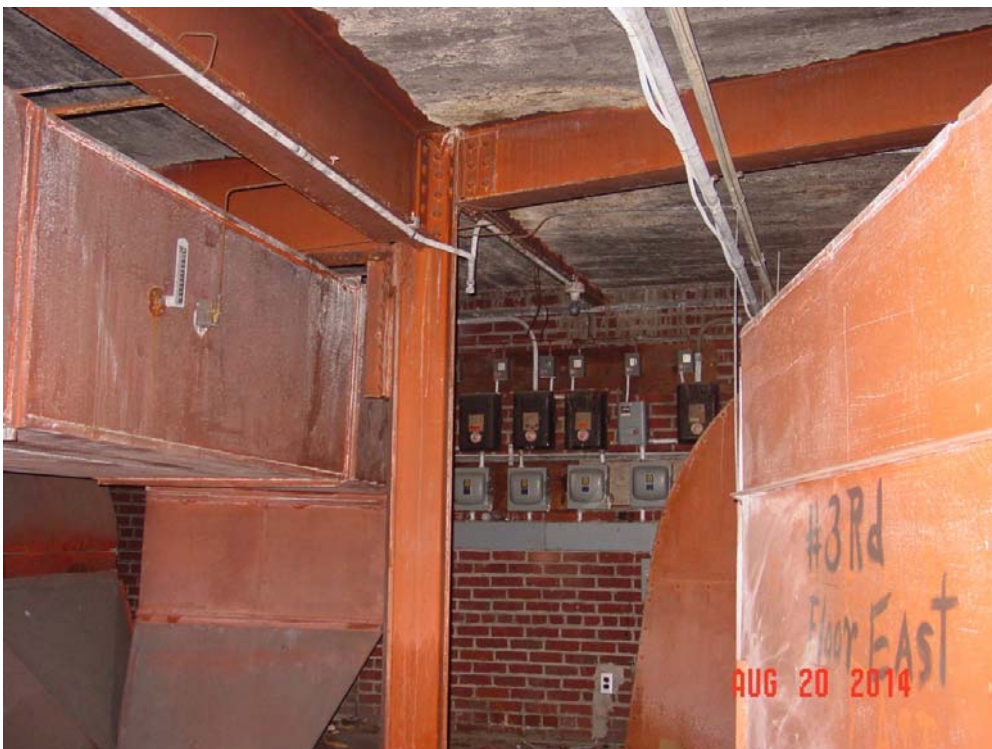
Main Building attic above entrance and central staircase. Note steel beams and column exhibit little to no corrosion.

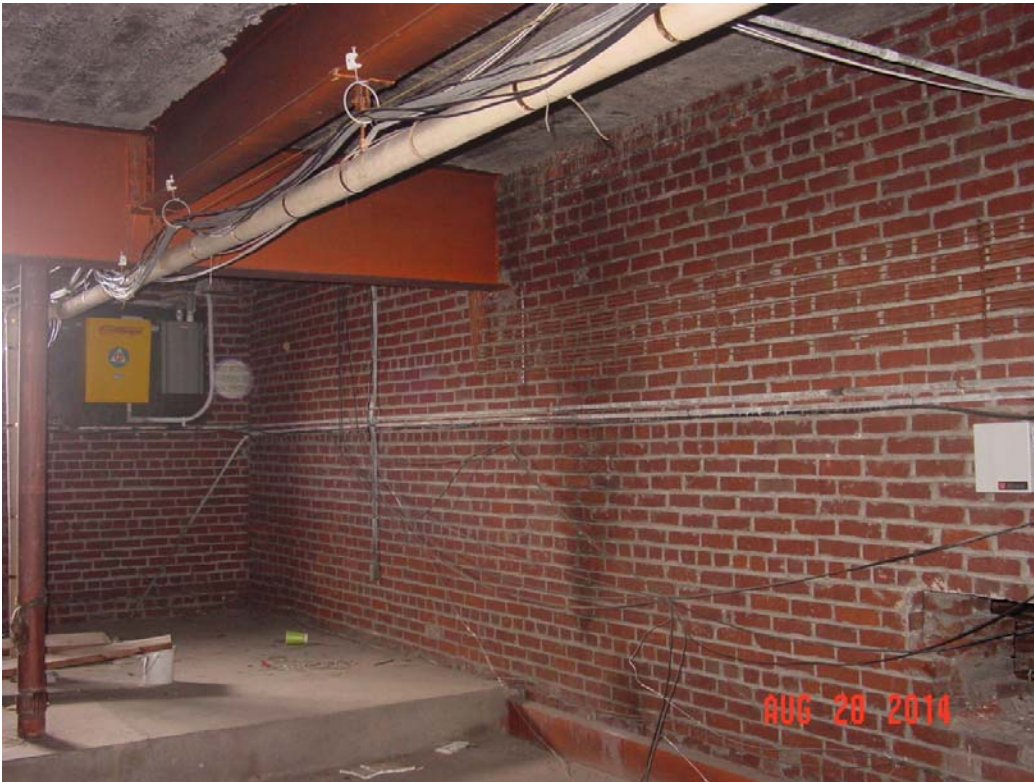
Main Building mechanical room over front entrance. Hole in brick wall allows access to ceiling in Architrave above entrance landing.

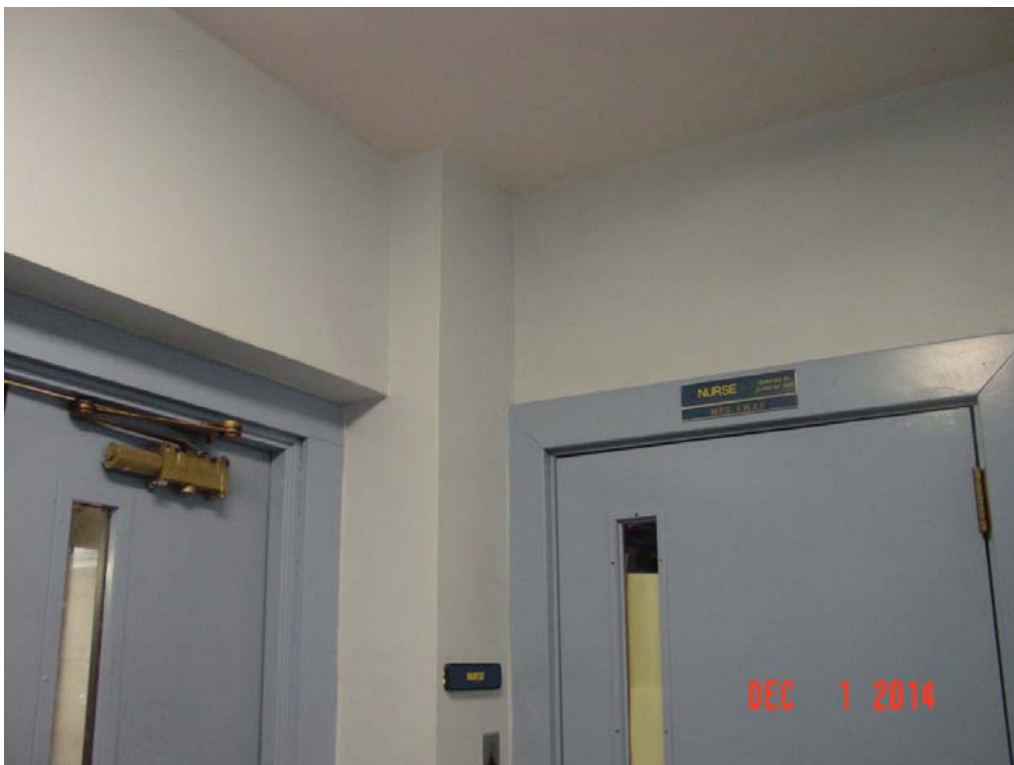
First floor interior corner at entrance to Main Building staircase from corridor running parallel with Carey Avenue. The Floor slopes 12" from front to rear in this area.

Note lack of cracking in corner finishes.

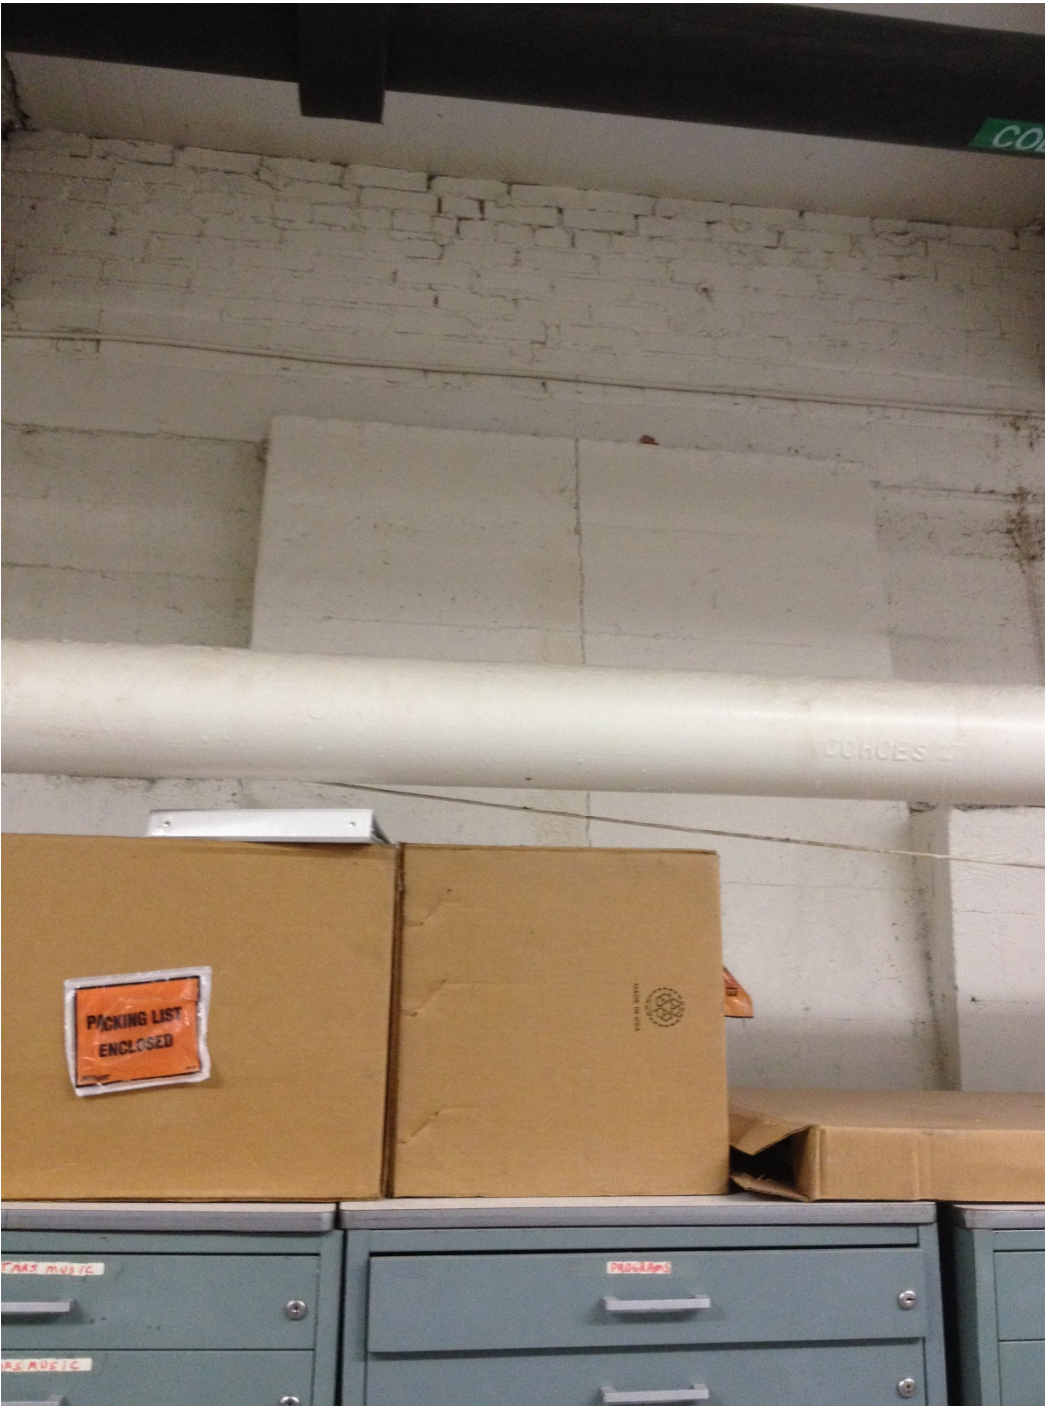
Mass concrete retaining wall  
below base of exterior brick  
wall.

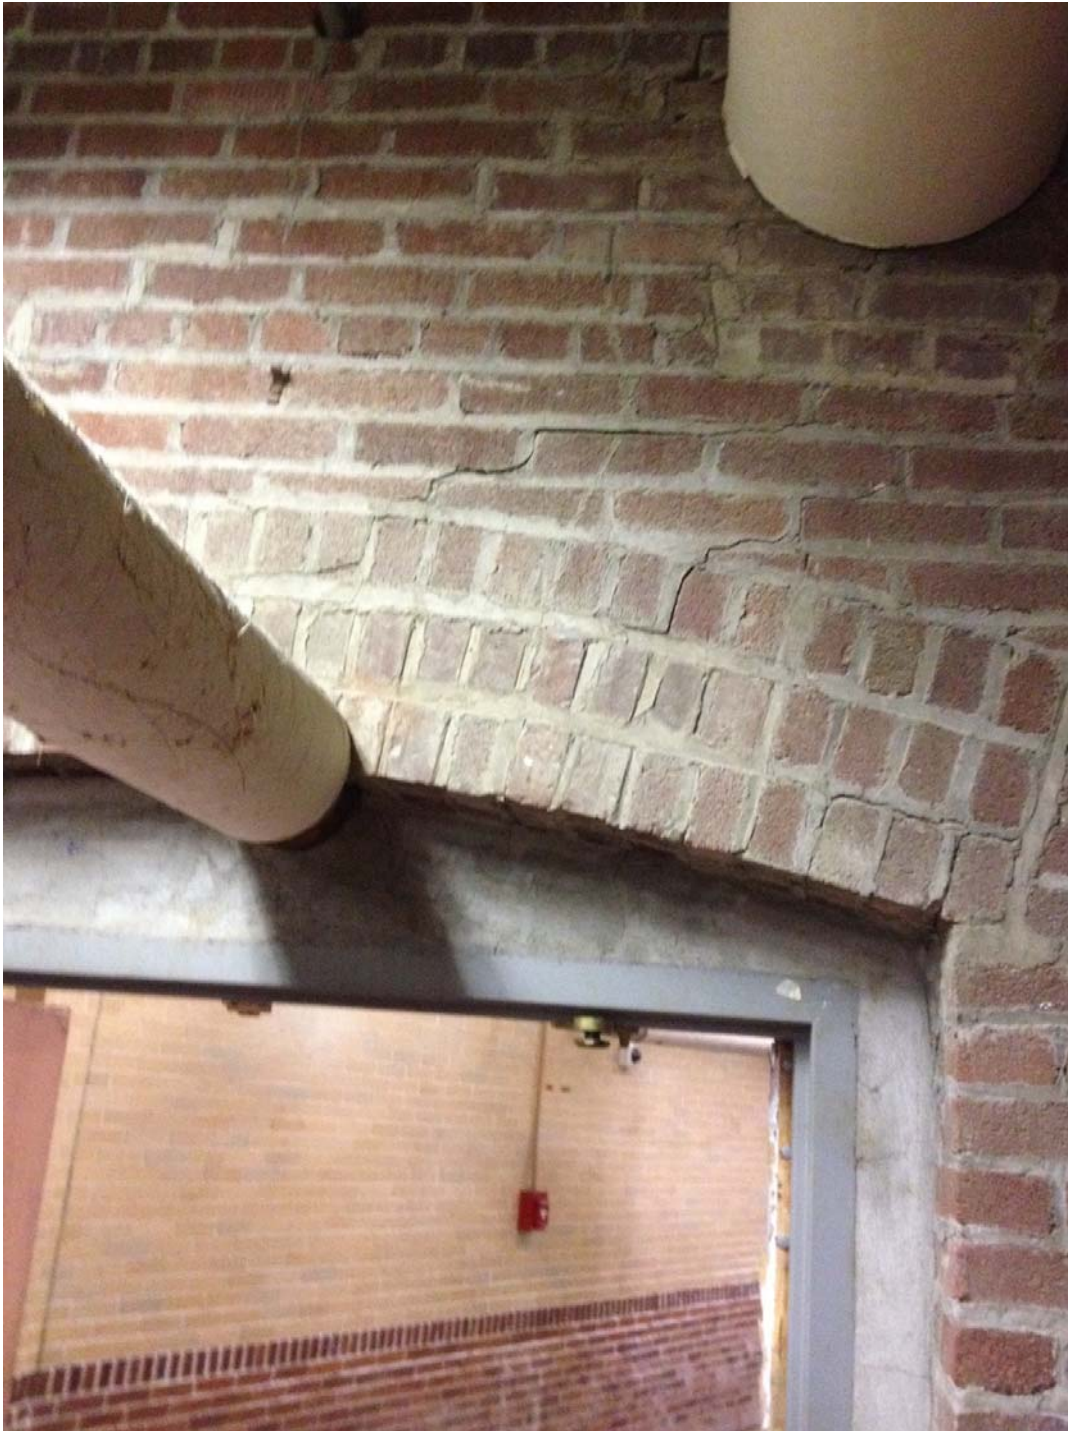
Cracking in basement archway near large pipe penetrations.

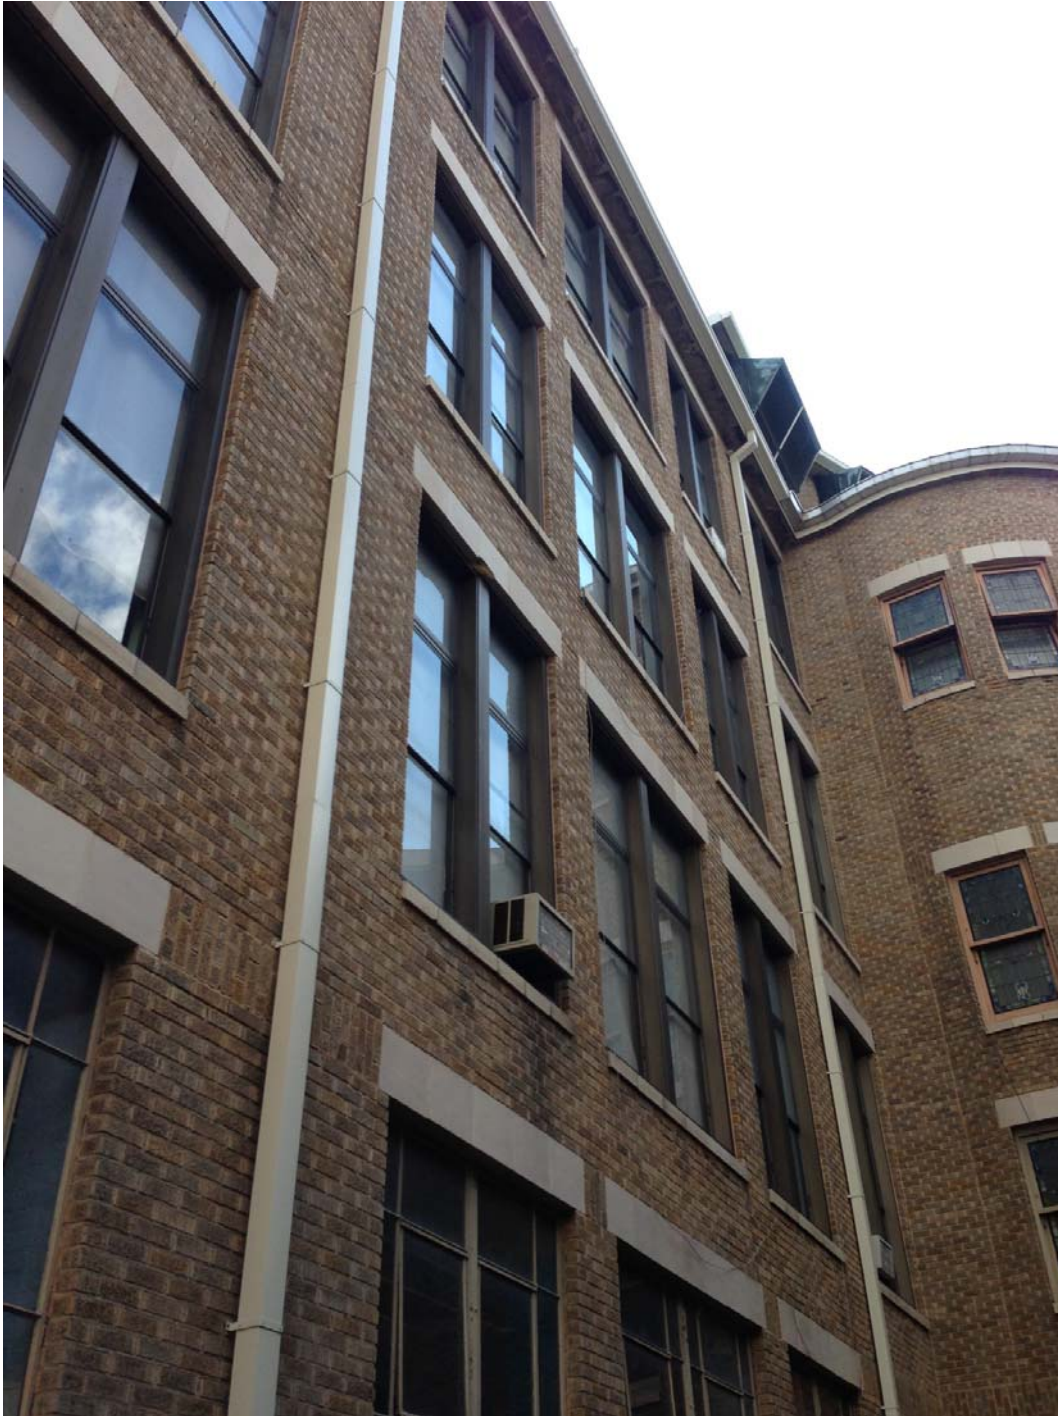
View from interior courtyard between girls' pool and Main Classroom Building. Circular wall is rear portion of main entrance staircase wall. Note lack of cracking in vertical corner joints.

Wall on left slopes 6" from Auditorium to stair wall. Corner at stair is low point in area where floors have settled 12" from front to rear.

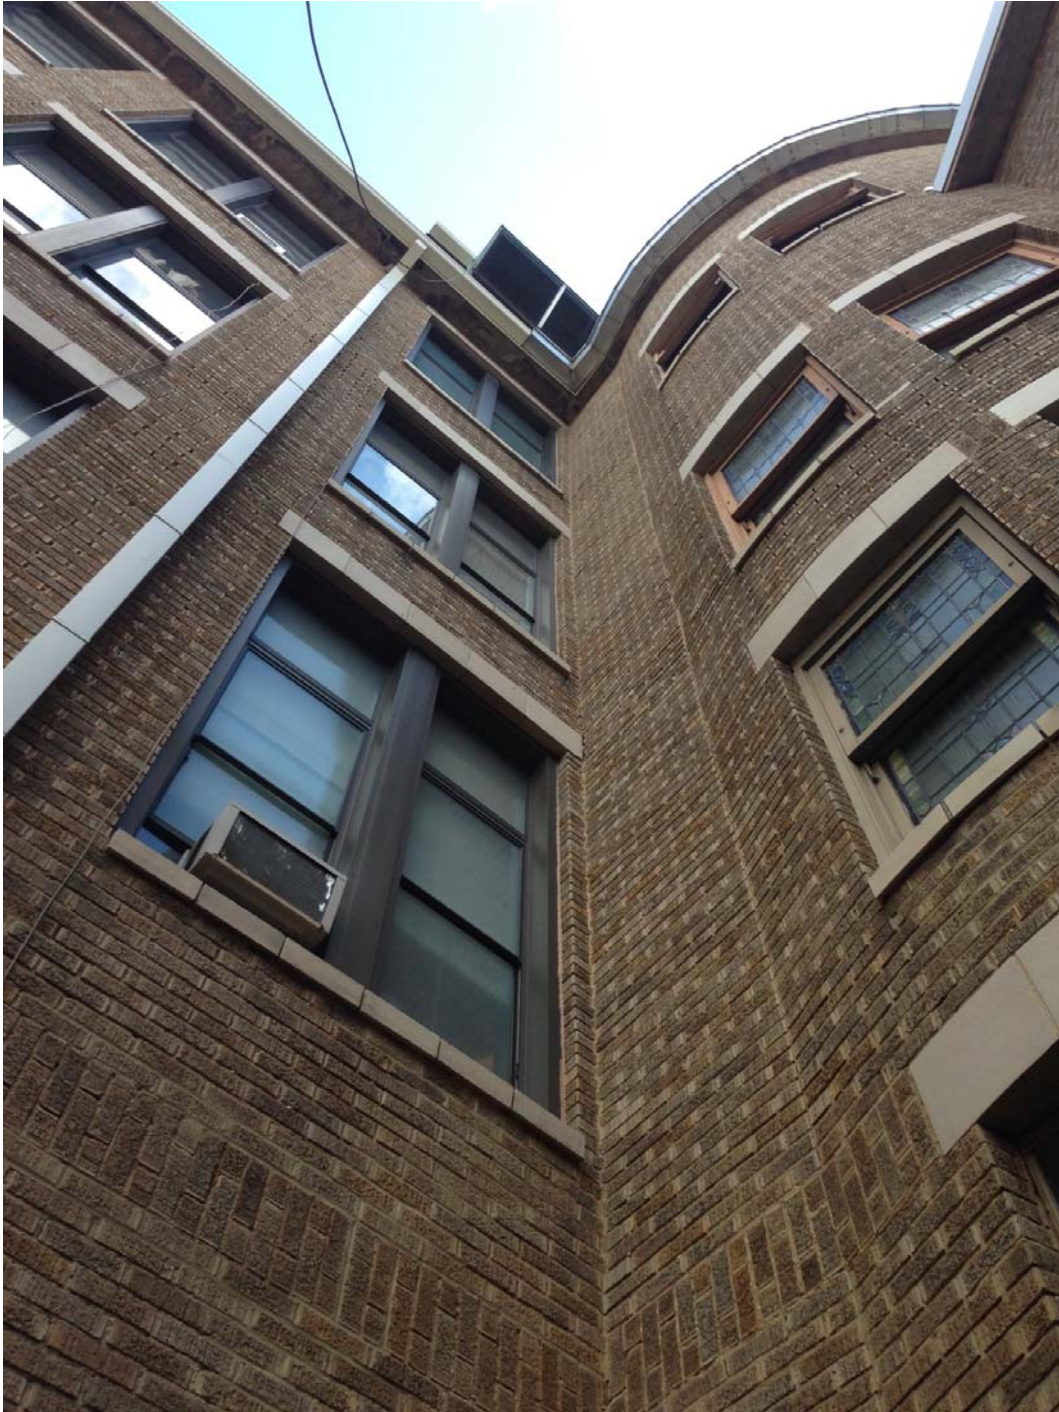
Corner is low point where floors have settled 12" from front to rear. Auditorium is to left in this view.

Survey of brick mortar joints along classroom wall shows 6" drop in joints from Auditorium to stair wall.

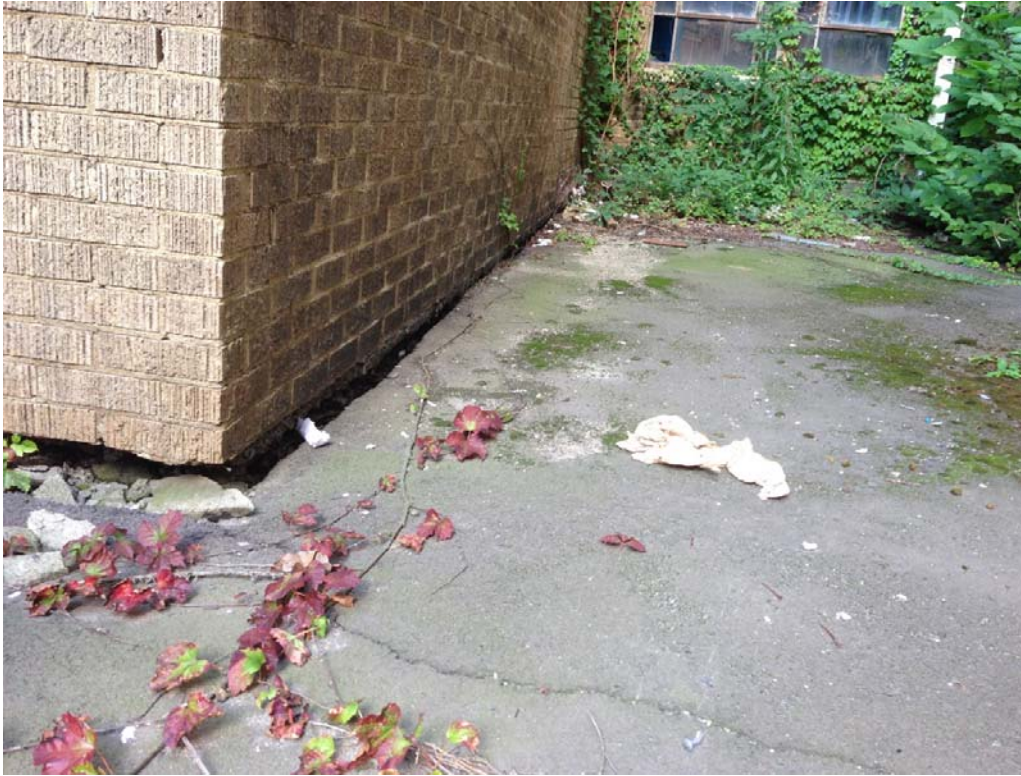
A small addition constructed in the Courtyard adjacent to the Girls Pool has extensive wall damage at the base. The wall has apparently been subject to extensive water infiltration and the masonry foundation is crumbling and repairs are recommended.

Base of exterior wall of small addition adjacent to Girls Pool. The concrete masonry unit (CMU) backup wall and different color brick indicate this structure was not built as part of the original construction. The exterior face of the backup foundation wall has been severely damaged by apparent water infiltration.

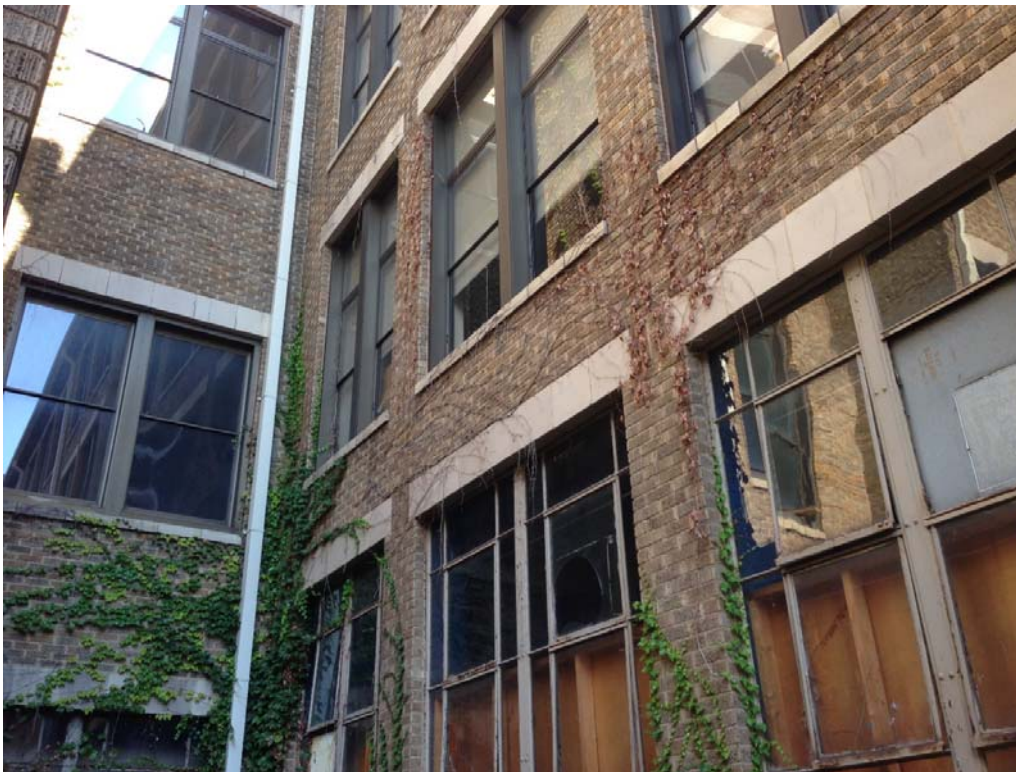
Interior courtyard view where Main Building classroom wing ties into auditorium area. Classroom wing wall drops 6" from this corner to tie in with Main Building staircase.

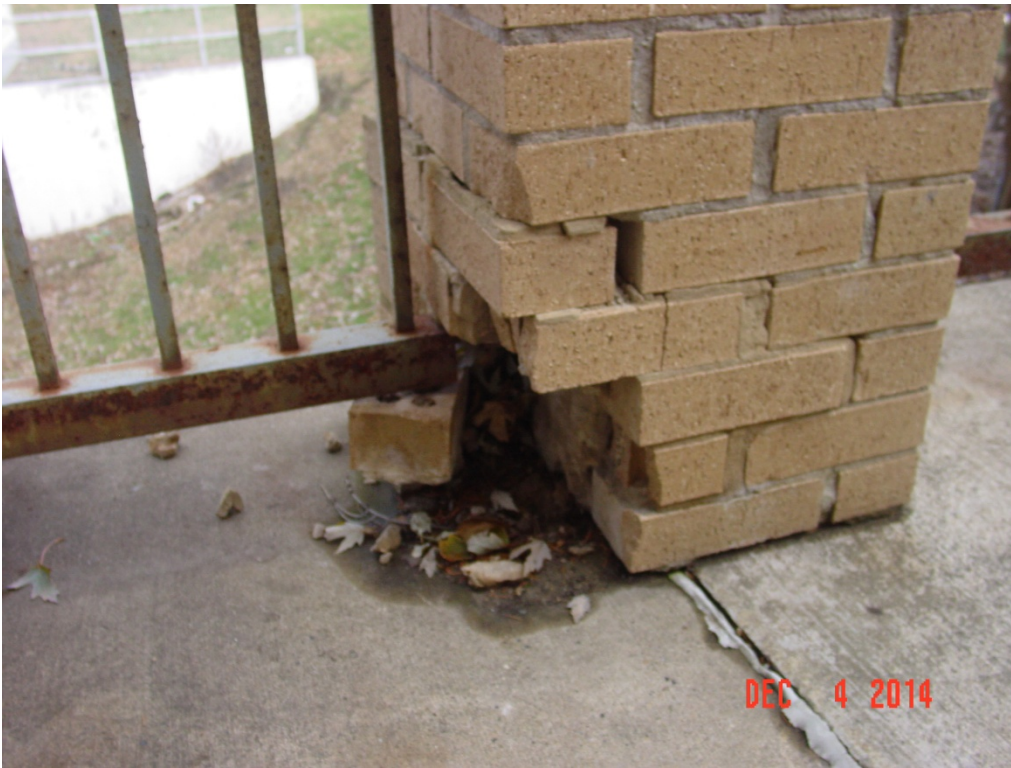
Also noted on the walkway were numerous corroded guardrail connections and one broken one which should be repaired .

Damaged walkway guardrail. Bottom connection is broken and moves easily. Many other rails are corroded and additional connections may fail in the near future.

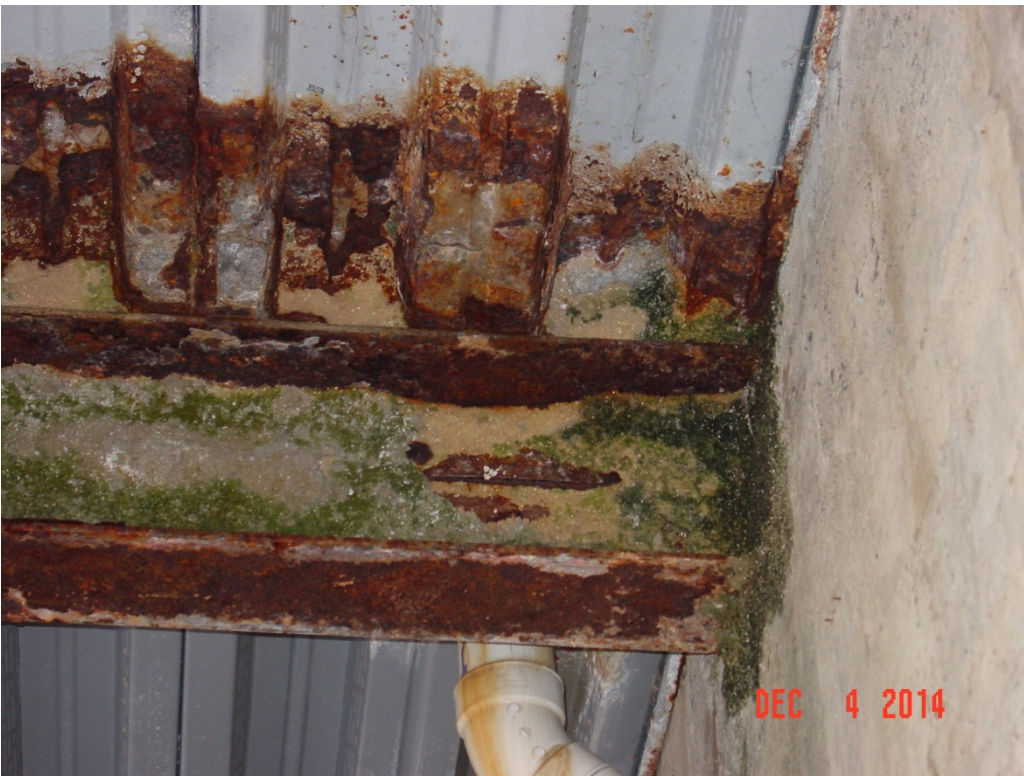
The steel framing supporting the walkway is showing signs of deterioration. It contains a sprayed-on fireproofing coating which is apparently trapping moisture and contributing to the corrosion. For a short-term (5 year) continued occupancy, we recommend having the fireproofing removed to allow closer inspection of the steel and to allow any repairs or reinforcing required by that inspection.

Corroded steel beam under the north end walkway. Fireproofing on this beam has failed and fallen from beam. Remnants of the fireproofing remain on the beam web with moss growth, indication high moisture content.

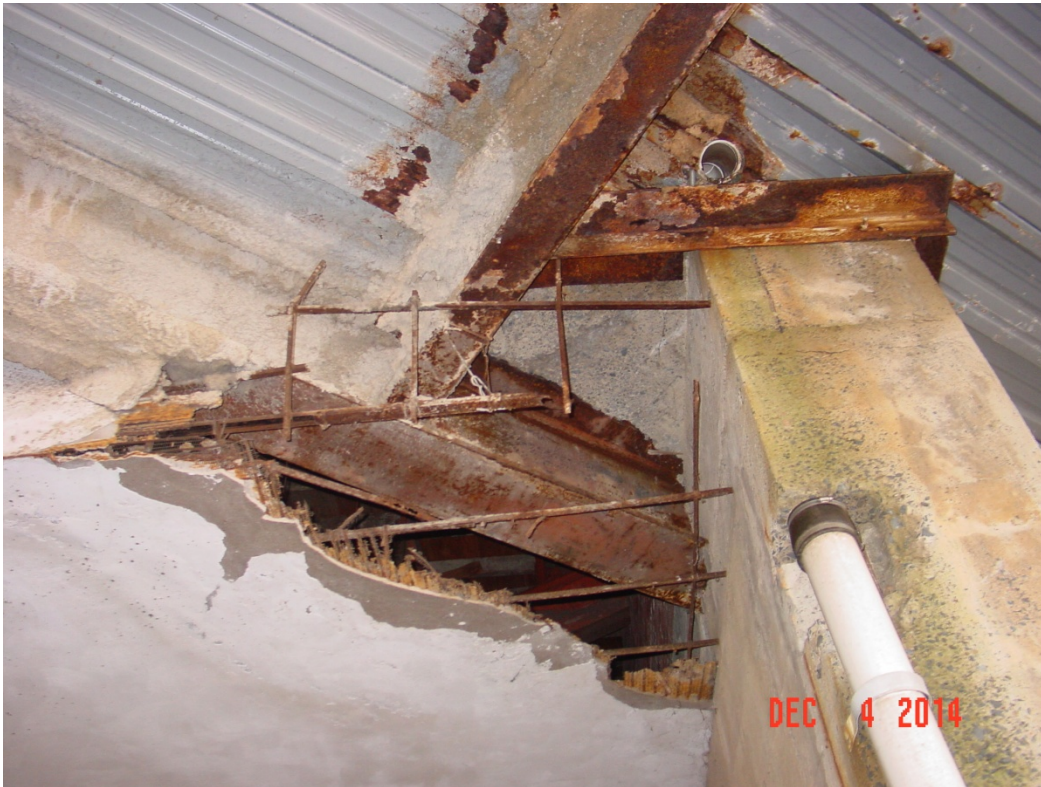
Damage to ceiling above Courtyard tunnel entrance under the north end walkway.

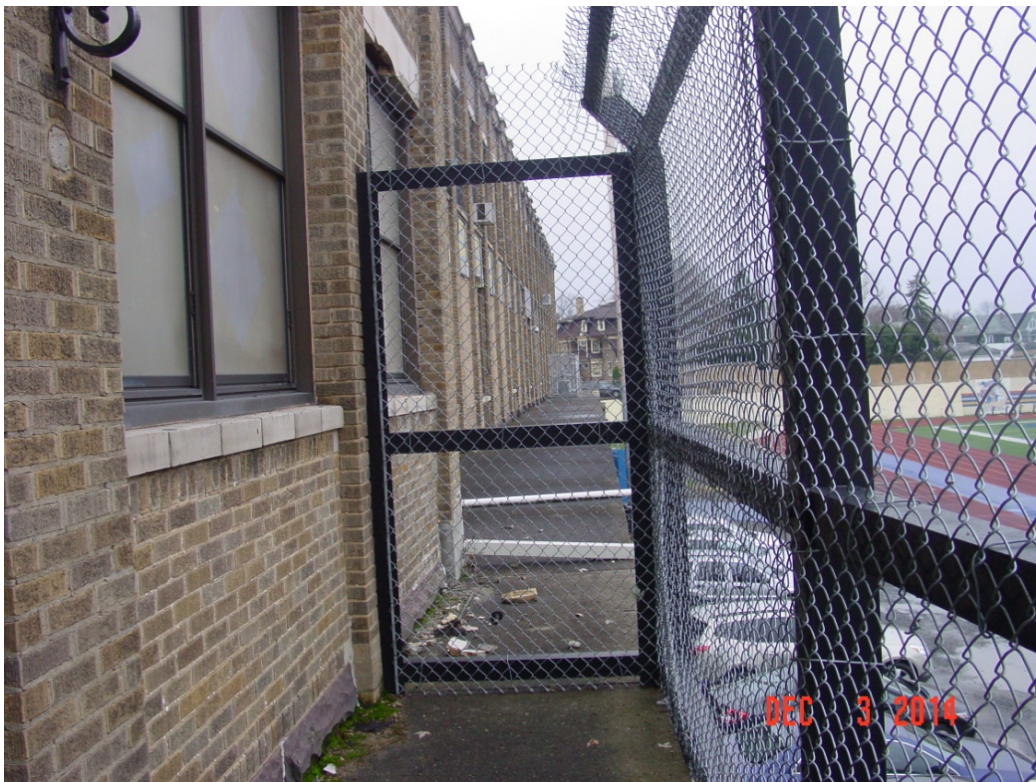
Walkway at Cafeteria exit. Note pieces of fallen terra cotta on abandoned portion beyond fence. Protective cover is currently being installed above the doors.

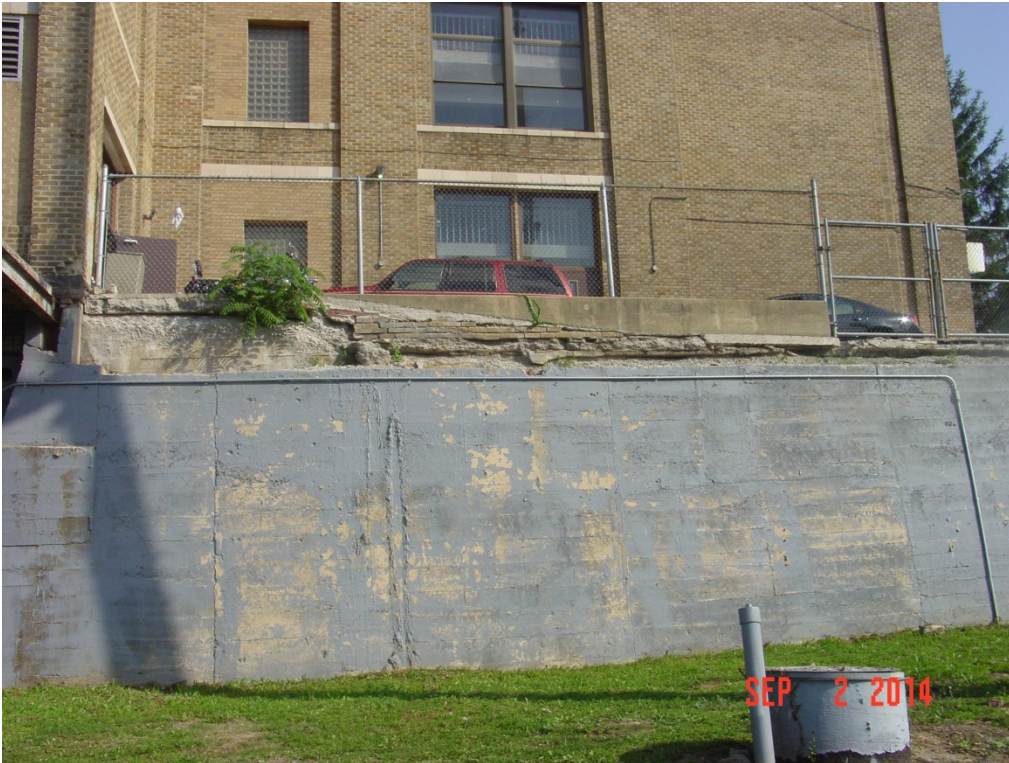
The columns along the west wall beneath the removed stadium walkway appear to be in stable condition. However the base of the ramp leading from Hanover Street to the Maintenance shop is in poor condition with a potential of stones falling to the lower level. While this is a fairly remote location with regards to parking, etc., we recommend having the area cordoned off.

Hanover Street entrance ramp to maintenance room. It is recommended this area is cordoned off due to loose brick above concrete retaining wall.

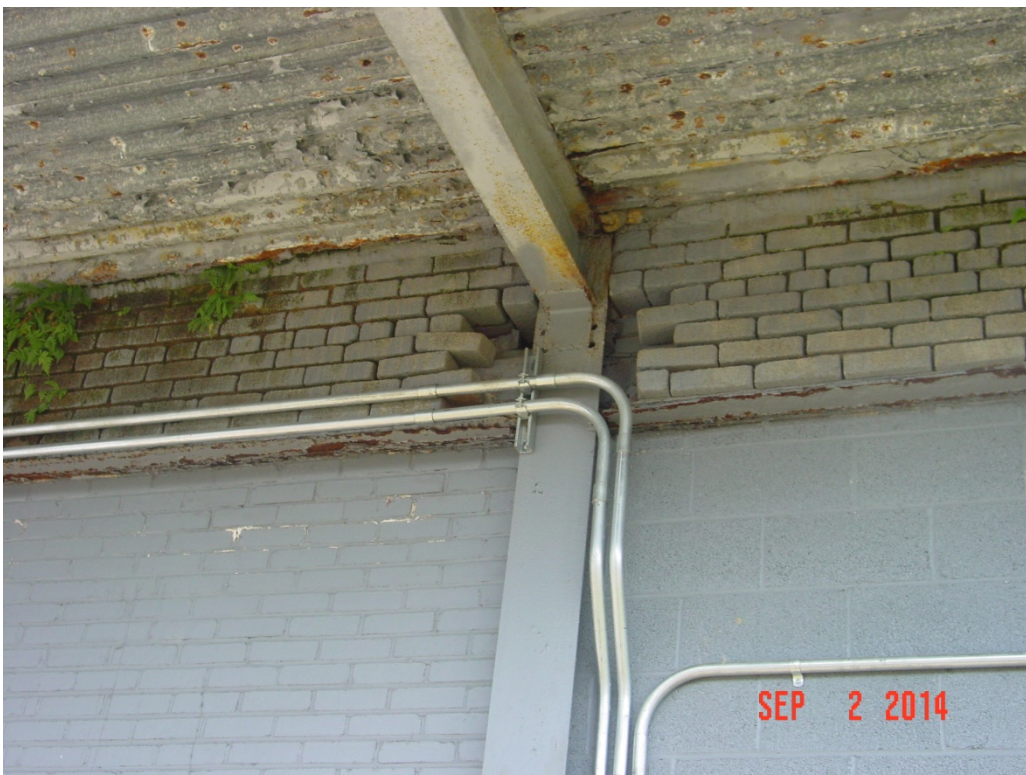
Columns under abandoned walkway at former stadium bleachers. Steel is in stable condition. Loose brick has been in place for extended time and it is recommended it is stabilized or the area under the walkway cordoned off.

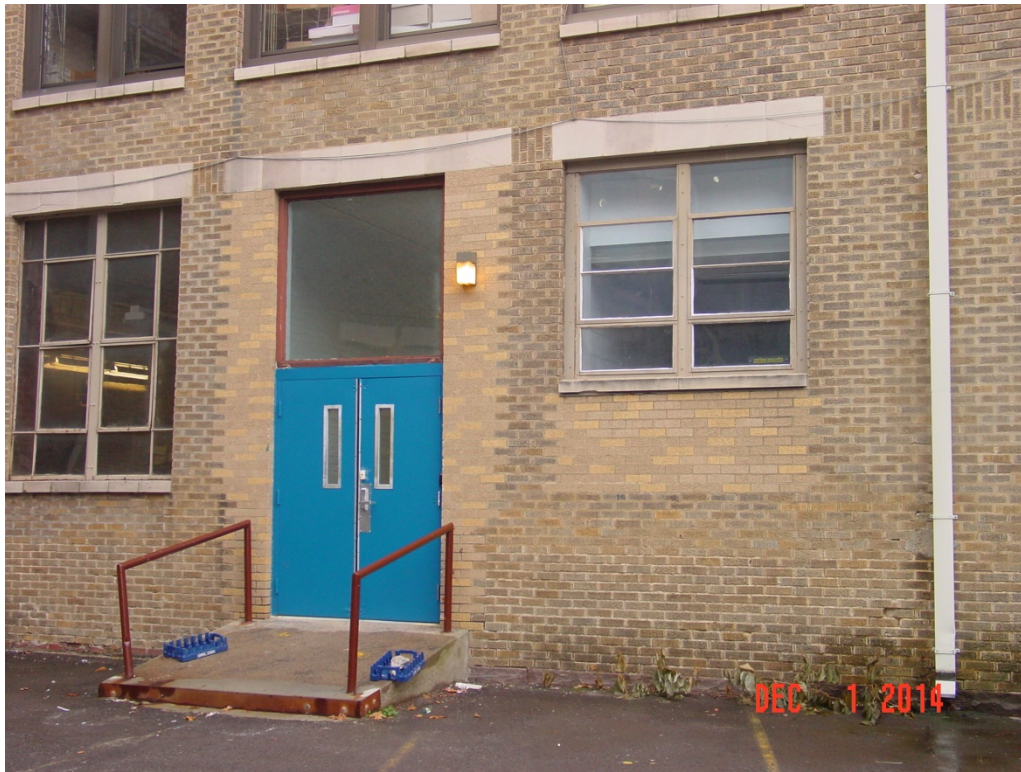
Entrance door in interior Courtyard contain has deteriorated terra cotta above. Protective structure is currently being built over ramp.

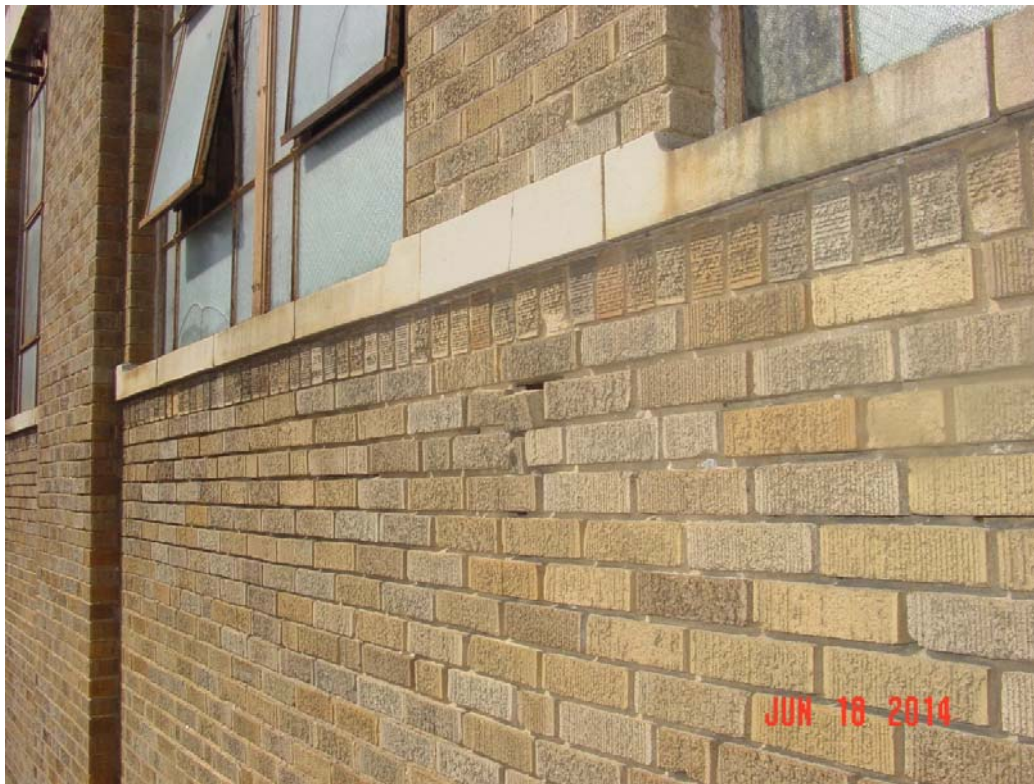
Heating Plant north wall above driveway. Note loose brick in center. This an several others were easily removed prior to the installation of a protective netting system.

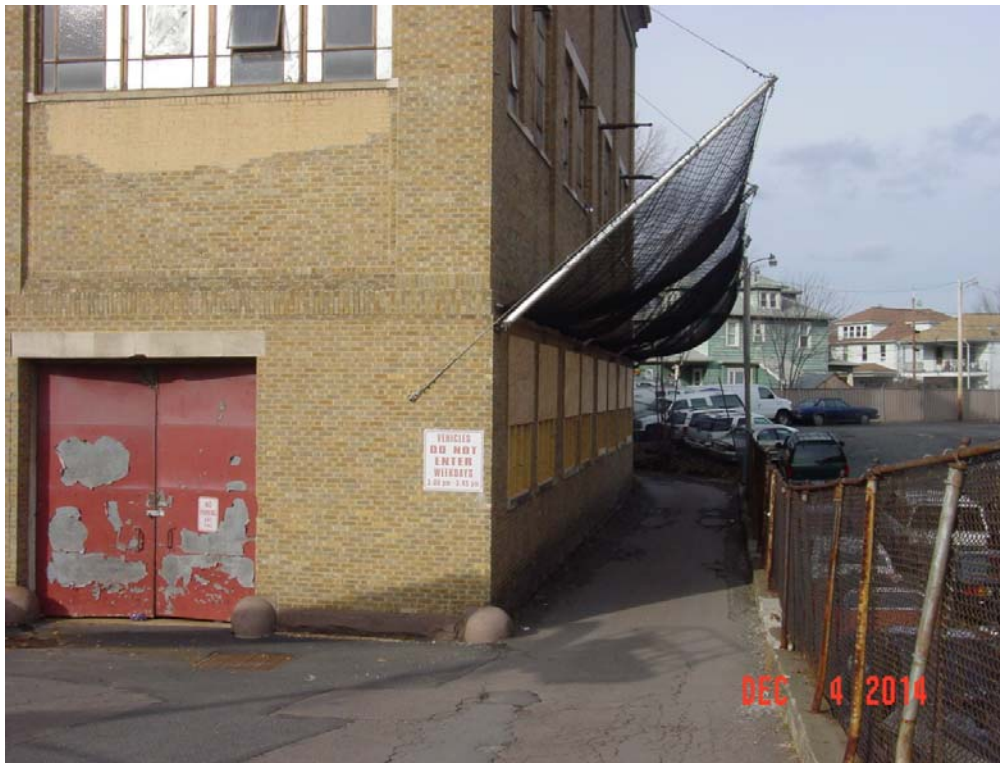
Heating Plant protective netting over Courtyard and Stadium access driveway.

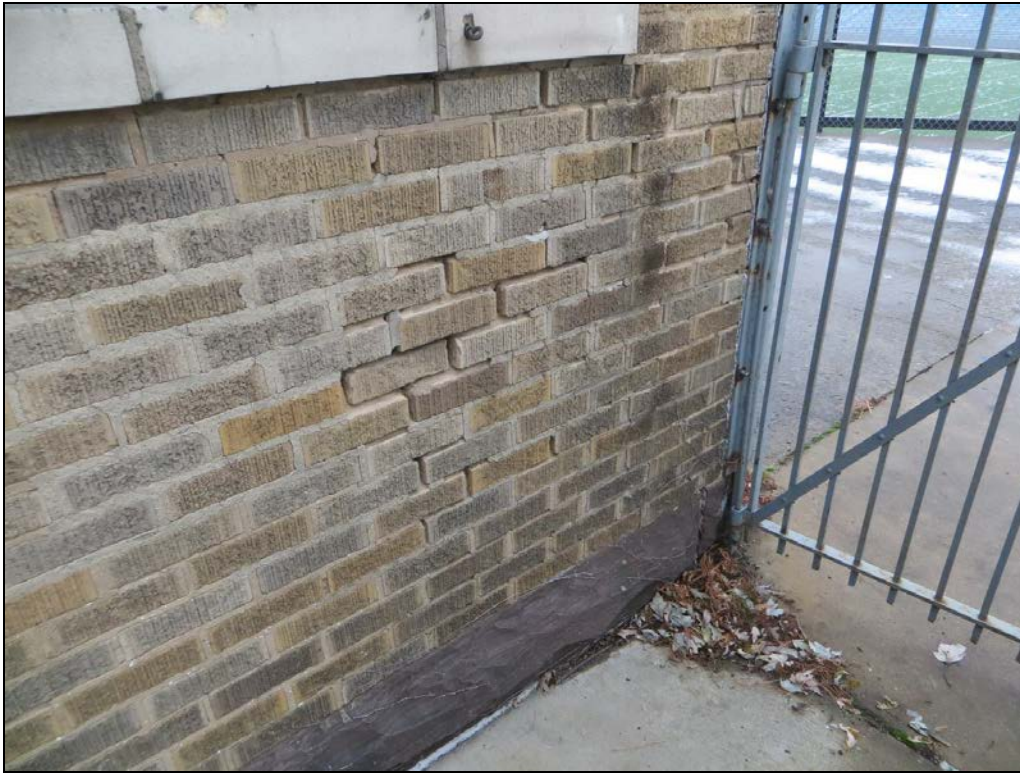
**Photograph 9:**

Failed and missing mortar joints at an area that was repointed.

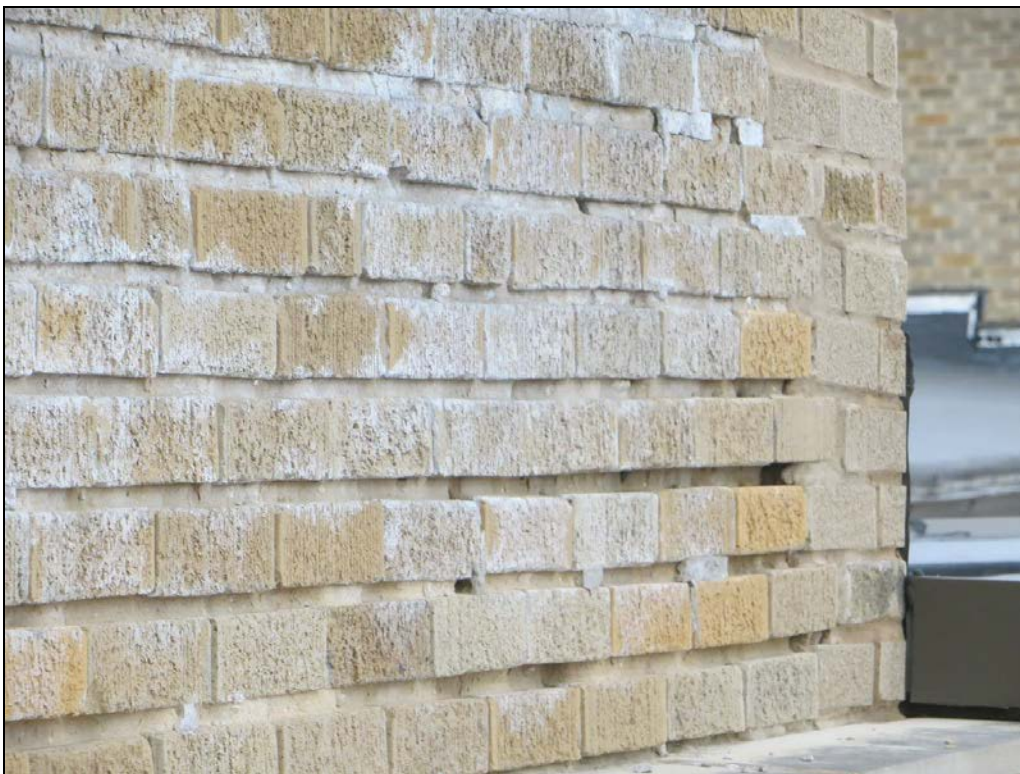
**Photograph 10:**

Missing and weathered mortar joints at an area with heavy efflorescence.

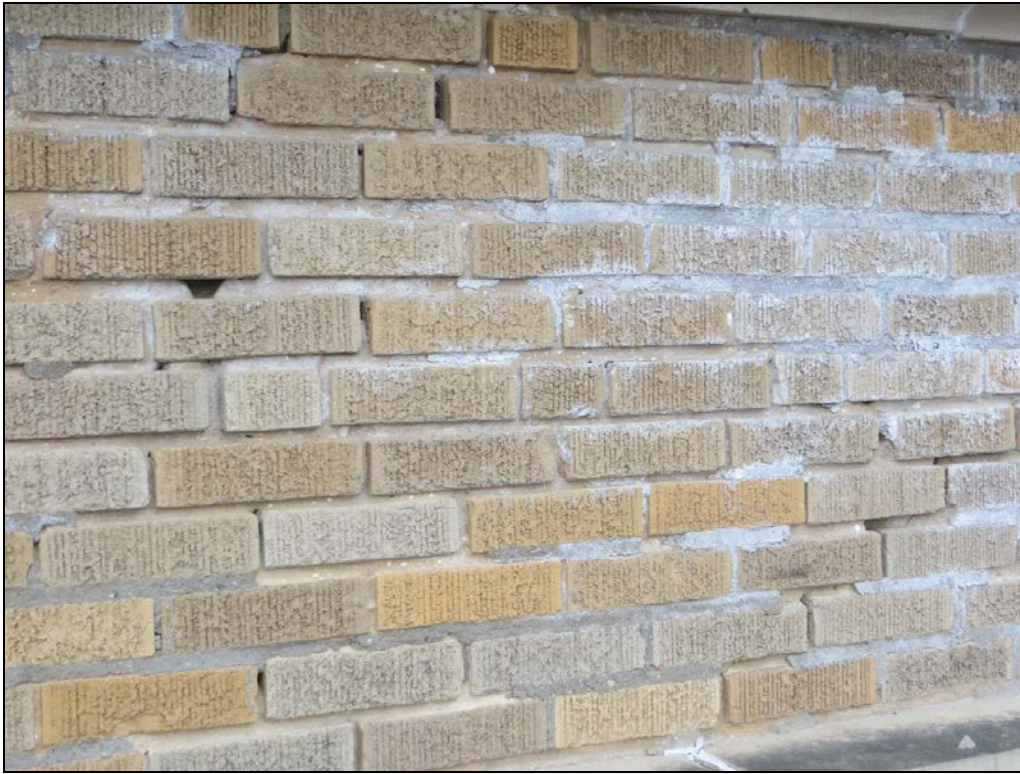
**Photograph 11:**

The majority of the repointed / grouted mortar is missing at this location.

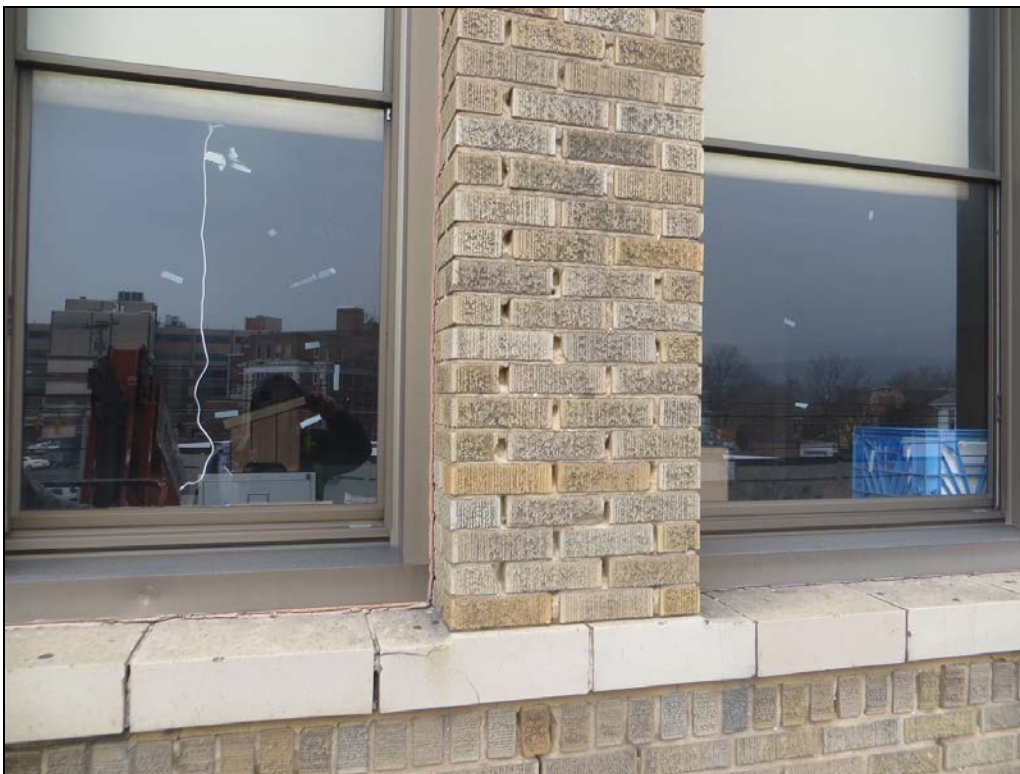
**Photograph 12:**

Significant loss of mortar at the header joints at this brick section between windows.

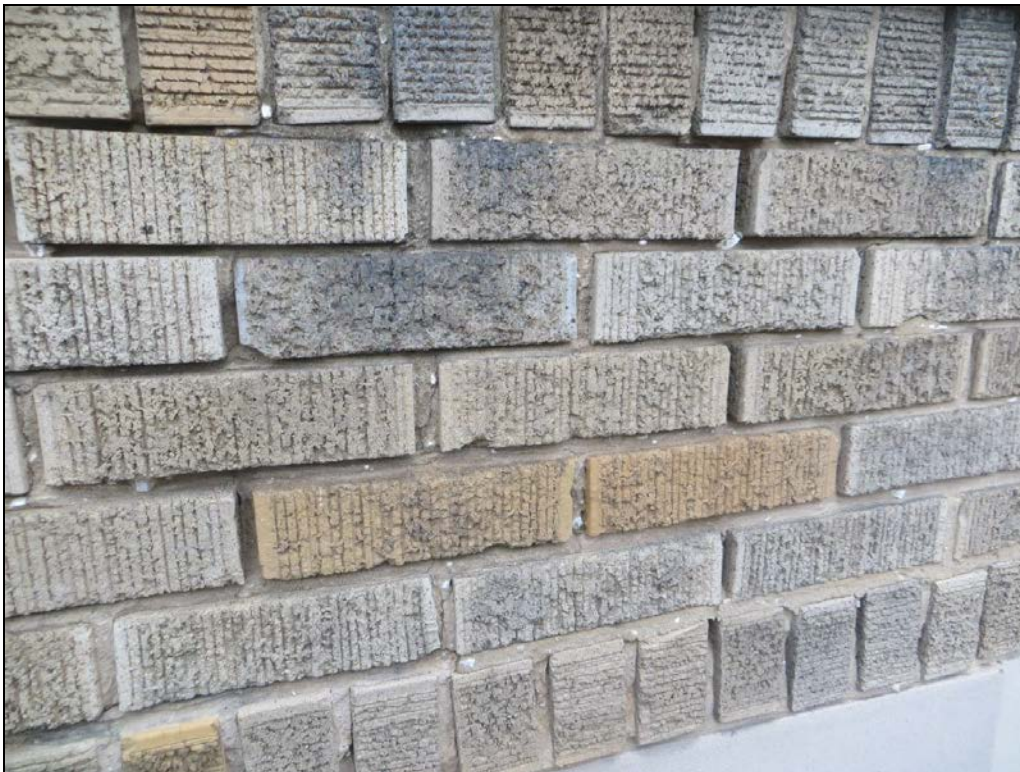
**Photograph 14:**  
The original mortar  
at this location is  
substantially  
weathered with  
numerous failures.

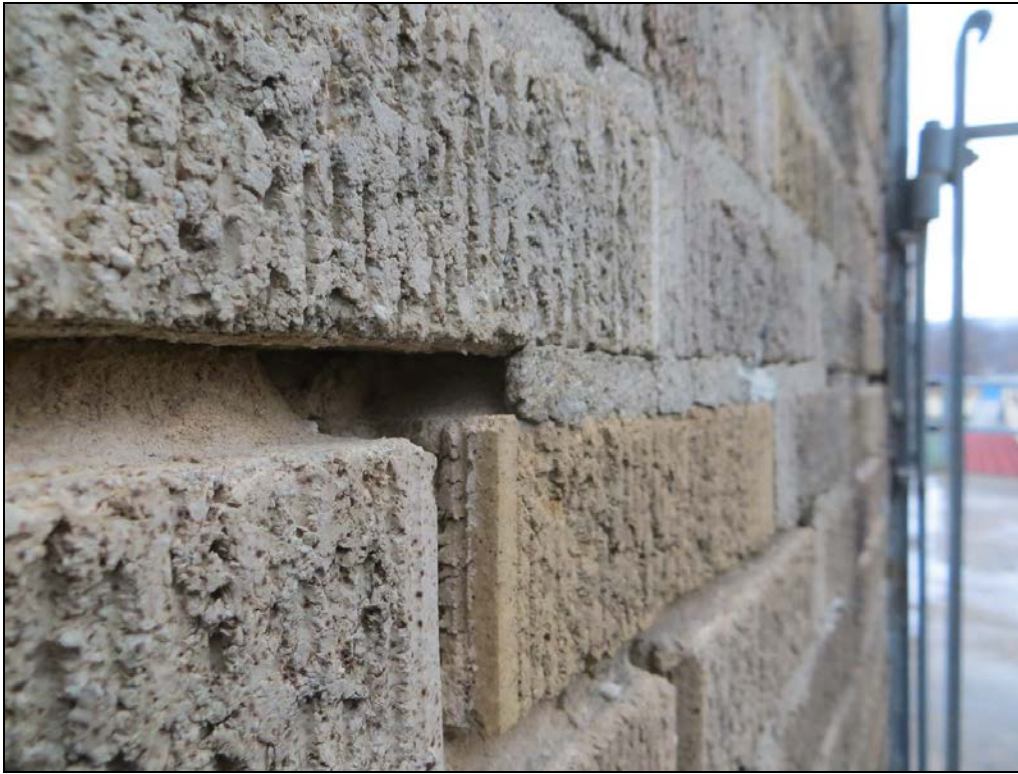
**Photograph 15:**

At the locations where the mortar was repointed / grouted, the new mortar was installed with a thin profile, which provides little resistance to water infiltration.
