## WILKES-BARRE AREA SCHOOL DISTRICT STRUCTURAL EVALUATION OF ELMER L. MEYERS HIGH SCHOOL

December 8, 2014

**Re: Structural Evaluation of Meyers High School**

# Meyers High School Structural Evaluation

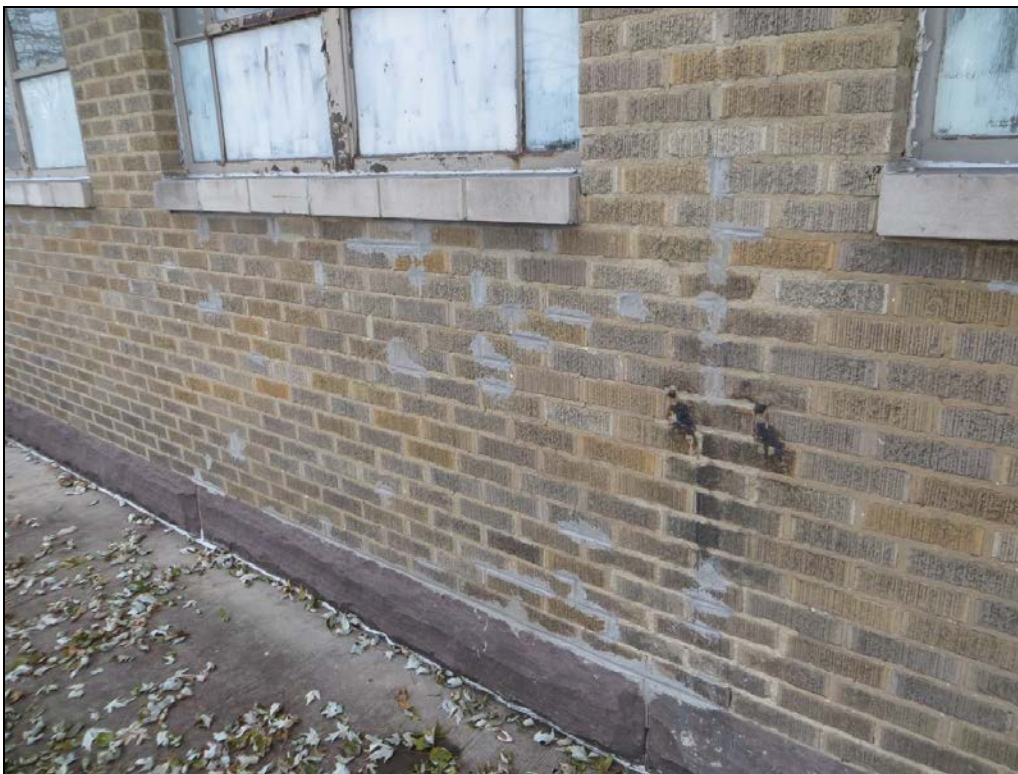
**Photograph 16:**

Spot pointing was completed at random locations around the building.

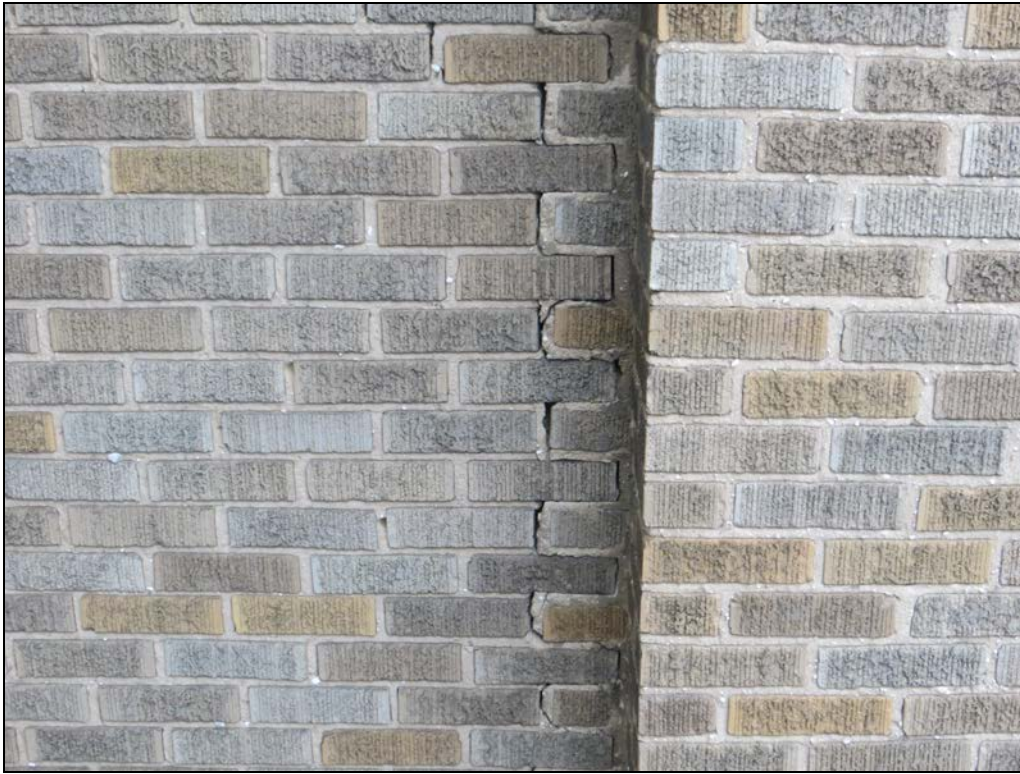
**Photograph 17:**  
Cracked mortar at  
a transition in the  
brick wall which  
appears to have  
been caused by  
thermal movement  
in the brick.

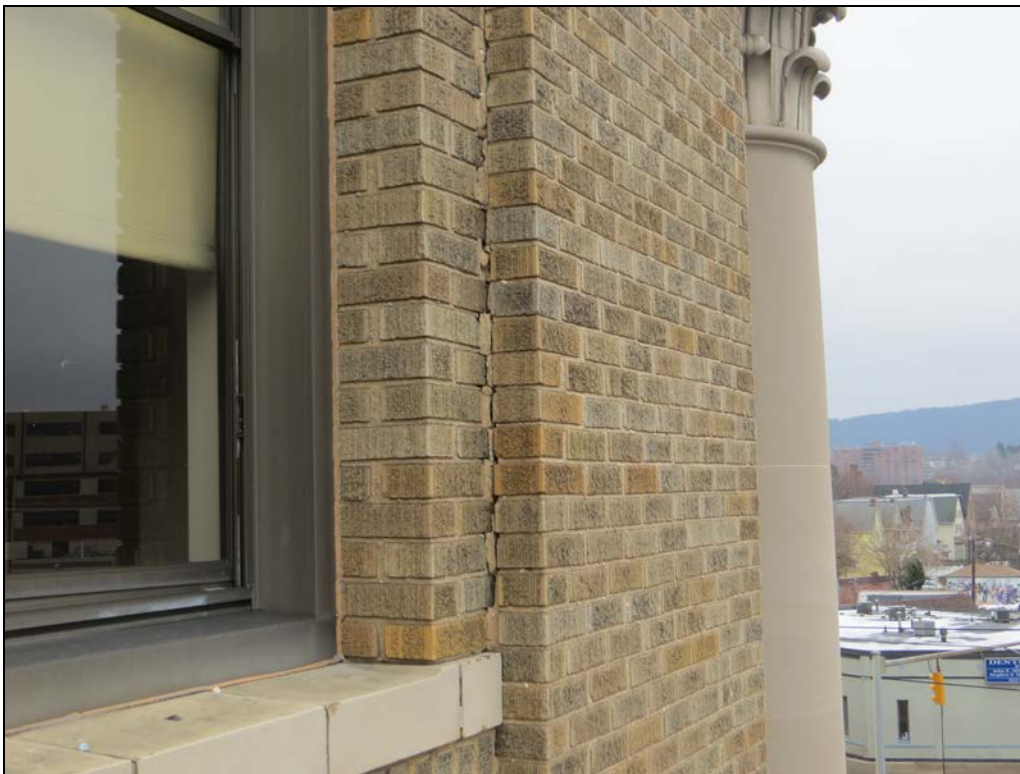
**Photograph 18:**  
Cracked brick  
where the brick  
sets back at a  
window. This also  
appears to have  
been caused by  
thermal movement  
of the brick.

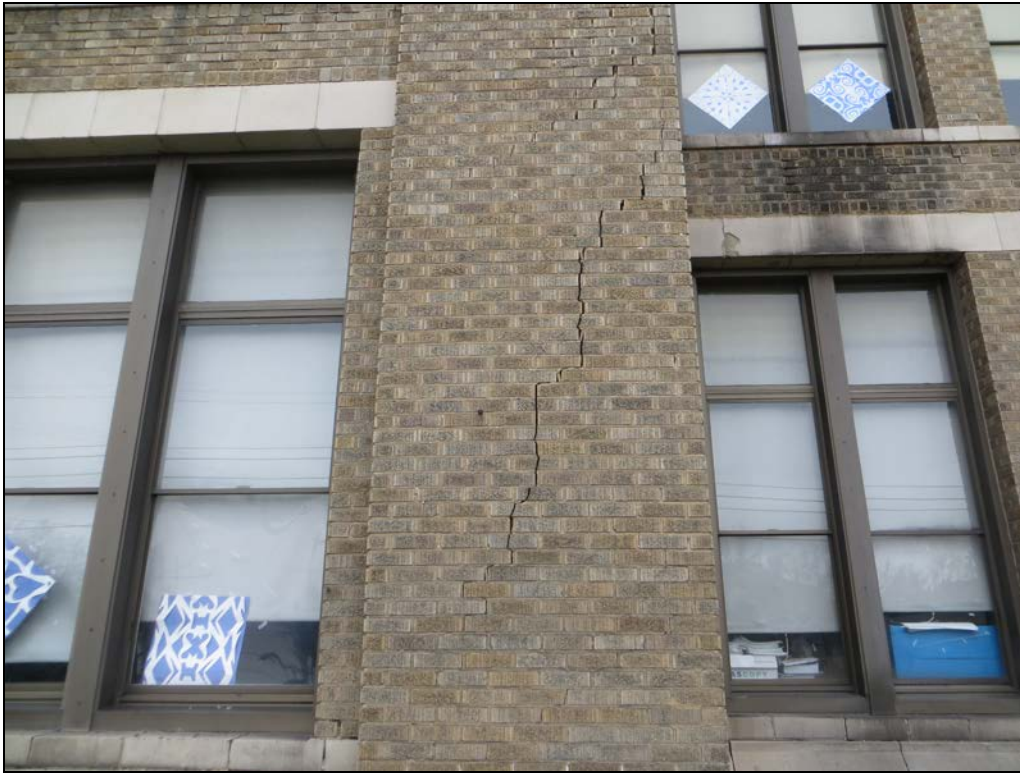
**Photograph 19:**  
Significant cracking at a brick pier may have been caused by corrosion of the embedded structural steel.

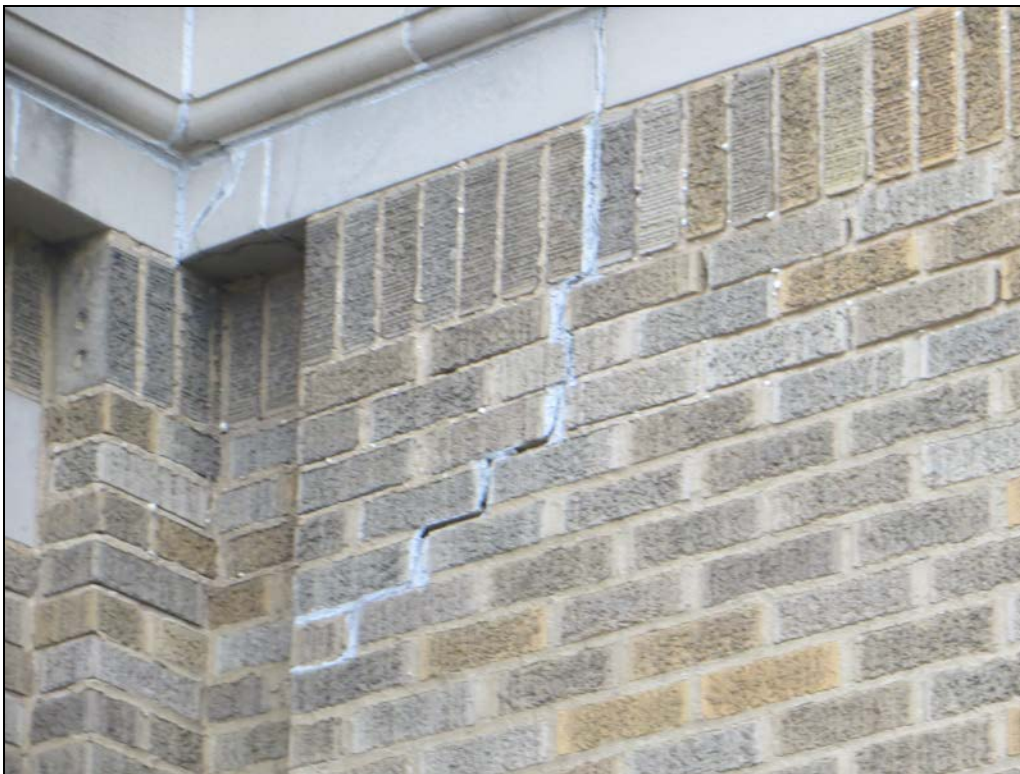
**Photograph 20:**  
The crack in the brick continues into the terra cotta.

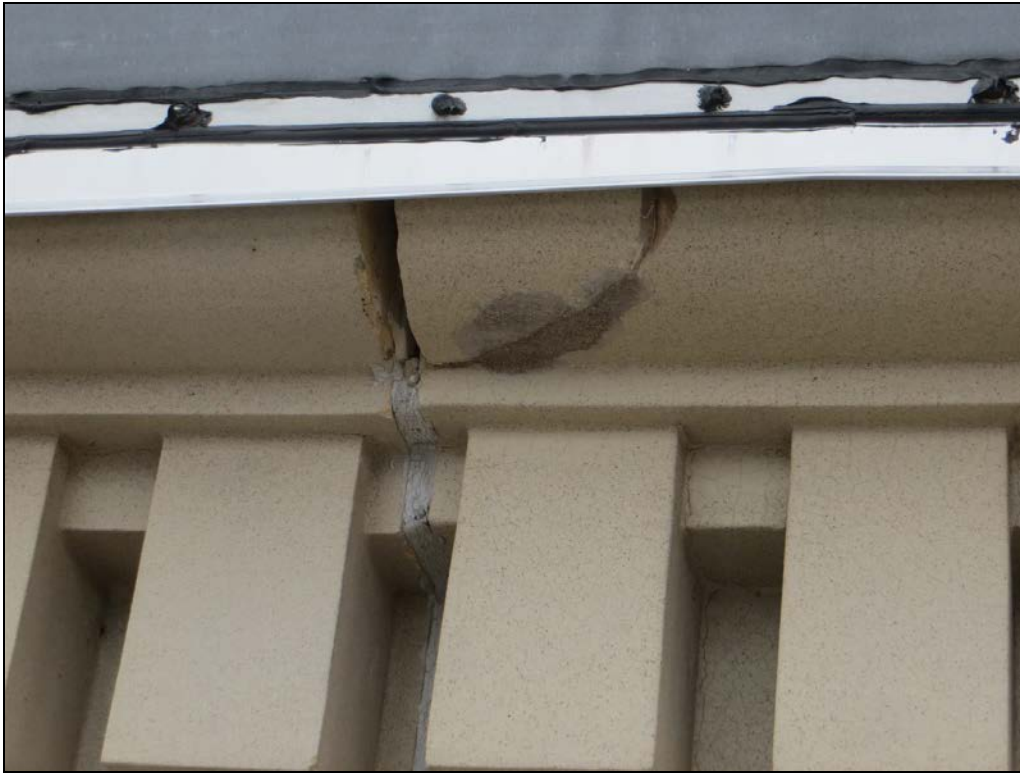
**Photograph 21:**  
Spalled terra cotta piece at the top of the elevation. The piece has been poorly repaired and it appears the metal drip edge is the only thing preventing the spall from falling to the ground.

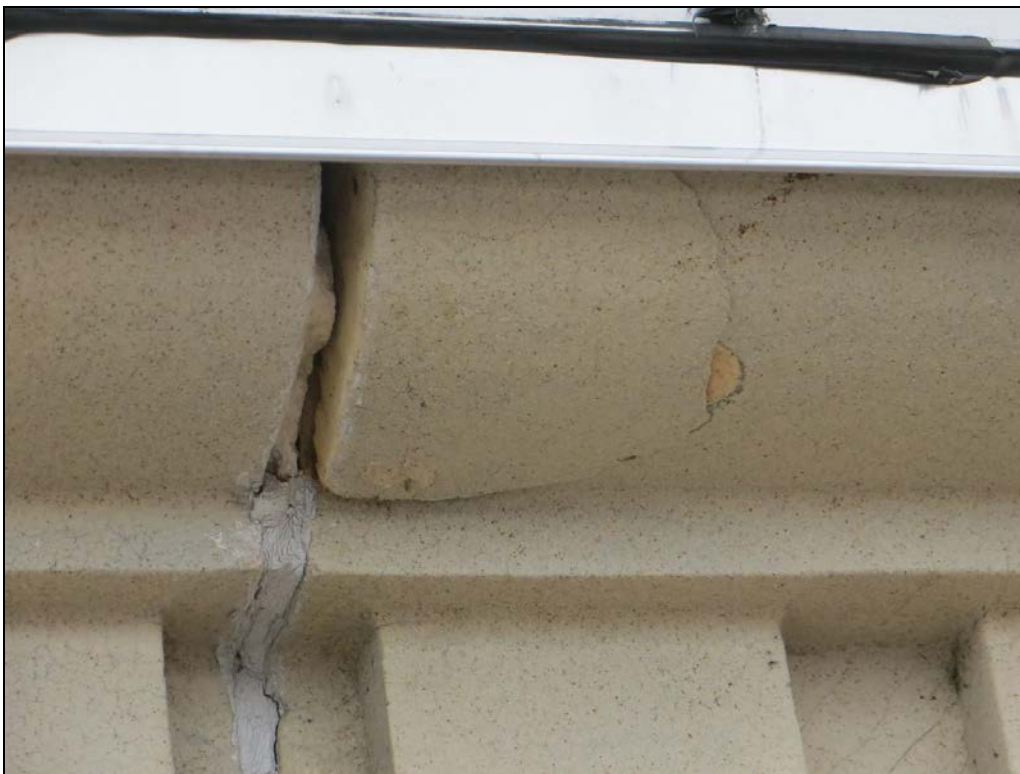
**Photograph 22:**  
This insipient spall could come loose at any time.

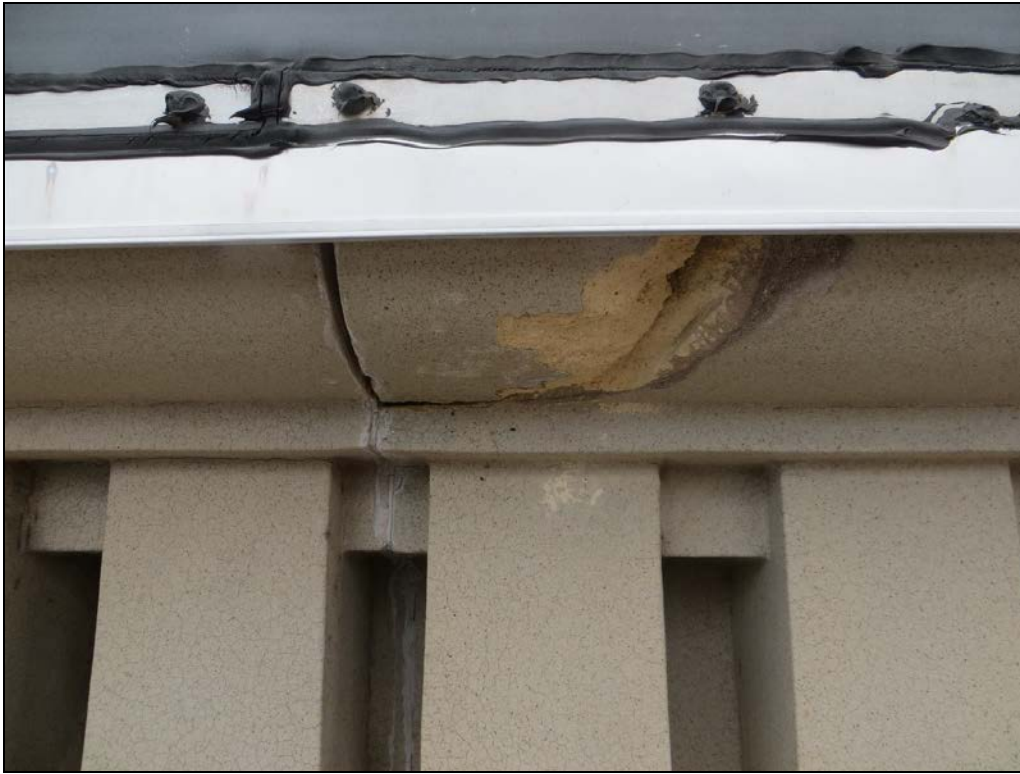
**Photograph 23:**  
This spall is loose  
and being held in  
place by the metal  
drip edge.

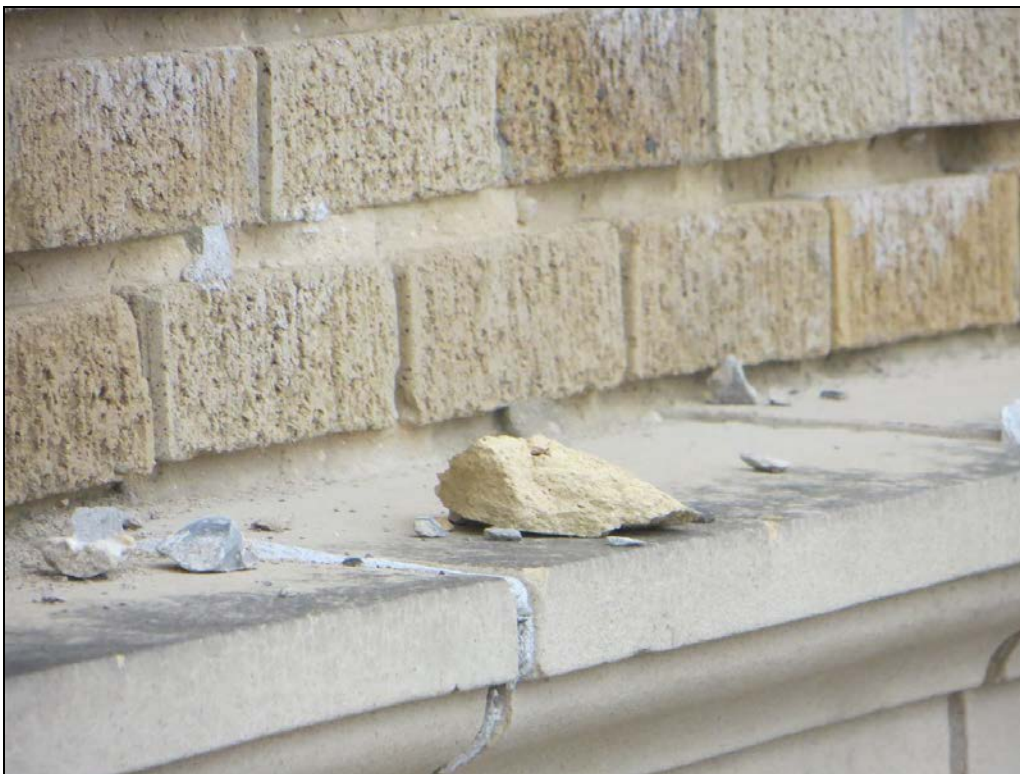
**Photograph 24:**  
A piece of terra  
cotta was found on  
the smaller terra  
cotta cornice  
below.

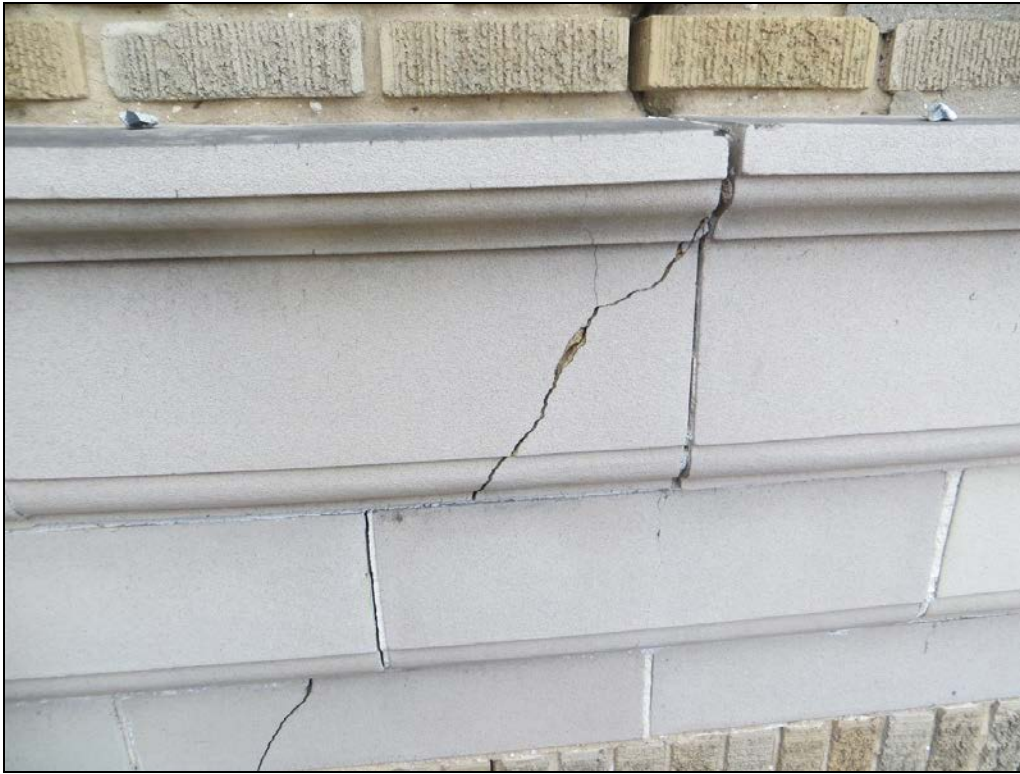
**Photograph 25:**  
Crack through the  
band of terra cotta  
near the top of the  
building.

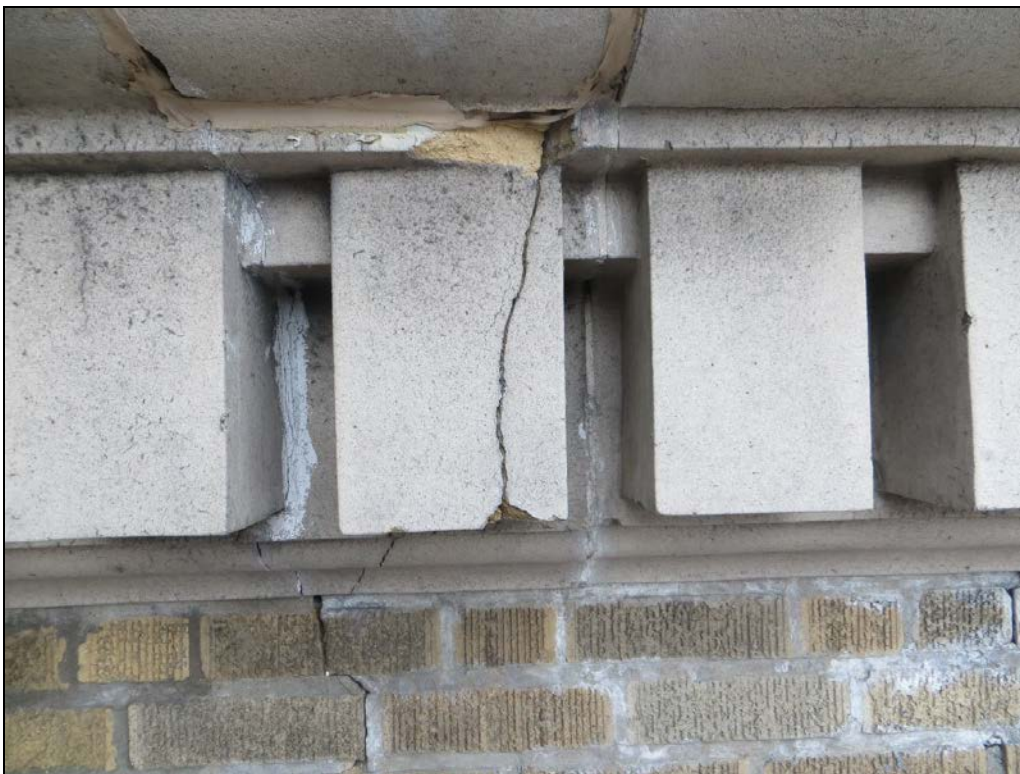
**Photograph 26:**  
Cracked dentil  
piece that will  
eventually break  
loose and fall to  
the ground.

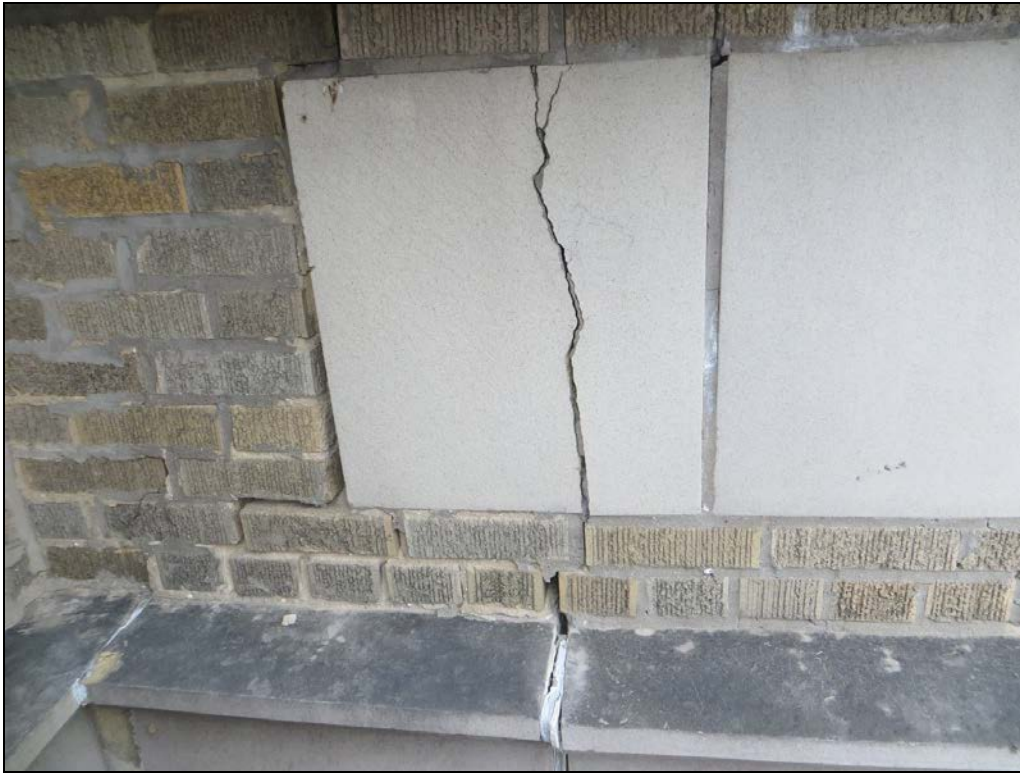
**Photograph 27:**  
Crack in a terra  
cotta panel.

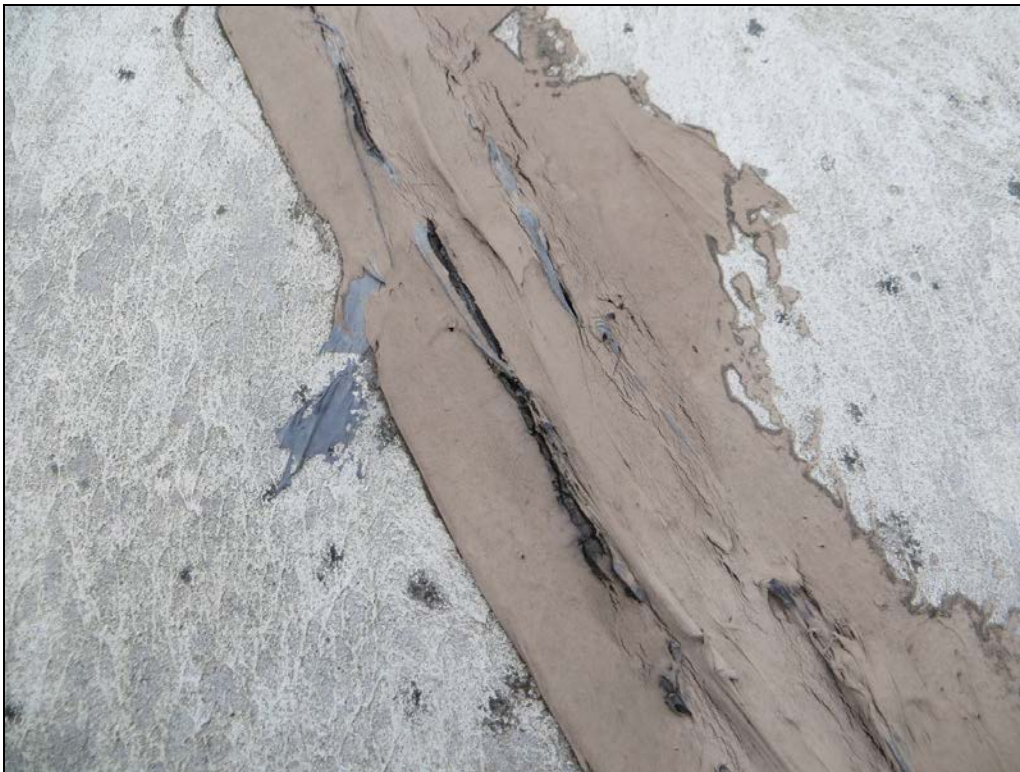
**Photograph 30:**  
The joints between  
the coping pieces  
had been sealed  
multiple times, yet  
we still found  
multiple failures in  
the sealant.

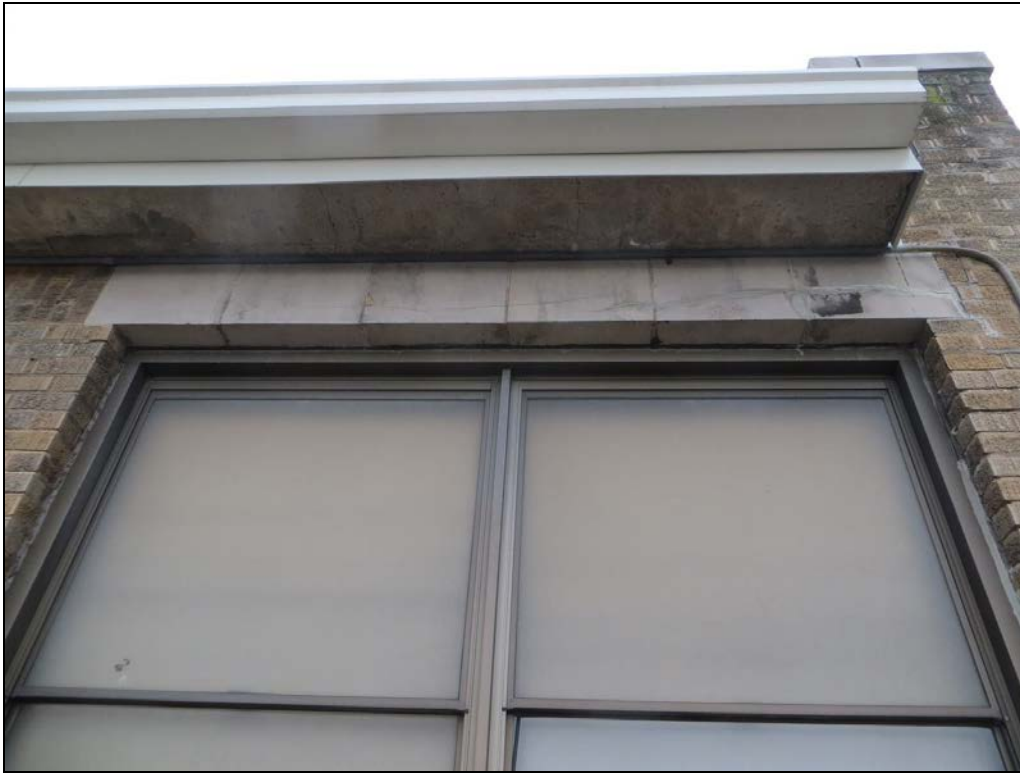
**Photograph 31:**  
Cracked terra cotta  
window header  
pieces which have  
been sealed.

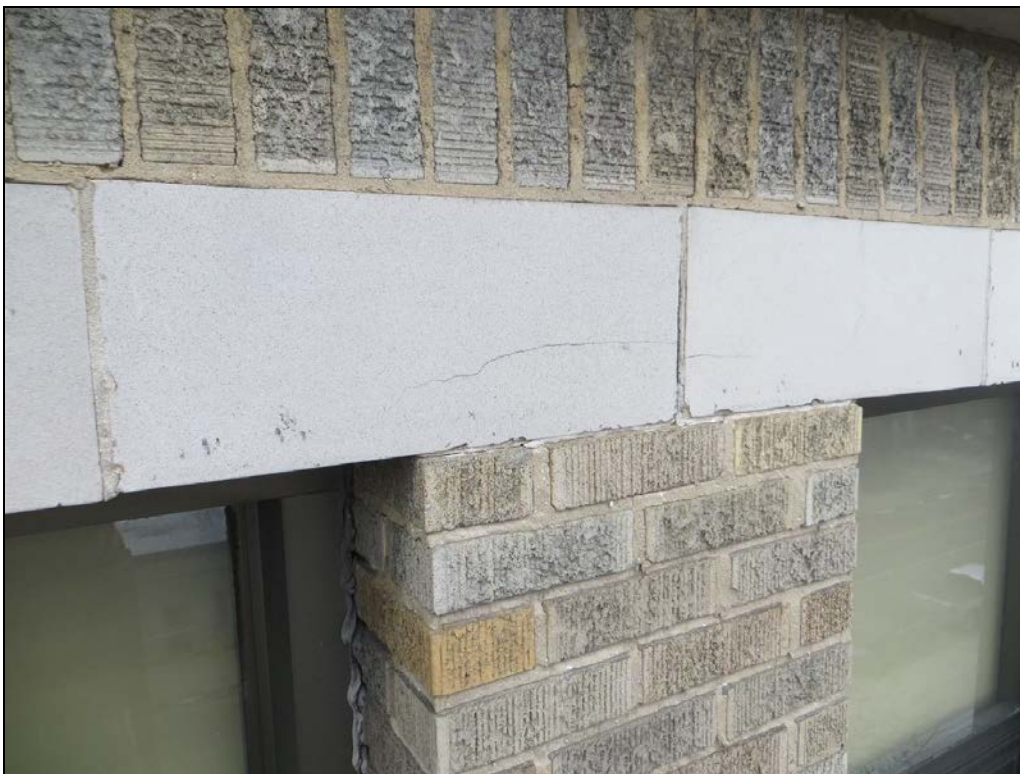
**Photograph 32:**  
Cracked window  
header piece where  
it is supported by  
brick.

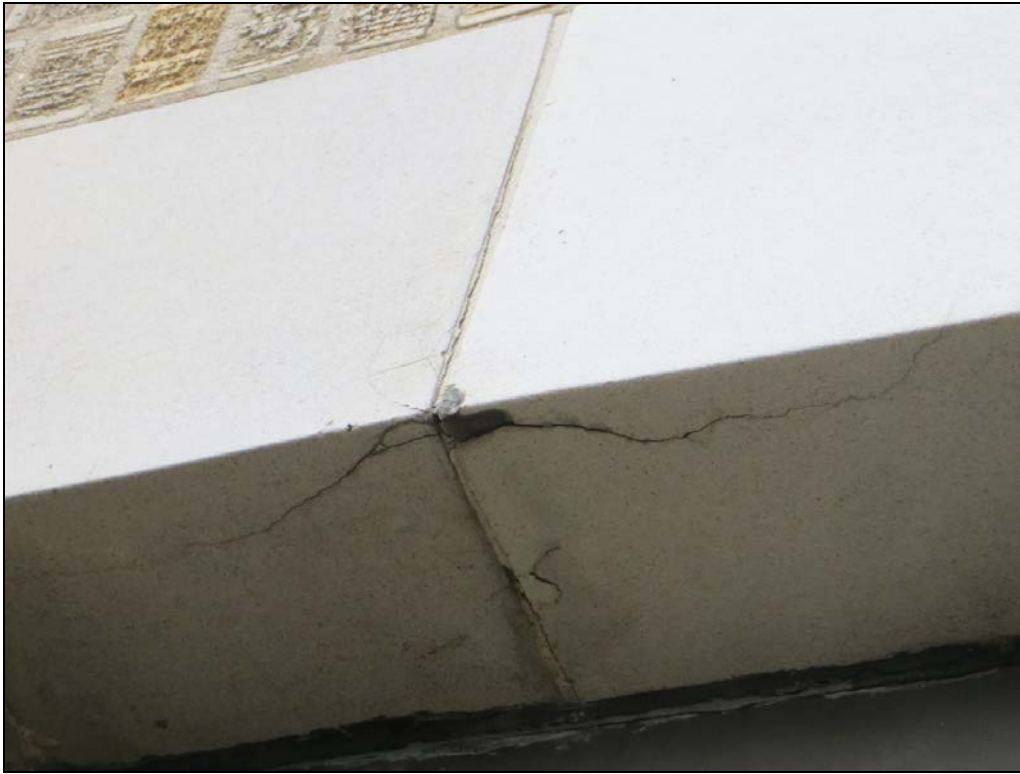
**Photograph 33:**  
Crack on the  
underside of two  
terra cotta window  
header pieces.

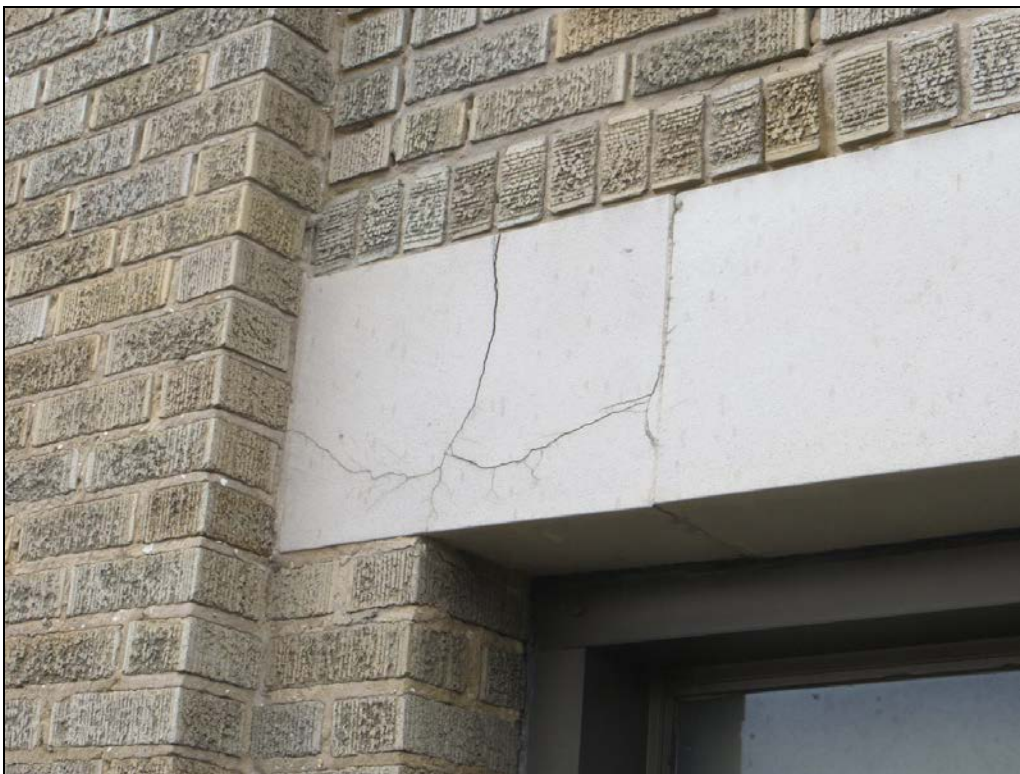
**Photograph 34:**  
Multiple cracks in  
one window header  
piece.

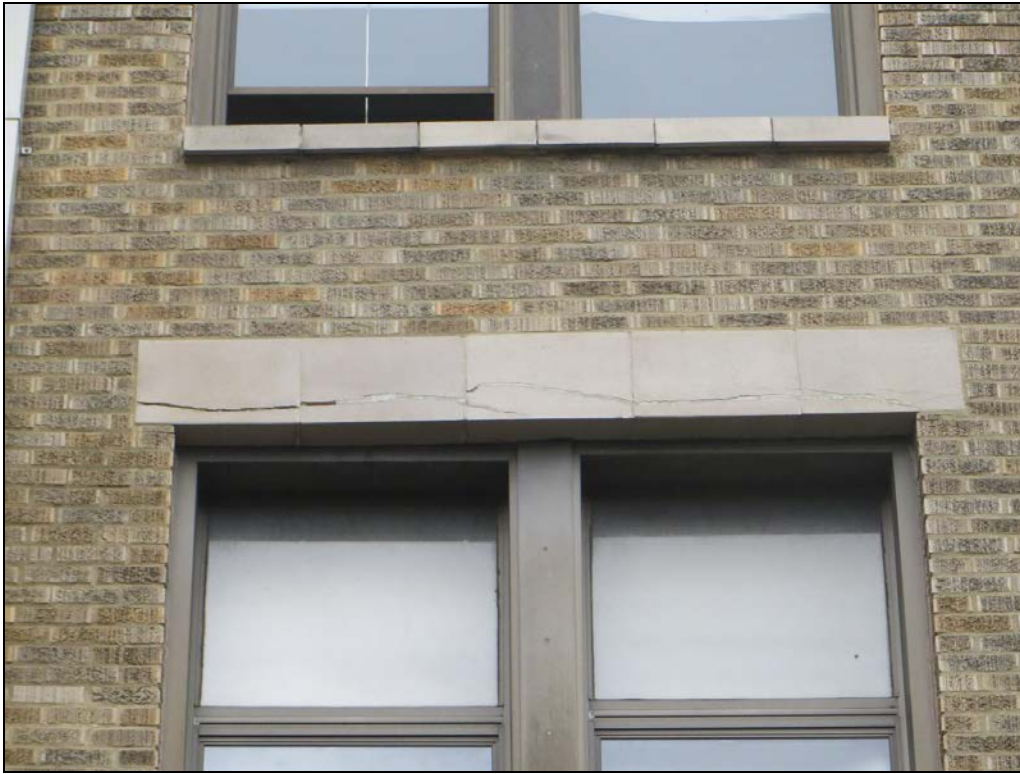
**Photograph 35:**  
Crack across all  
five window  
header pieces.

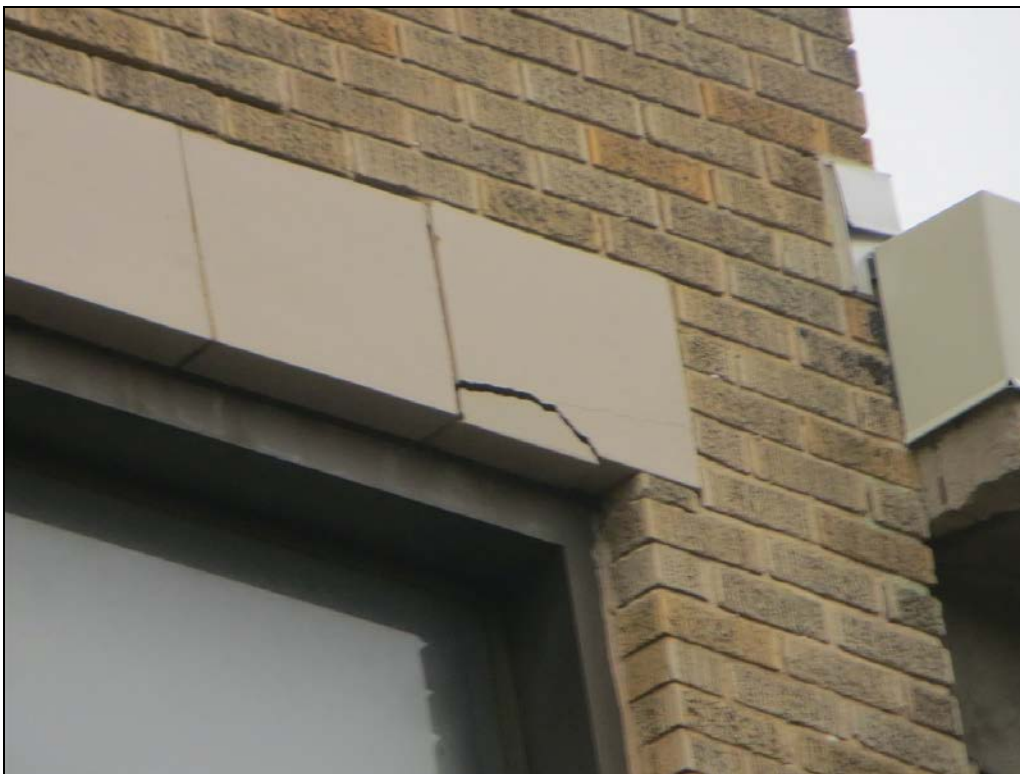
**Photograph 36:**  
Spalled terra cotta  
window header  
piece.

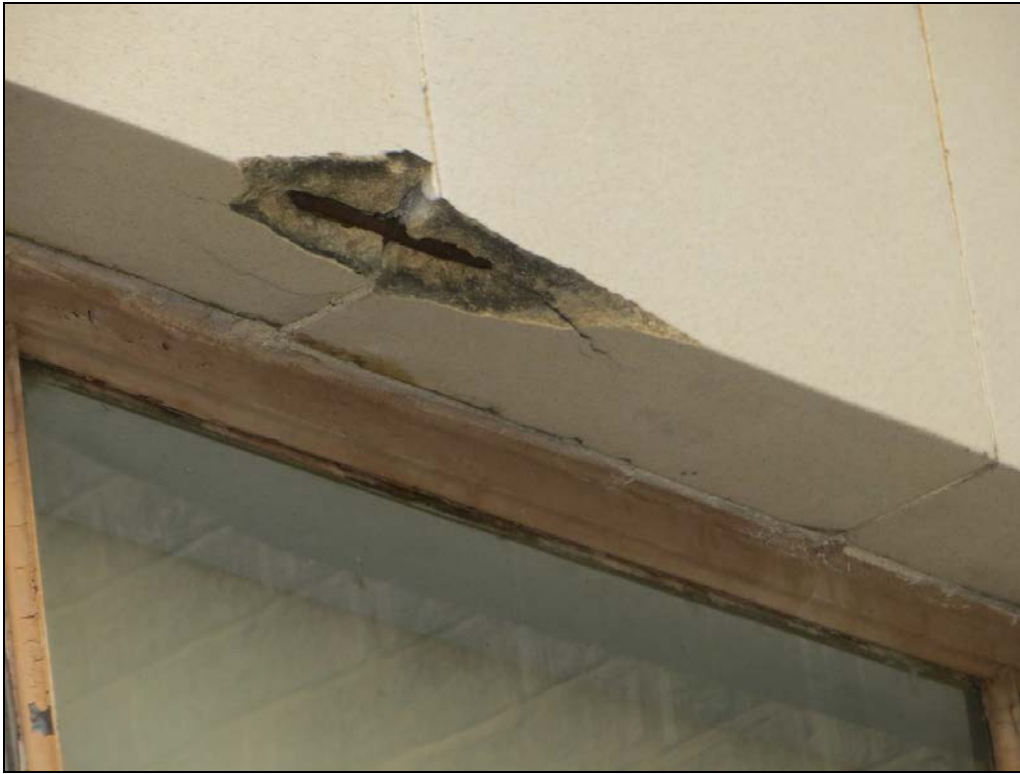
**Photograph 37:**  
Spall at corroded  
pin between pieces.

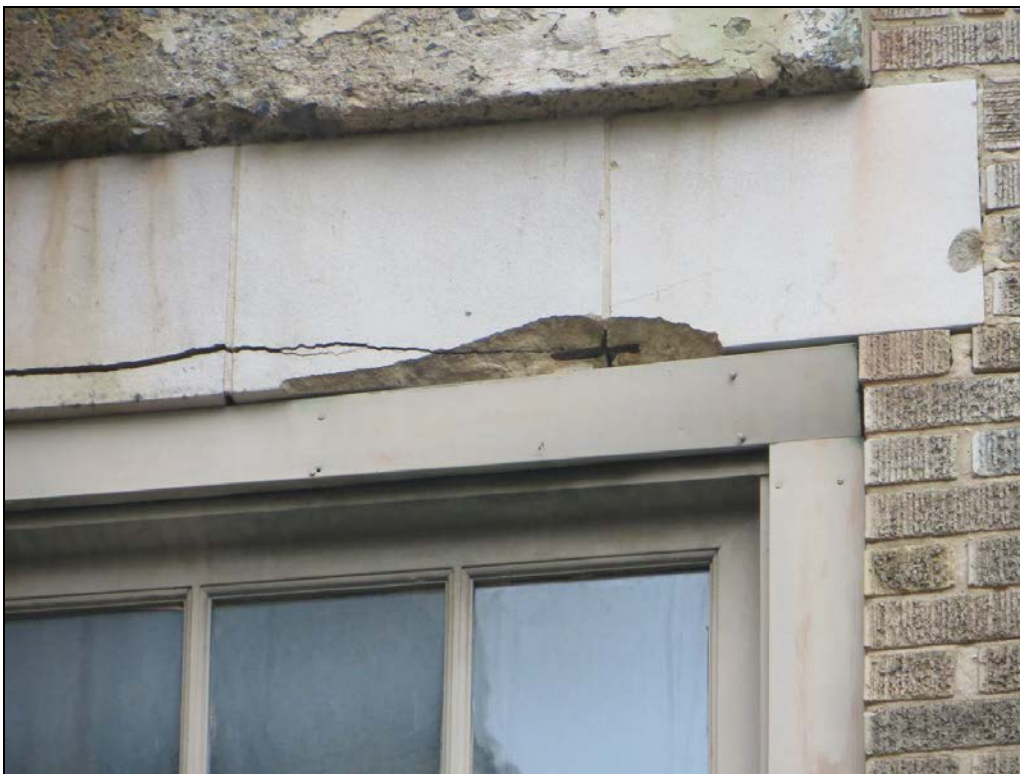
**Photograph 38:**  
Large spall and  
crack in the  
window header  
pieces. Additional  
terra cotta pieces  
will eventually fall  
to the ground.

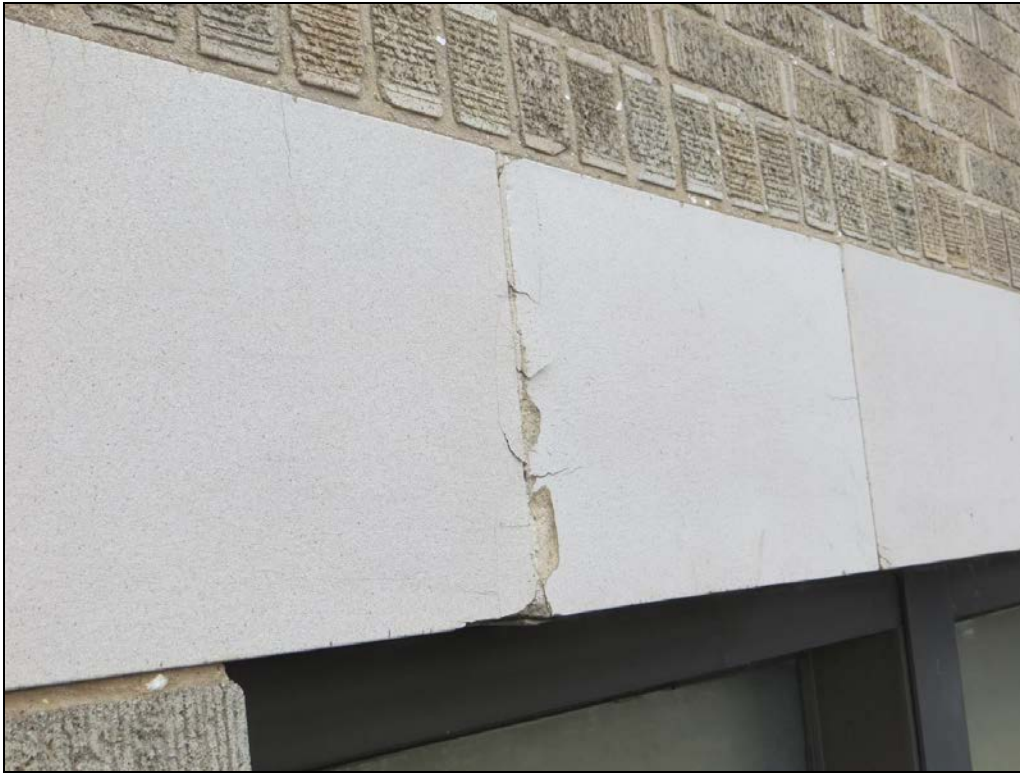
**Photograph 39:**  
Spalls on both  
sides of a mortar  
joint.

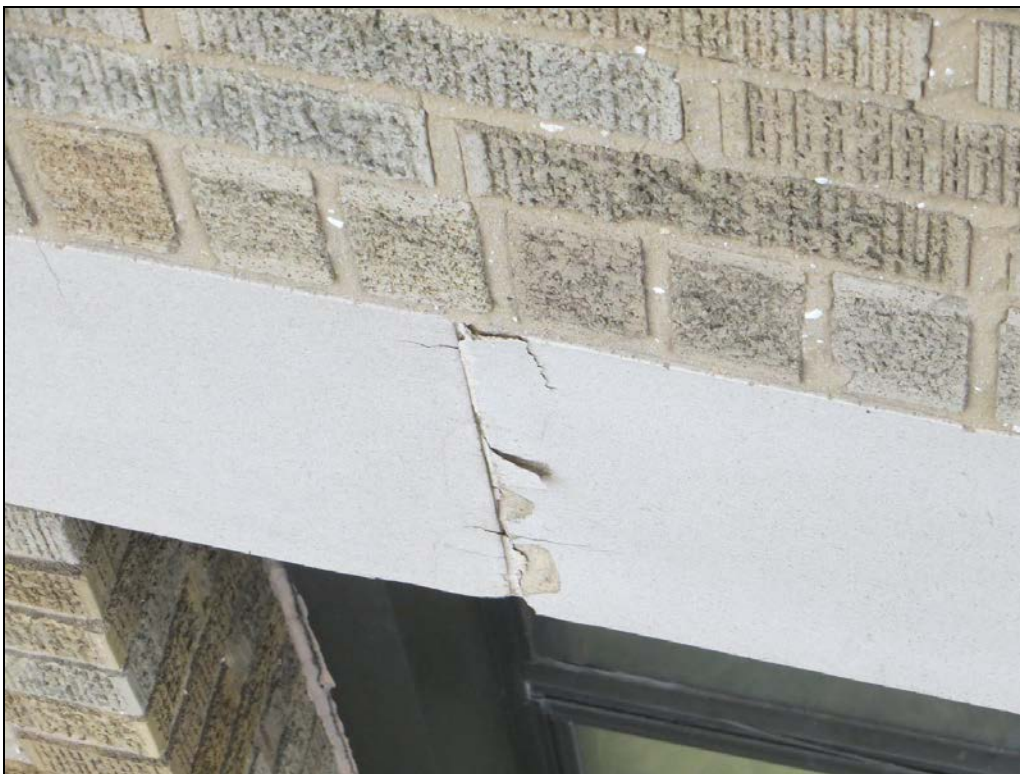
**Photograph 40:**  
The spalling is an  
indication the terra  
cotta is  
overstressed,  
typically caused by  
thermal expansion.

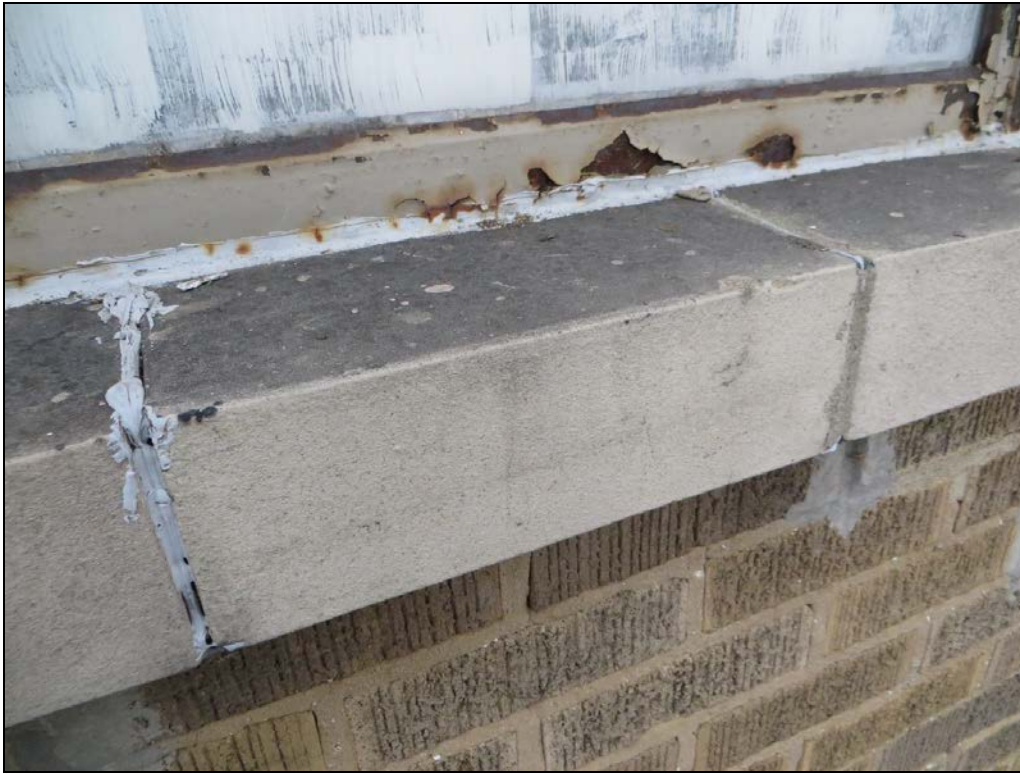
**Photograph 41:**  
The joints between the window sill pieces were in poor condition.

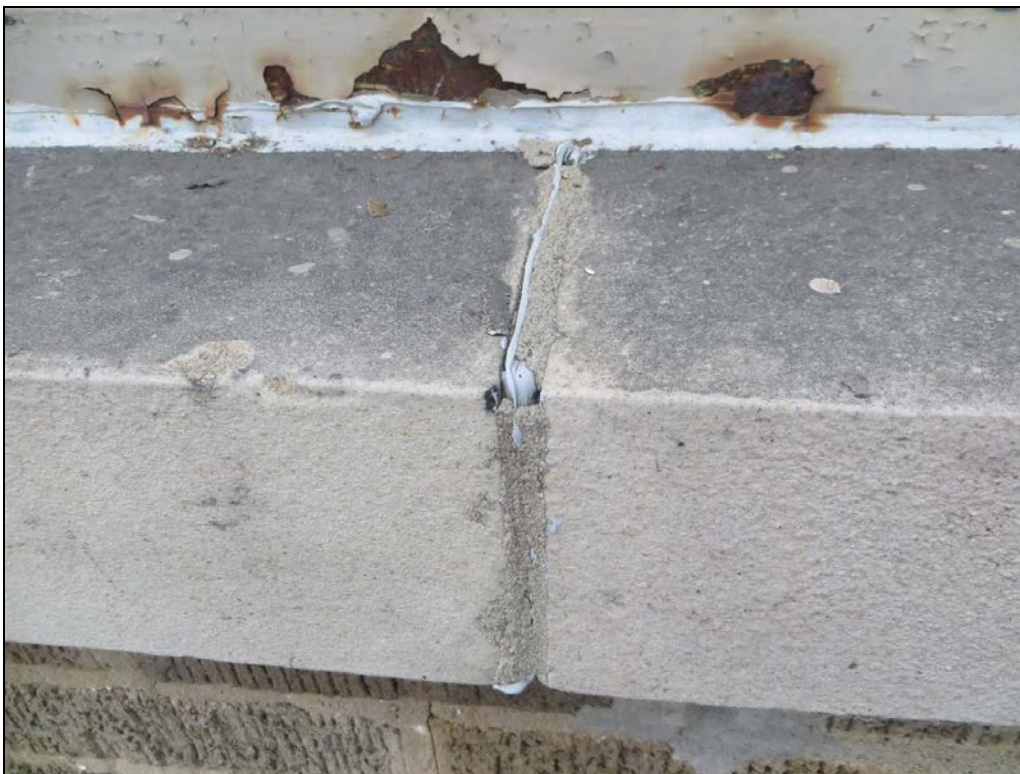
**Photograph 42:**  
The failures of the window sill joints are allowing excessive amounts of water in the wall assembly.

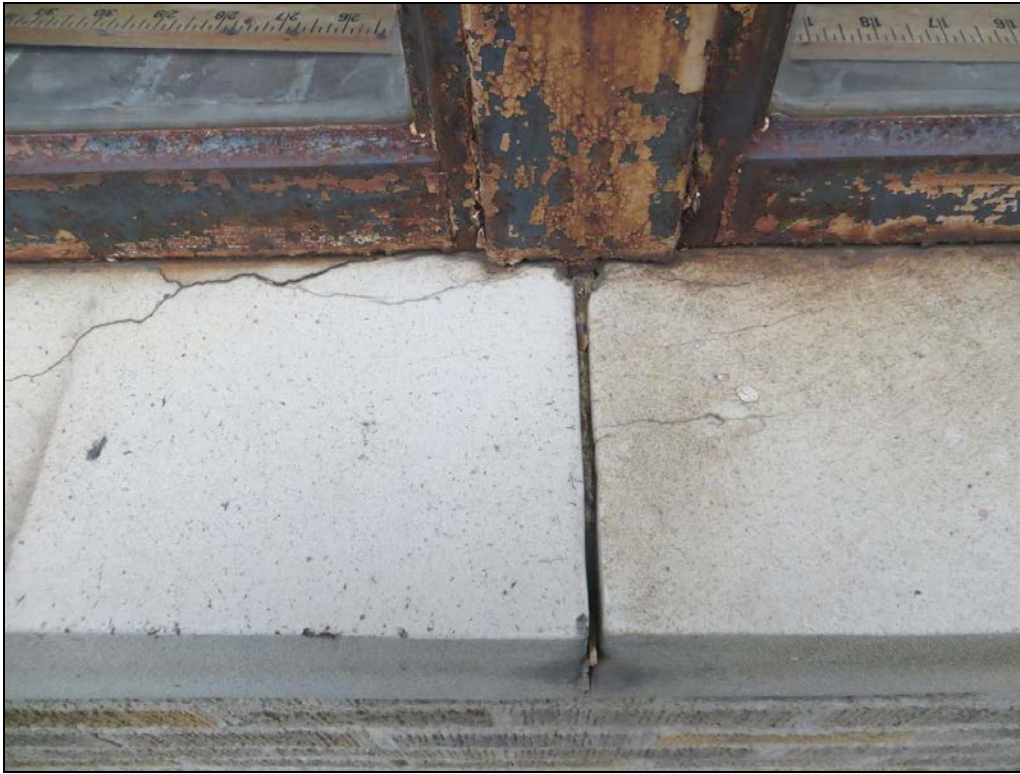
**Photograph 43:**  
A cracked window  
sill caused by a  
corroded window  
frame.

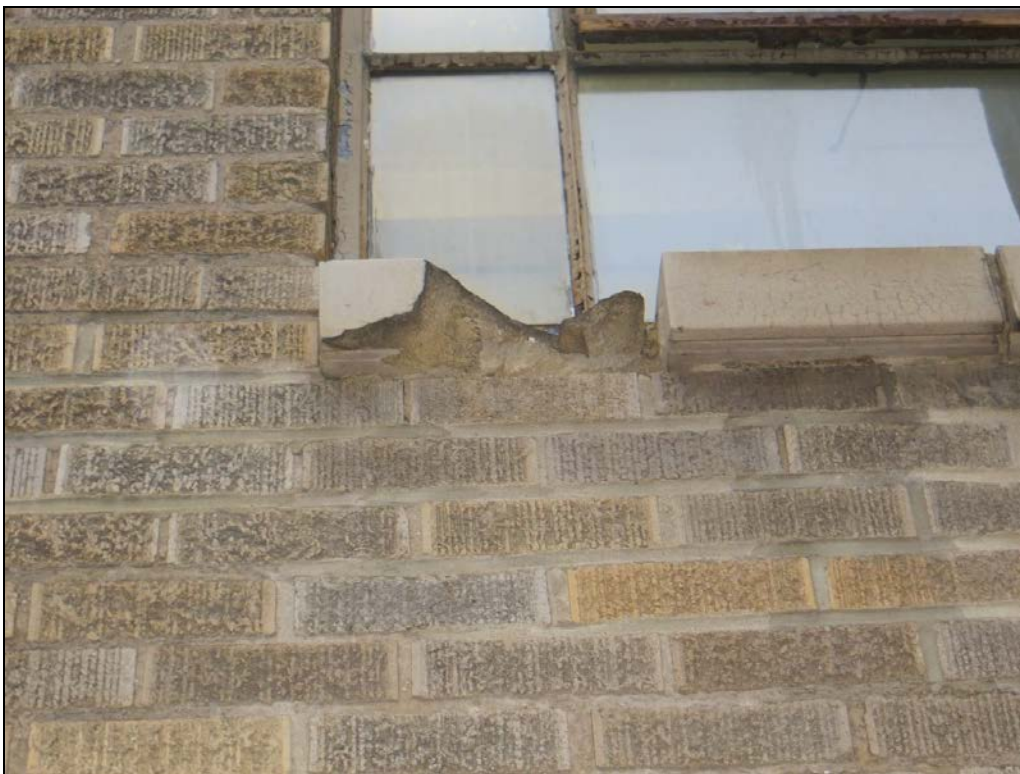
**Photograph 44:**  
A terra cotta  
window sill with  
significant damage.

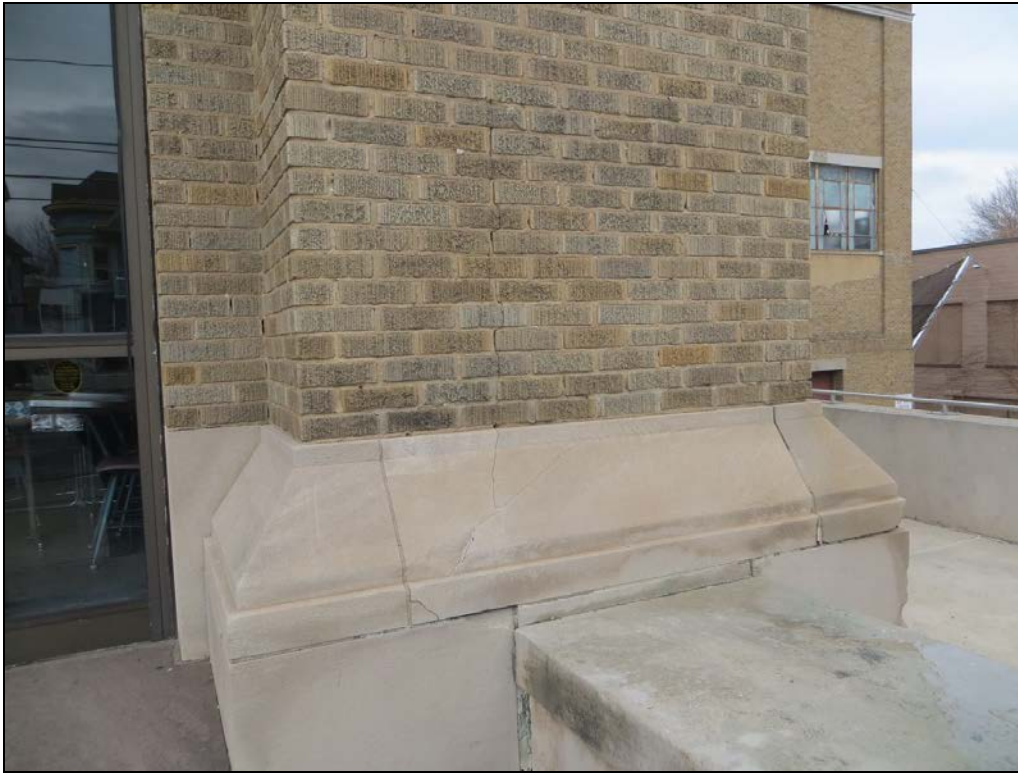
**Photograph 45:**  
Cracked limestone  
piece at the base of  
the building.
