## WILKES-BARRE AREA SCHOOL DISTRICT STRUCTURAL EVALUATION OF ELMER L. MEYERS HIGH SCHOOL

December 8, 2014

**Re: Structural Evaluation of Meyers High School**

# Meyers High School Structural Evaluation

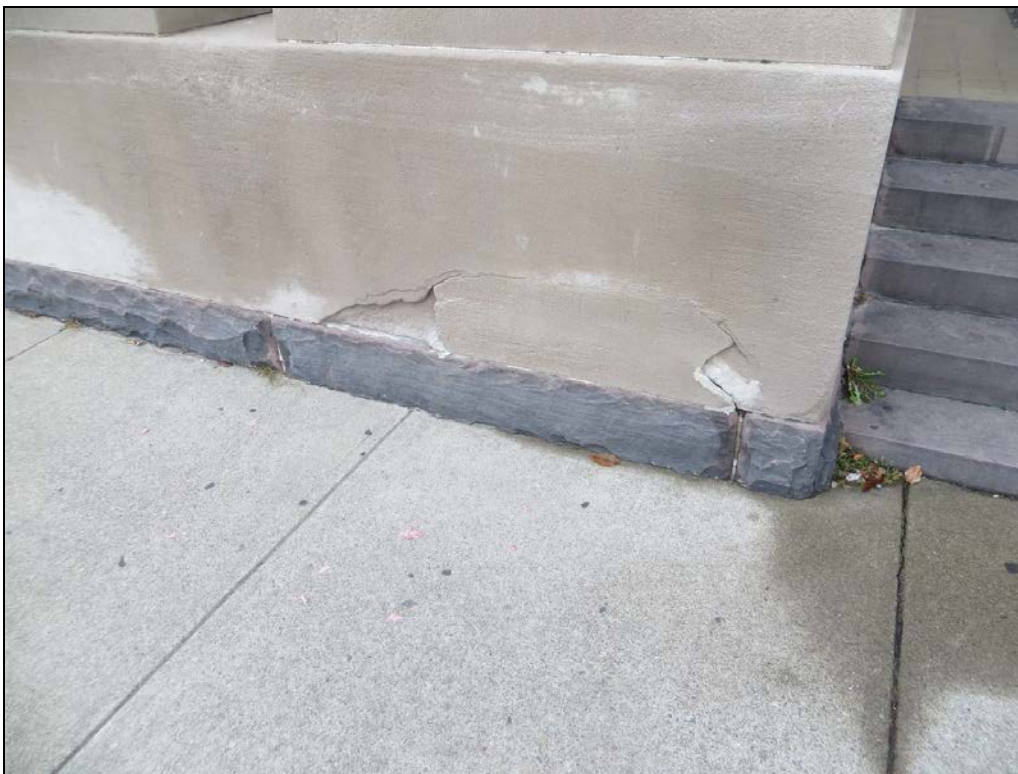
**Photograph 46:**  
Spalled limestone  
piece caused by the  
use of deicing  
salts.

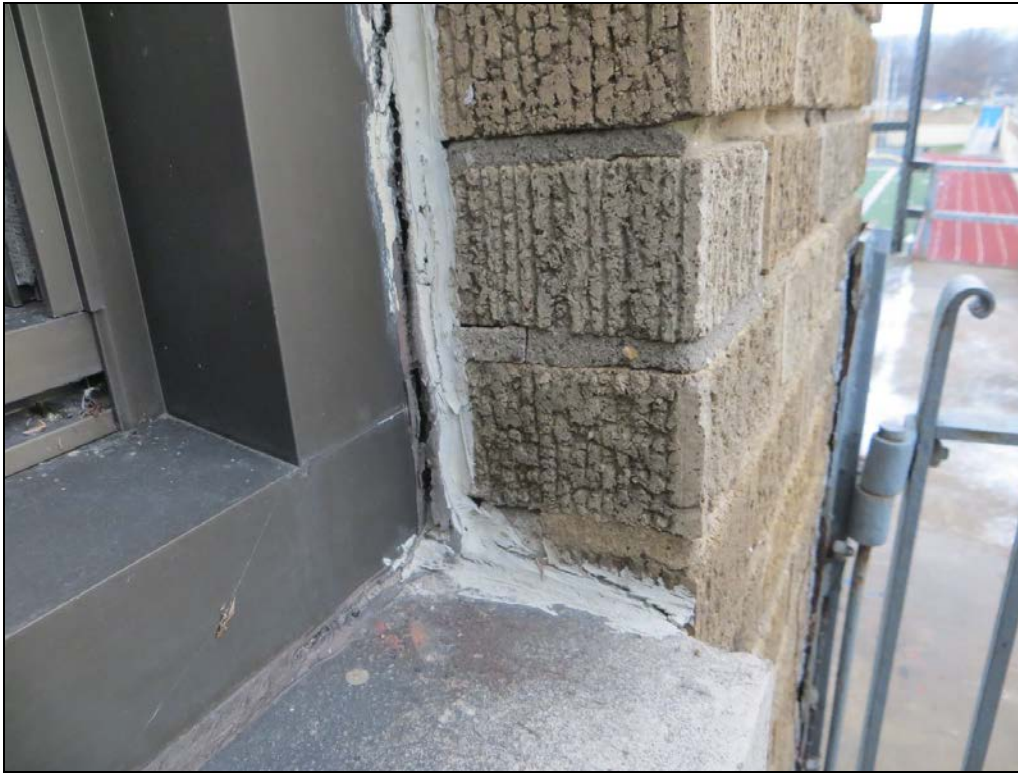
**Photograph 47:**  
Failed sealant at the perimeter of a window. There were multiple generations of sealant present.

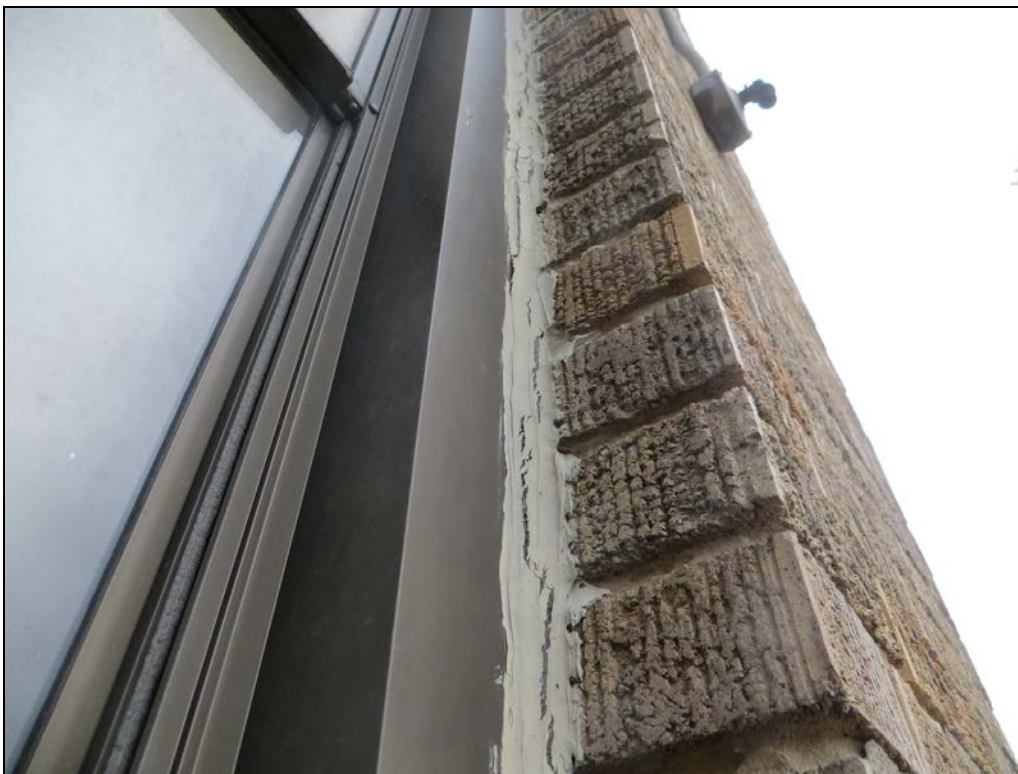
**Photograph 48:**  
This sealant joint had both adhesive and cohesive failures.

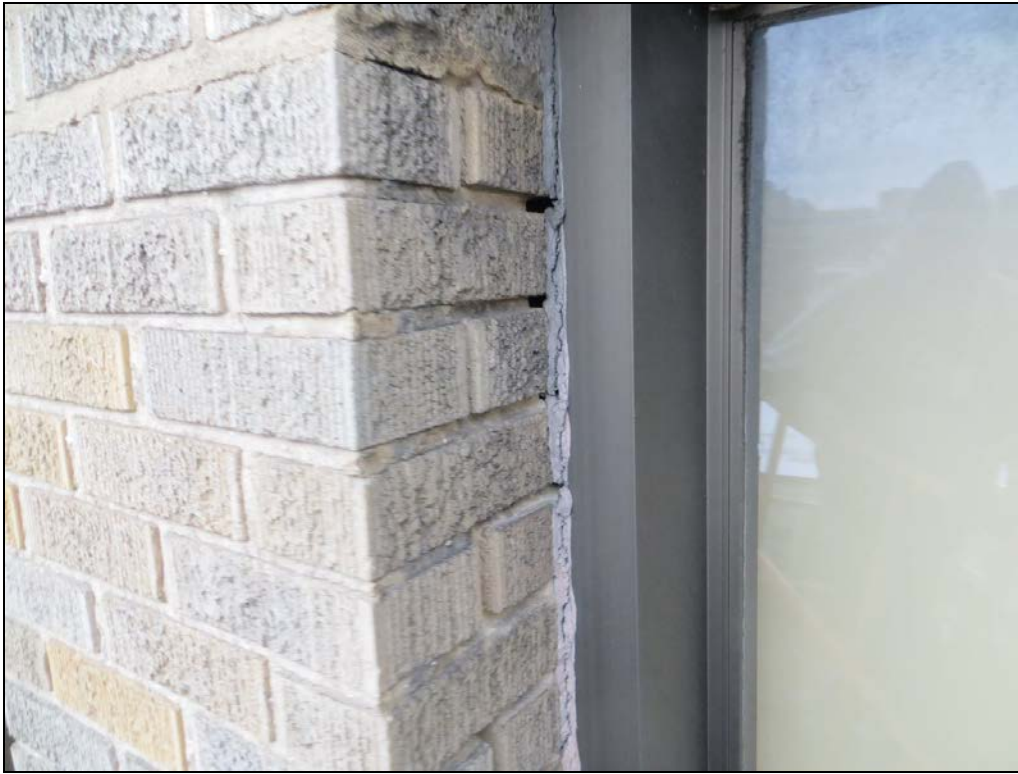
**Photograph 49:**  
All of the window sealant appears to have reached the end of its useful life.

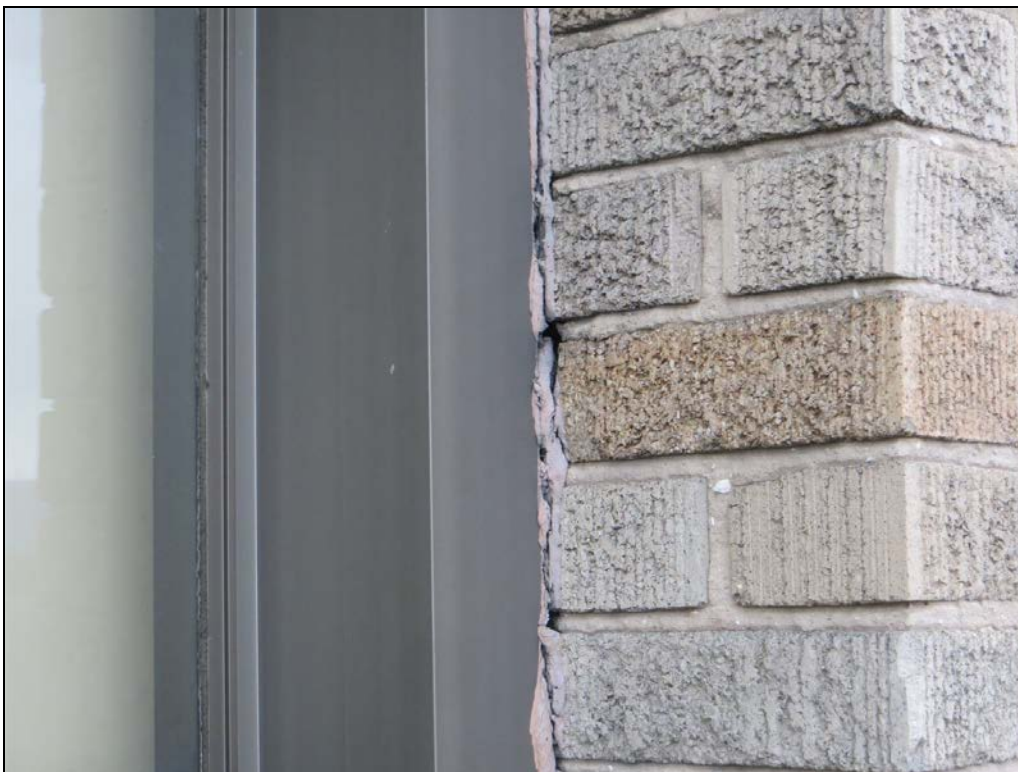
**Photograph 50:**  
The failed sealants are allowing large amounts of bulk rain water to enter the exterior wall assembly.

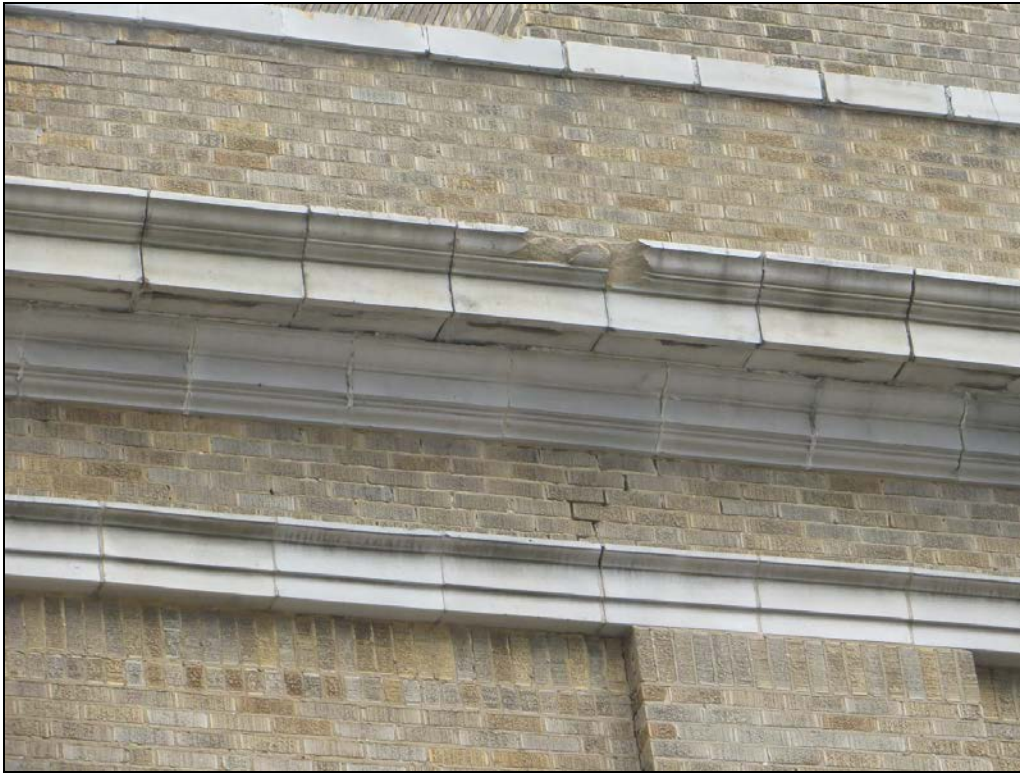
**Photograph 53:**  
Large spall in a  
terra cotta piece at  
the cornice on the  
building.

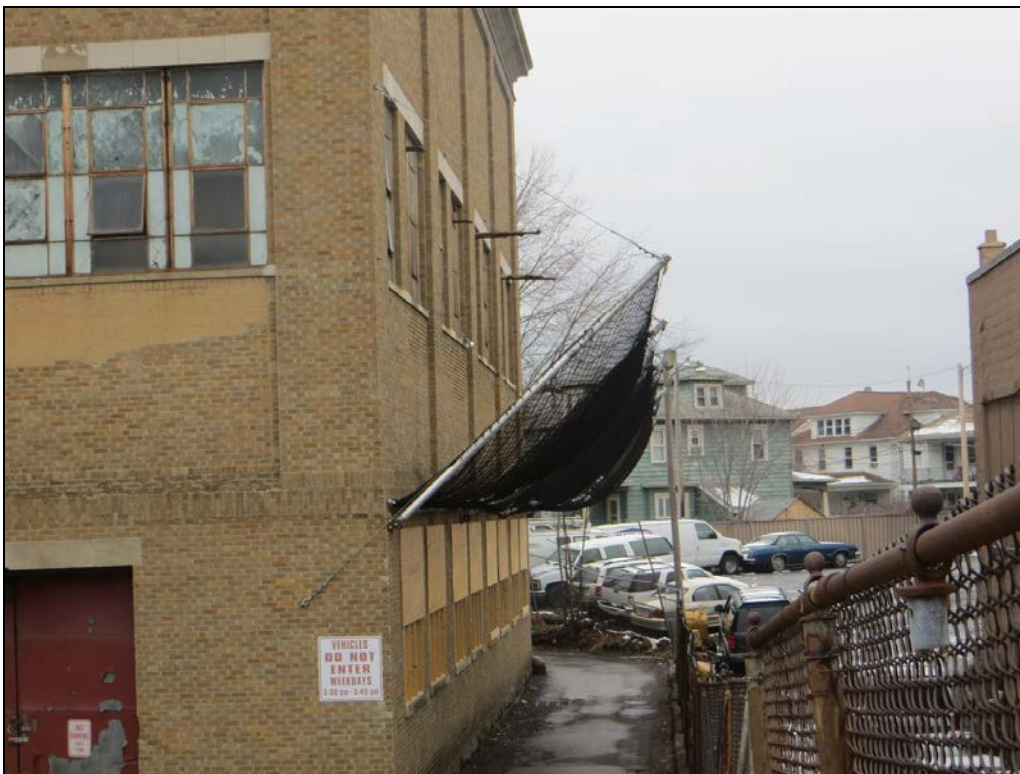
**Photograph 54:**  
The deterioration  
to the mechanical  
building was so  
severe extensive  
netting was  
required on the  
north elevation of  
the building.

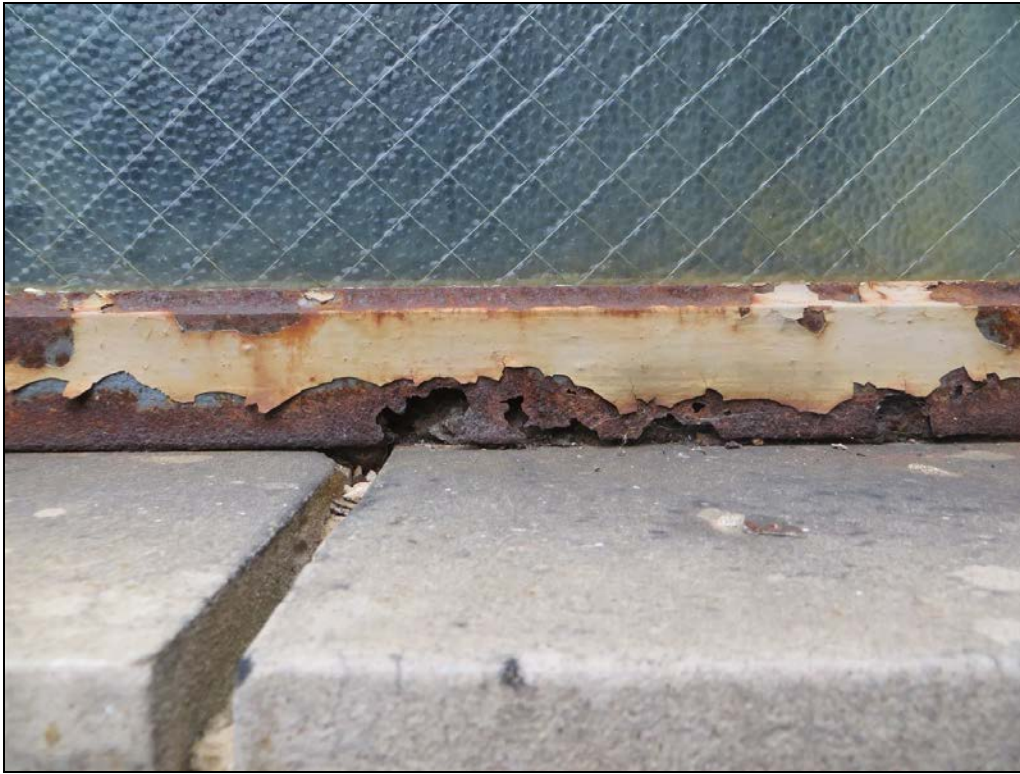
**Photograph 57:**  
Several of the remaining steel framed windows are heavily corroded.

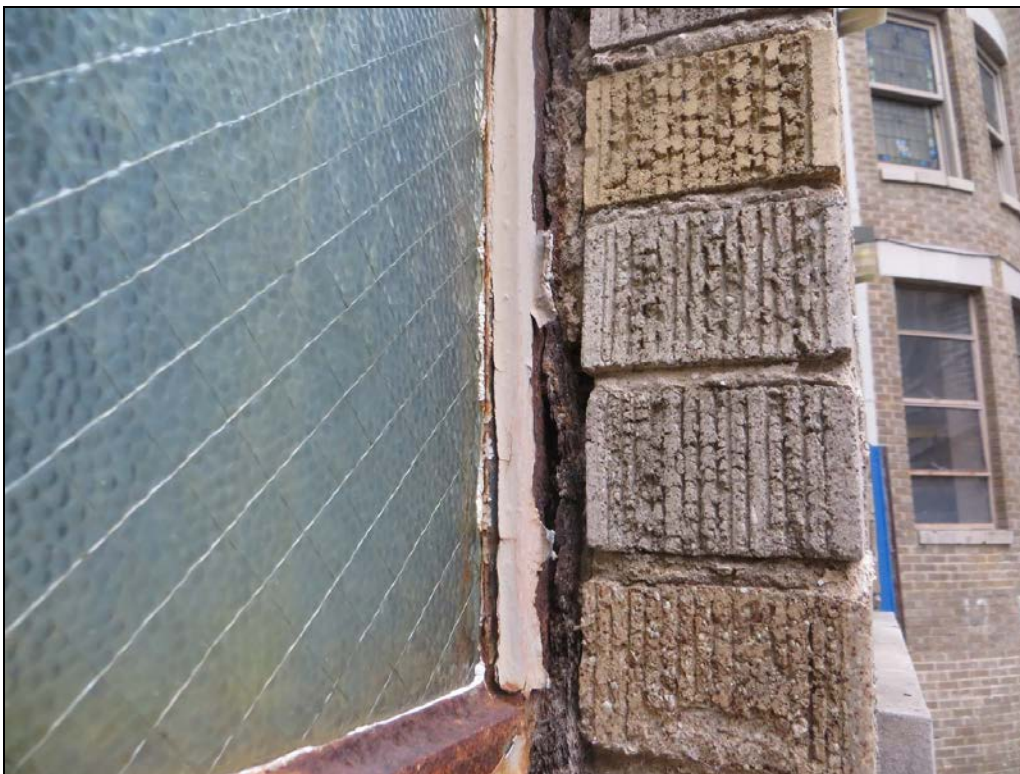
**Photograph 58:**  
The steel frames of the original windows are built into the surrounding masonry and may have been used to temporarily support the terra cotta above. Extensive masonry work will be required when the steel frames are removed.

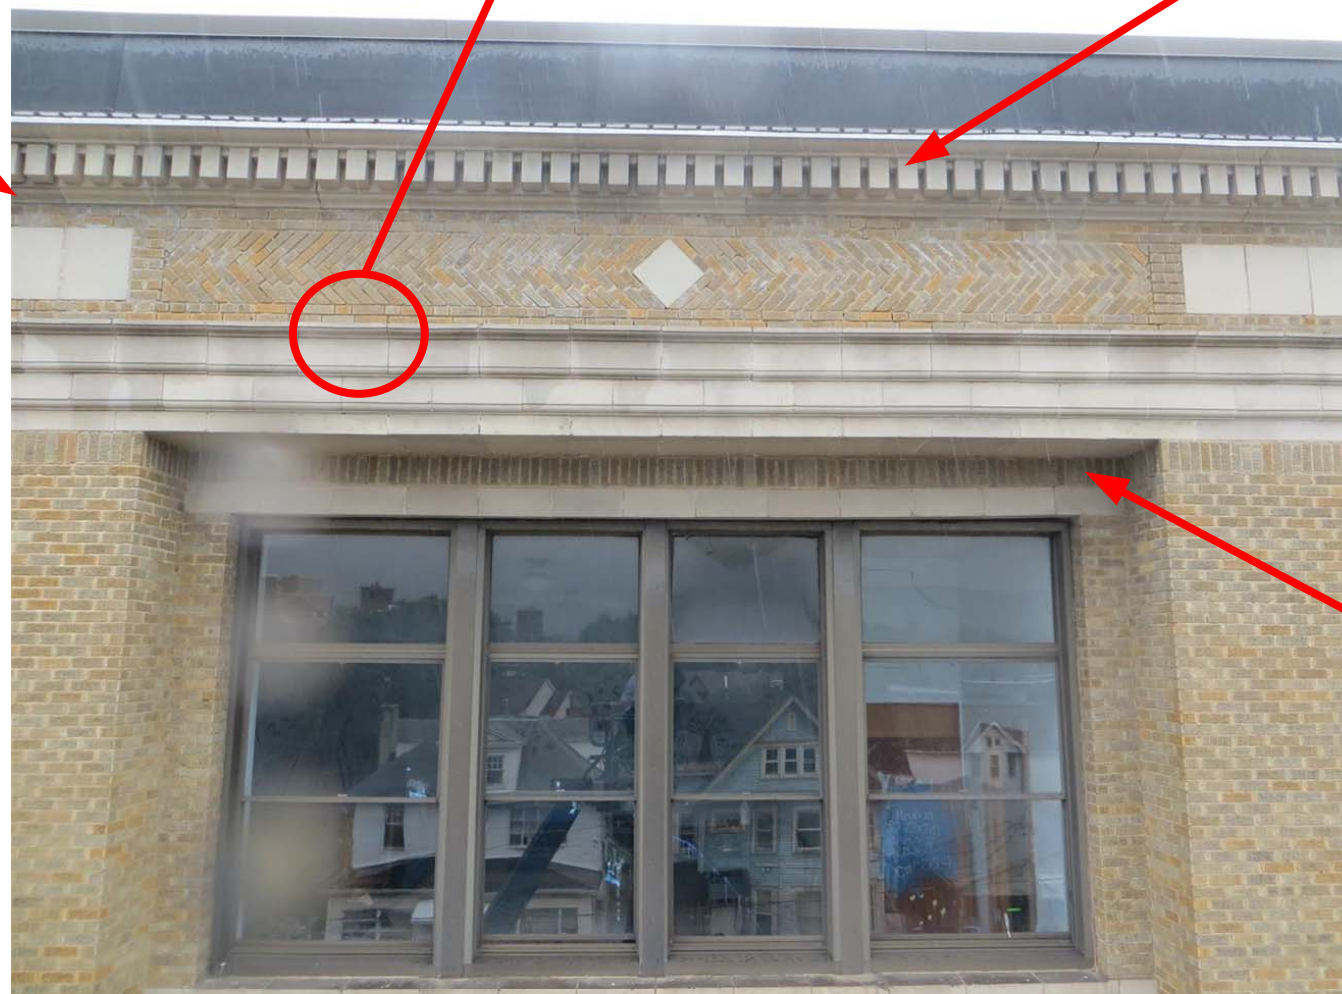
East Window Soffit

The mortar in the brick above the terra cotta was in poor condition. Previous attempts to repoint the mortar were unsuccessful and have already failed.

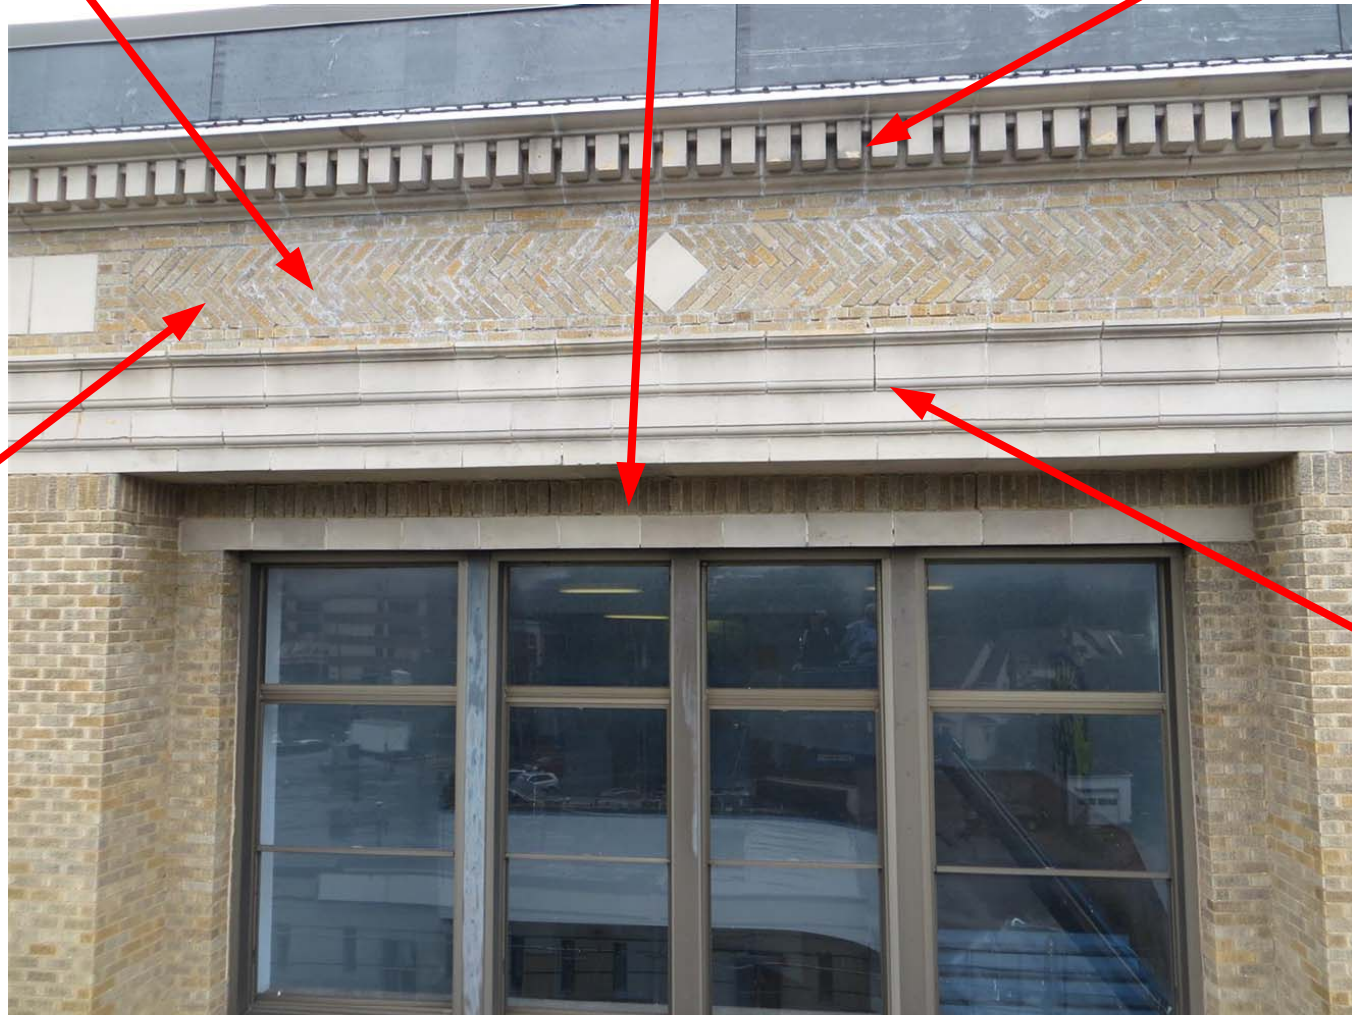
West Window Soffit

Spalling of the glazing was present at a few locations in this area.

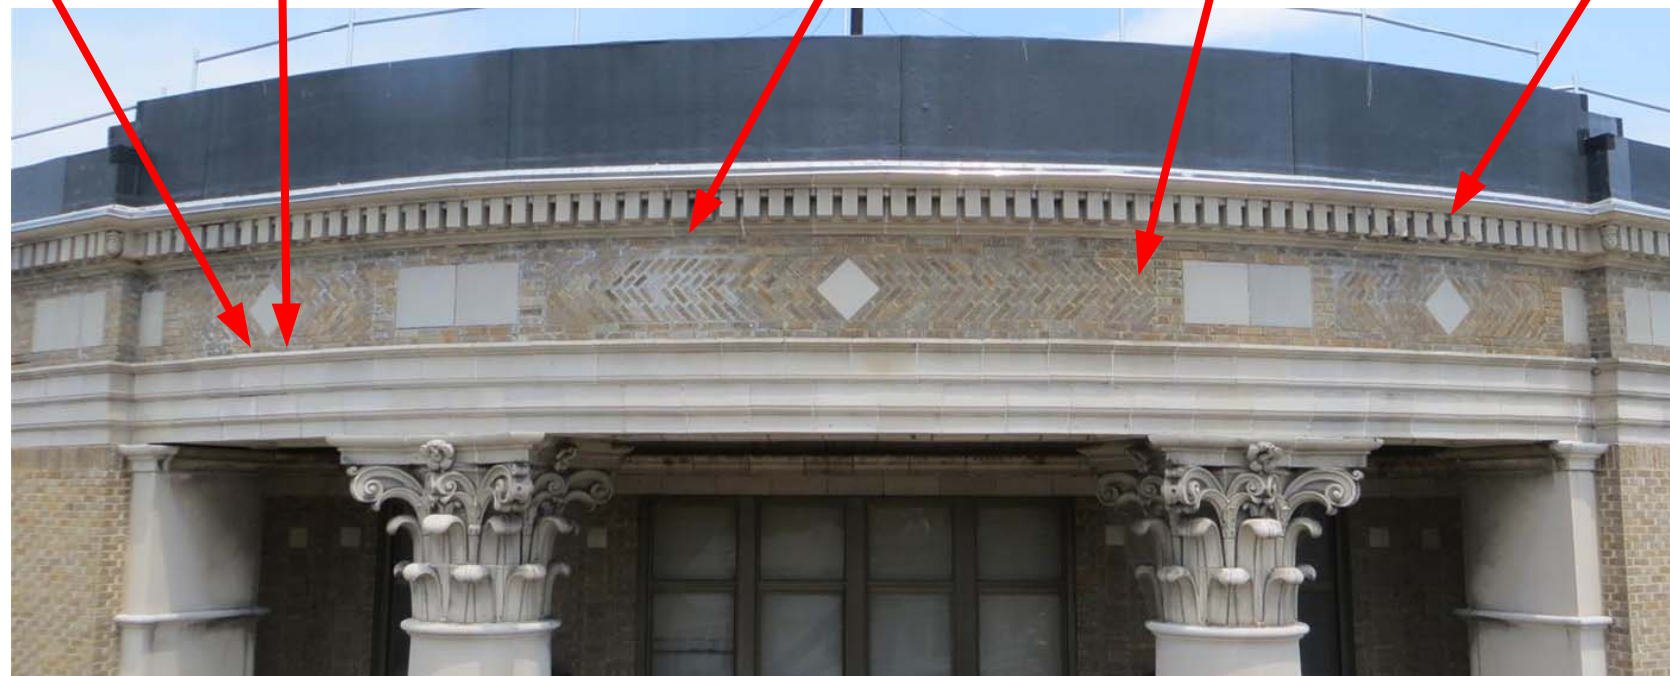
West Architrave

Some small spalls were noted on the dentil above the architrave.
