## WILKES-BARRE AREA SCHOOL DISTRICT STRUCTURAL EVALUATION OF JAMES M COUGHLIN HIGH SCHOOL

**Re: Structural Evaluation of Coughlin High School**

# Coughlin High School Structural Evaluation

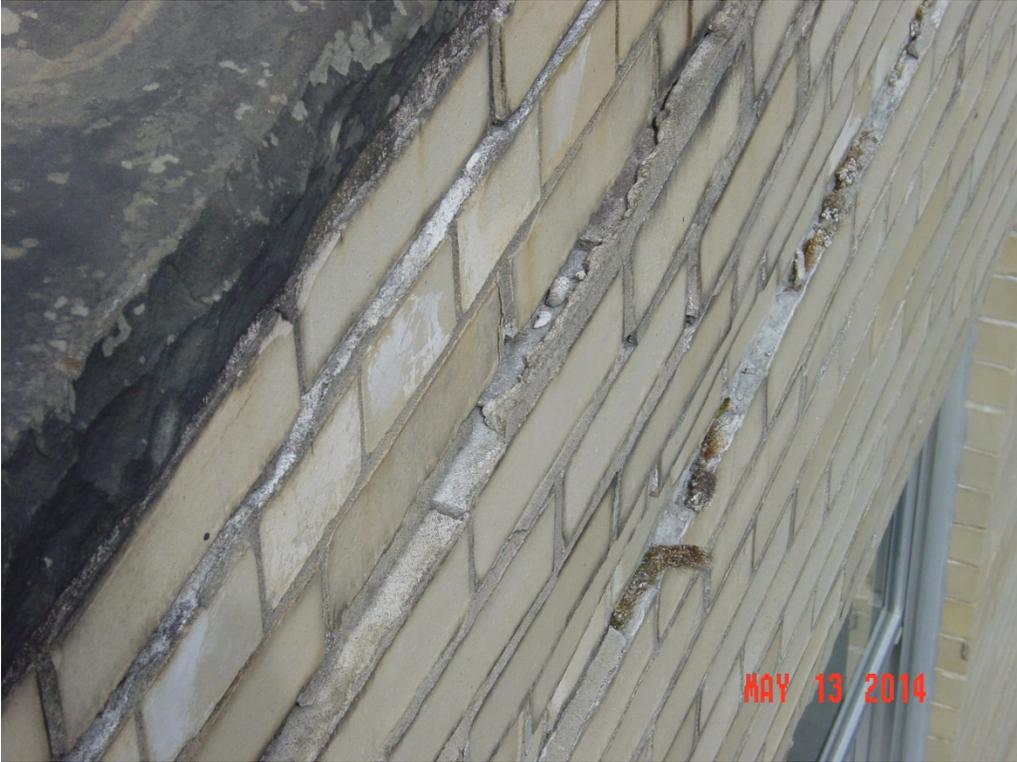
The load-bearing perimeter and courtyard brick walls have been exposed to the elements for over a century and are exhibiting signs of extensive deterioration. During a routine roof inspection in the spring of 2014, school officials discovered that a number of bricks in the upper courtyard walls appeared to be loose and pulling away from the wall. A more detailed investigation was performed and it was determined the mortar in the top portion of the wall had been seriously weakened, due to water infiltration and freeze/thaw cycles.

**Brick at top of southeast corner of Courtyard wall prior to repairs**

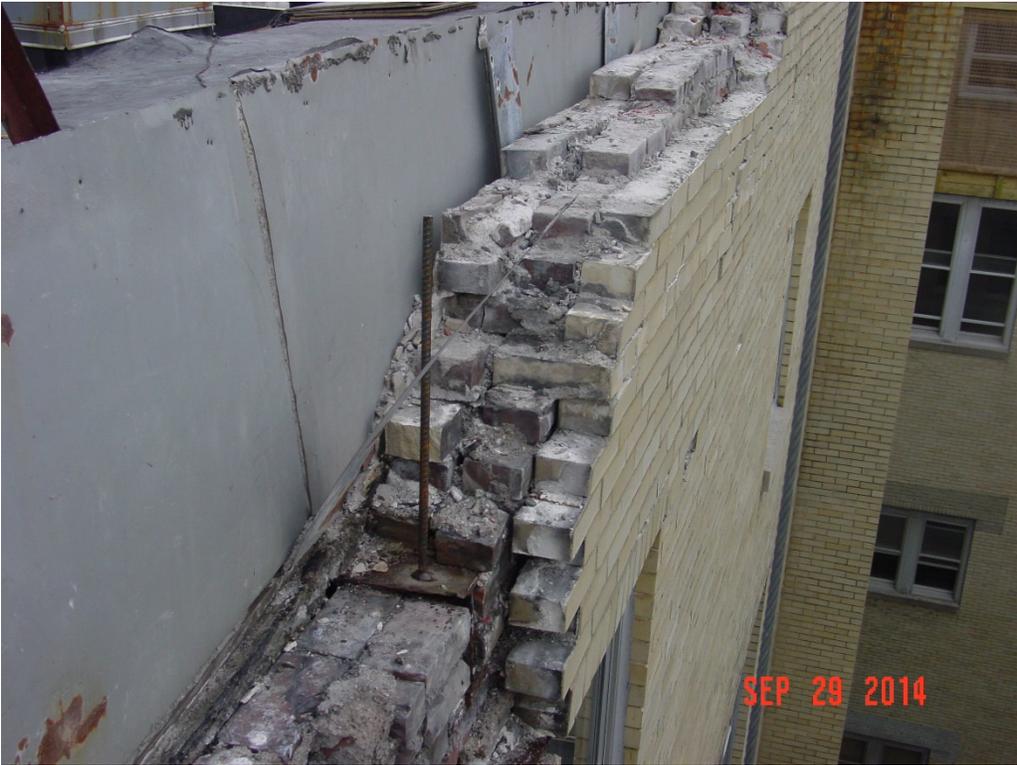
Because of the poor conditions of the mortar at and below the roof steel bearing, the new parapets were anchored to the roof beams with welded rods.

**Parapet Steel Reinforcing Bars Added During Courtyard Wall Repairs.**

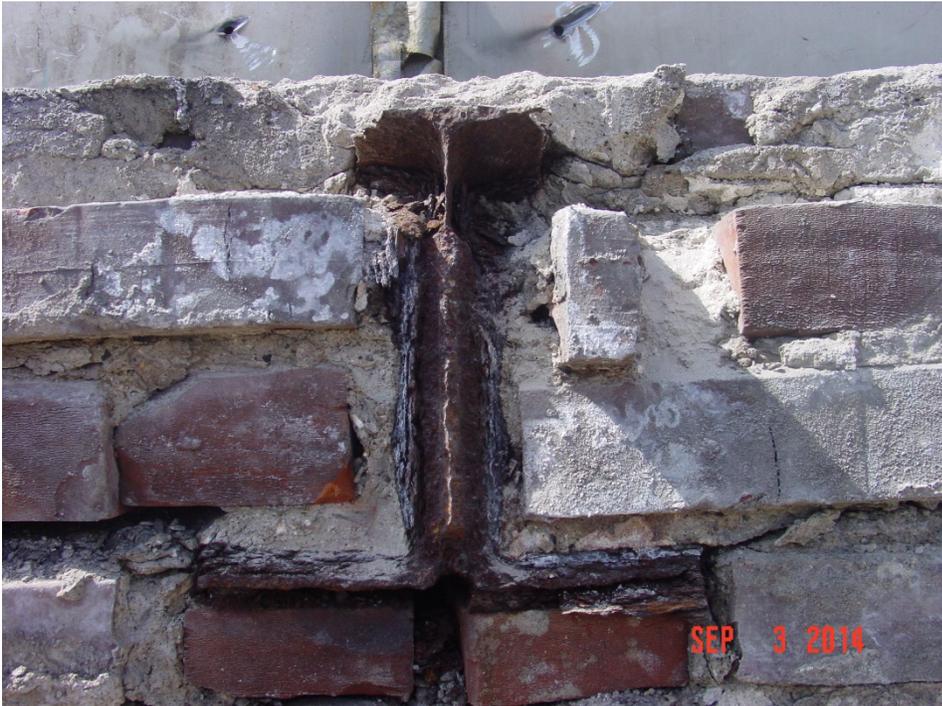
The partial removal of the parapet revealed that the ends of the steel roof beams, which bear on the inner two wythes of brick, had corroded similarly to the exposed window lintels. In some areas the outermost portion of the beams and their steel bearing plates were severely corroded and delaminated. The expansion of these members produced jacking forces in the brick walls, resulting in movements and cracking. This, in turn, has created more paths for storm water to infiltrate the wall and accelerate the deterioration process. The potential damage of the roof beams was noted during the containment design process and the affected beams were shored with built-up wood studs bearing on the attic slab. This was done to protect the roof from localized failure.

Exposed End of typical roof beam at courtyard wall.

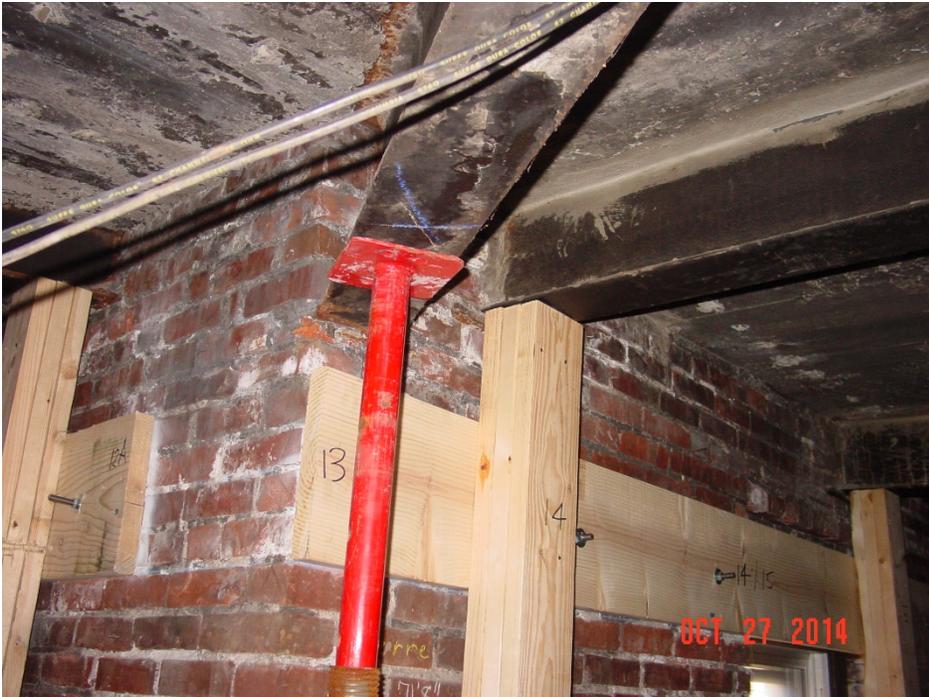
Roof shoring installed in Attic during 2014 courtyard wall repair and containment project

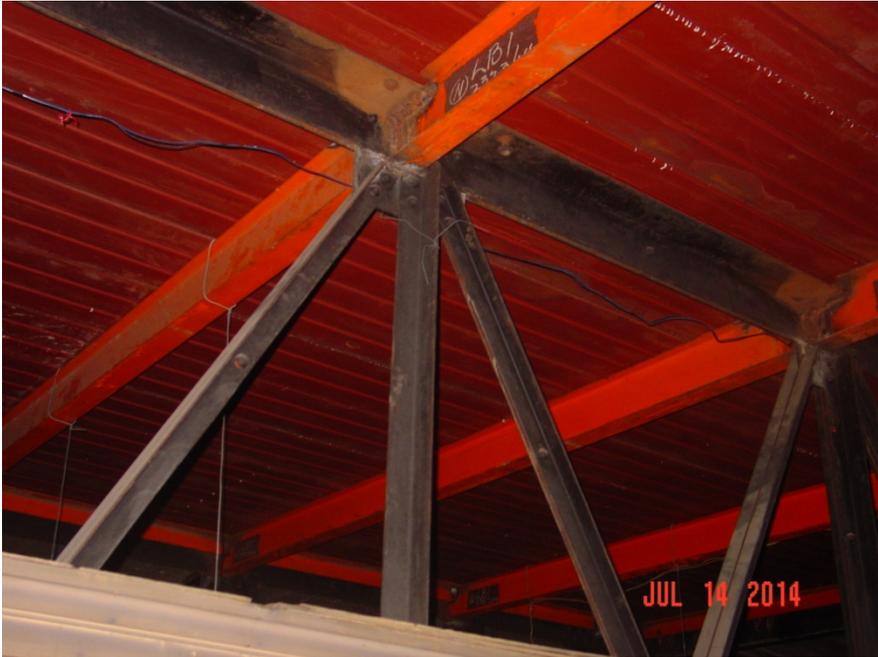
View above library ceiling showing steel framing (orange) in-filled above original skylight.

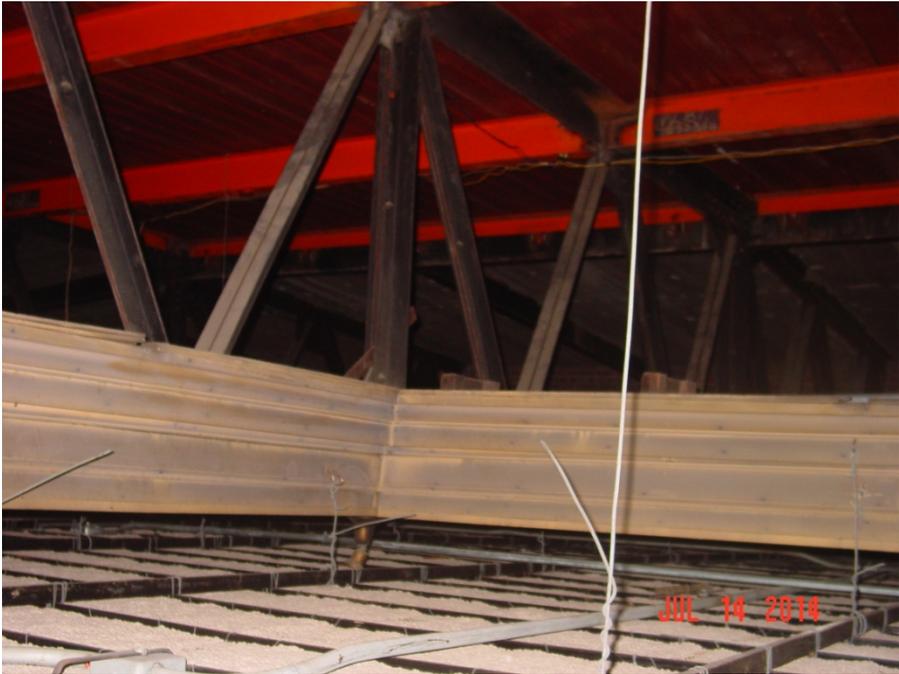
View of former Library skylight window frames and the replacement plaster ceiling hung below.

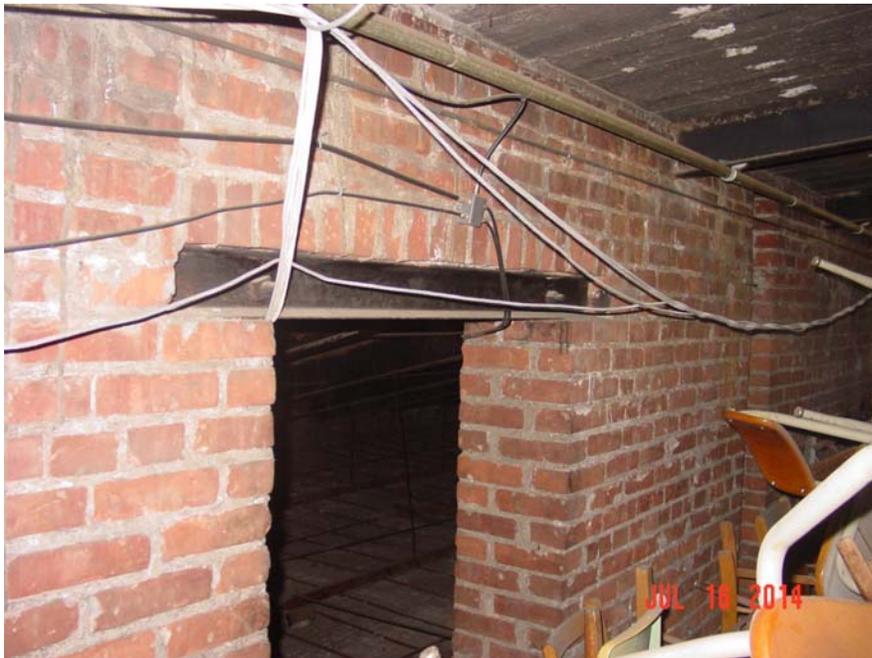
Since they have always been protected by the main roof, the interior walls have not been exposed to moisture infiltration through leaking stone caps or wind-driven rain as the courtyard and outside perimeter walls have been. Therefore these walls were found to be in good condition throughout the attic where they are fully exposed.

**Existing interior Attic brick walls and steel lintels are in sound condition.**

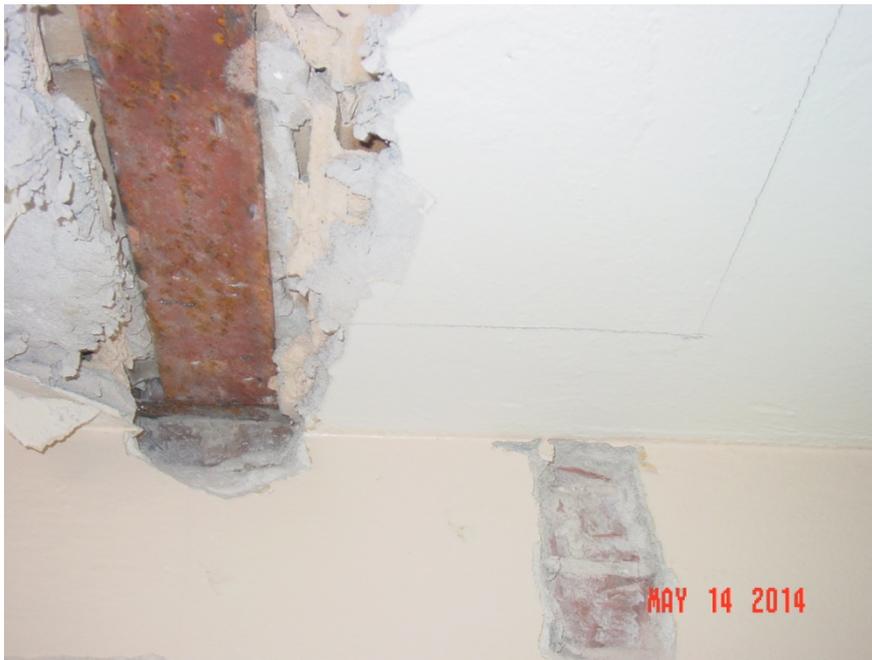
**Interior 4th floor beam bearing on Courtyard wall was exposed and found to be in sound condition.**

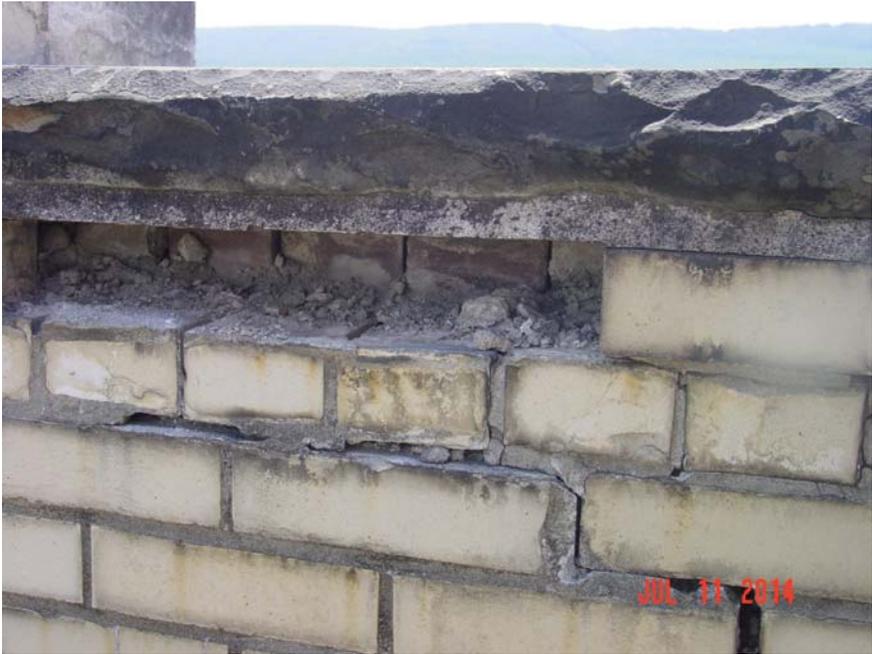
In the summer of 2014, a short-term parapet repair and brick containment project was completed to allow the students to safely occupy the school for the 2014-2015 year. The most severely deteriorated portions of the courtyard parapet, located in the northwest and southeast corners, were removed down to the tops of the steel roof beams and re-constructed with reinforced concrete masonry units and face brick. Upon removal of the stone cap in these areas it was discovered the mortar had completely failed through the entire width of the walls. Since the mortar had disintegrated, the brick parapets were easily removed by hand.

**Top of Courtyard parapet prior to repairs in Summer of 2014. Note the deteriorated mortar. The missing bricks were easily removed by hand.**

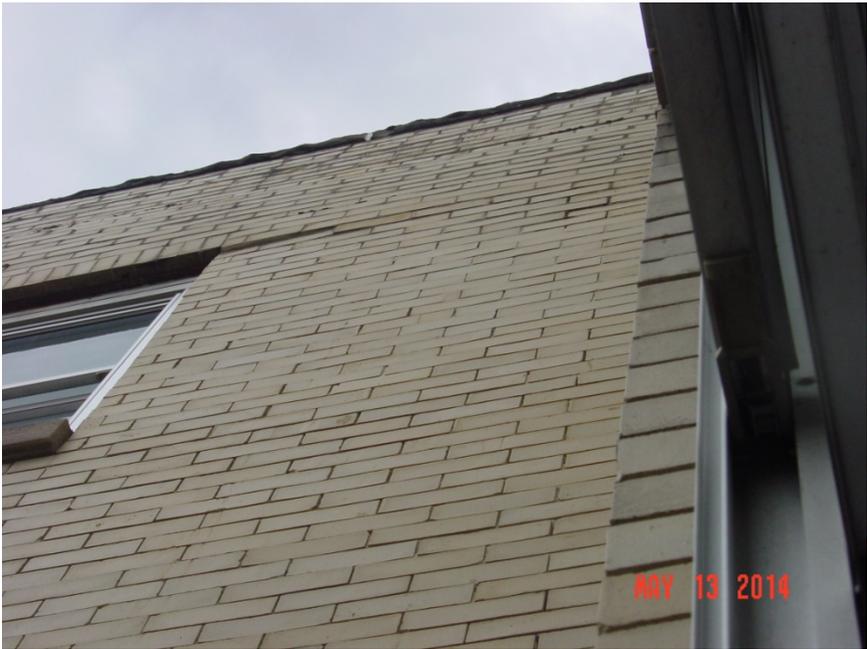
The long-term moisture exposure has also taken its toll on the steel lintels above the numerous courtyard windows. The lintels have corroded, delaminated and expanded to the extent the face brick bearing on them has begun to bulge away from the backing courses. Because the water likely entered the walls through deteriorated joint seals in the stone caps, this condition is most severe in the attic windows and becomes less pronounced at the lower levels. Upon discovery of the precarious condition of the brick and the potential for displaced sections to fall, the library was closed and the second floor windows were covered with plywood. The plywood was installed because the bases of the windows are located only a few inches above the library roof, and therefore brick falling from the roof area had the potential to bounce and break the glass.

**Courtyard wall prior to 2014 repairs. Note top corner of window where heavy corrosion in steel window lintels caused the steel to delaminate, expand and push the brick outwards.**

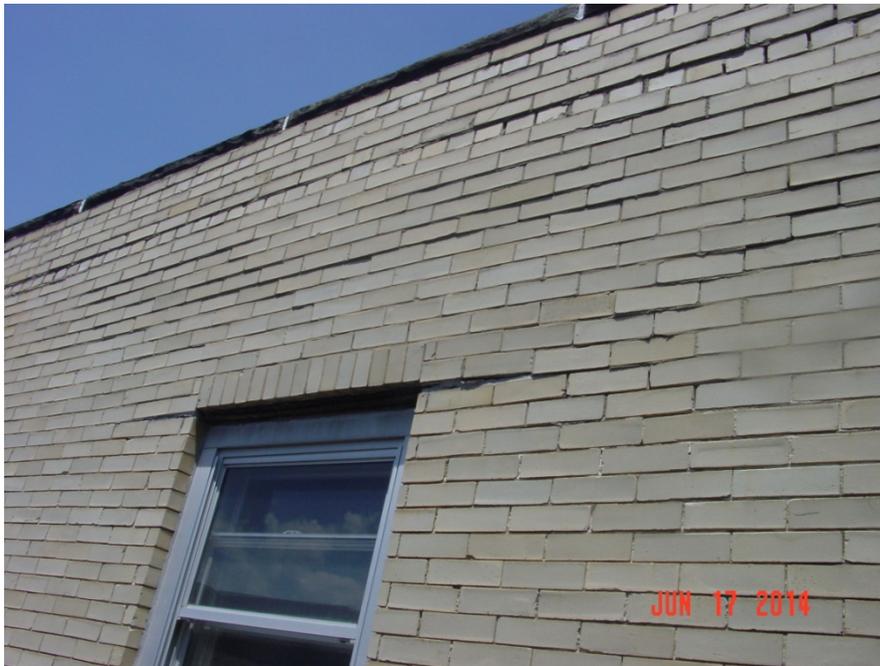
**Bowing of brick above an Attic window due to corrosion and expansion of the steel lintel.**

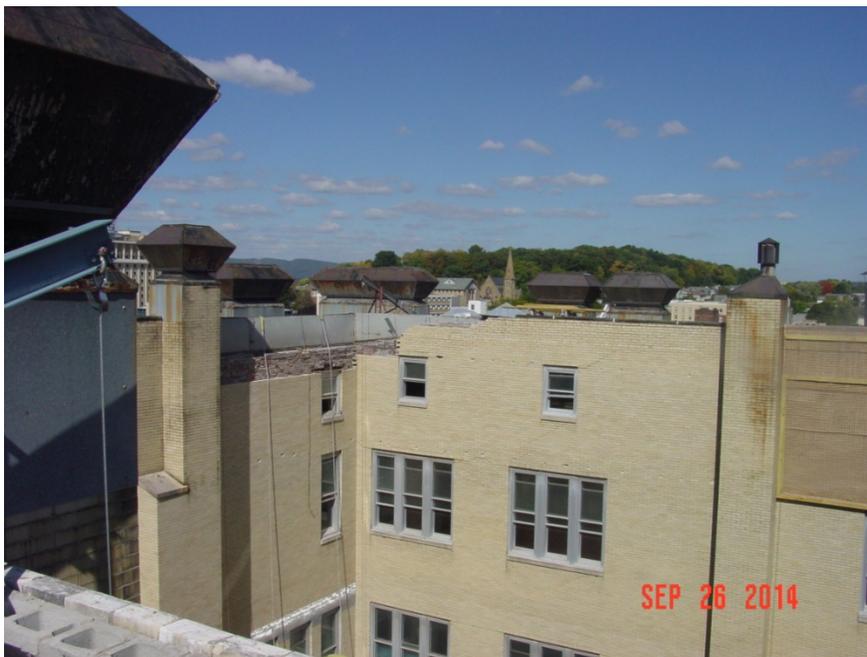
**Badly damaged sections of the Courtyard parapets were removed and rebuilt in the 2014 repair/containment project.**

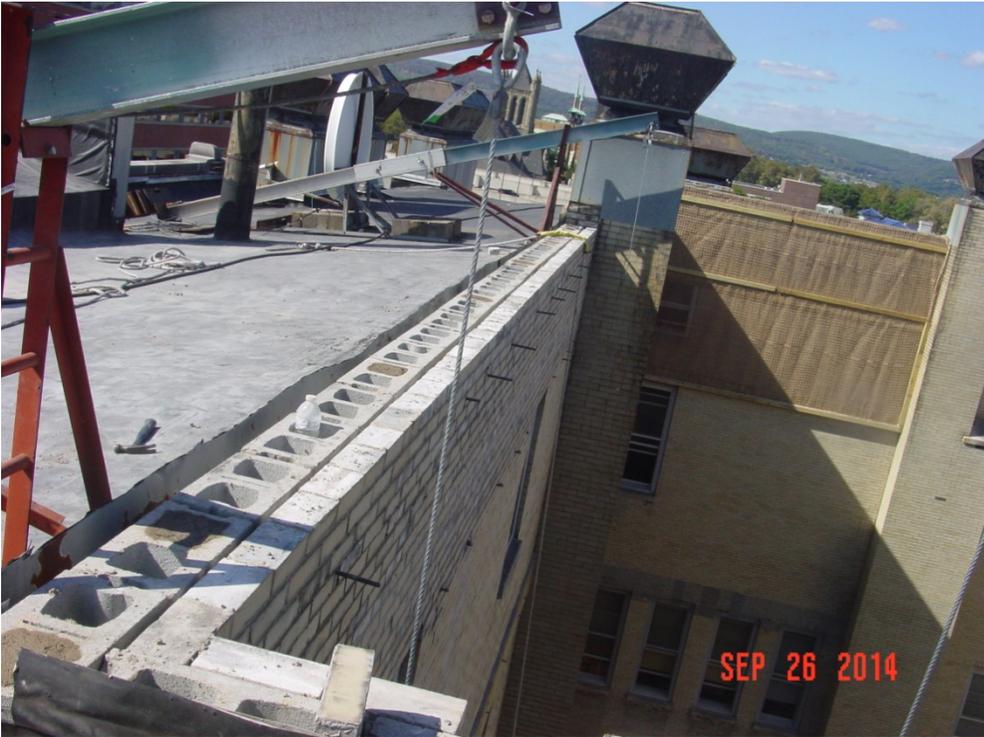
View of re-built section of parapet during 2014 repair/containment project.

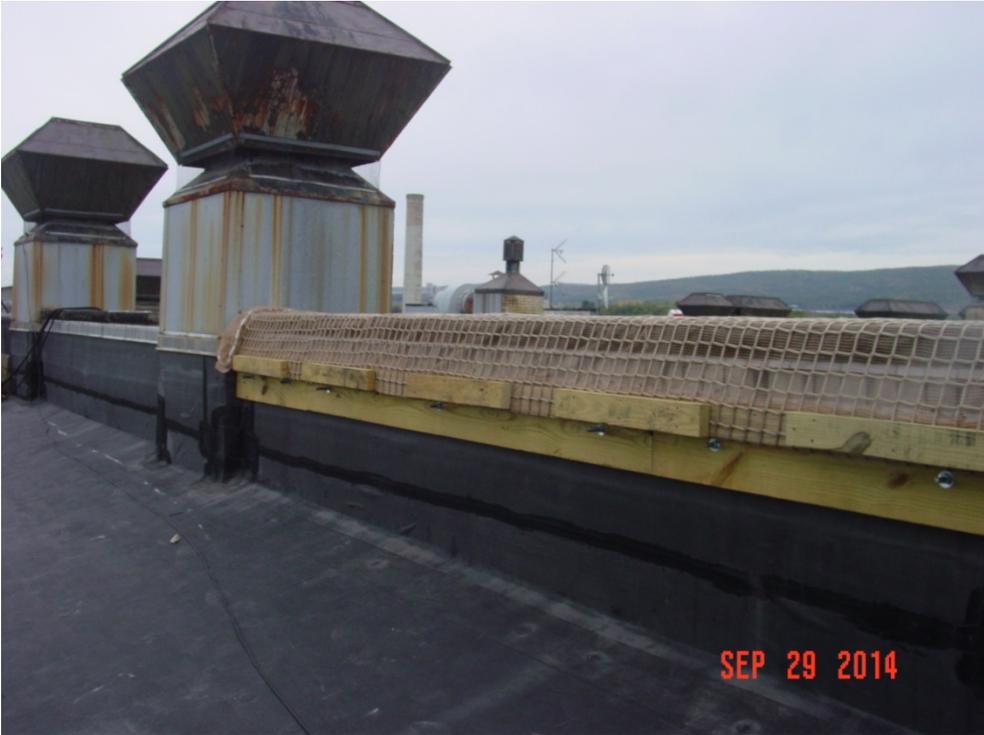
Anchorage of containment netting on rear of existing parapet.

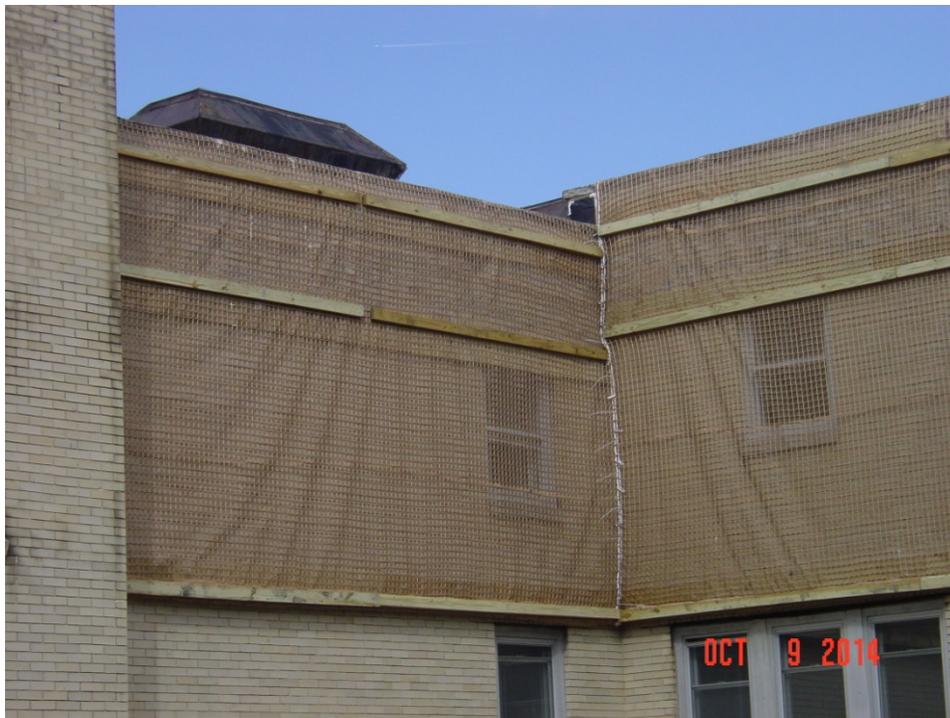
**View of completed repair/containment netting in northwest corner of Courtyard. Existing parapet was rebuilt at lower elevation on west side where roof elevation drops above Auditorium stage.**

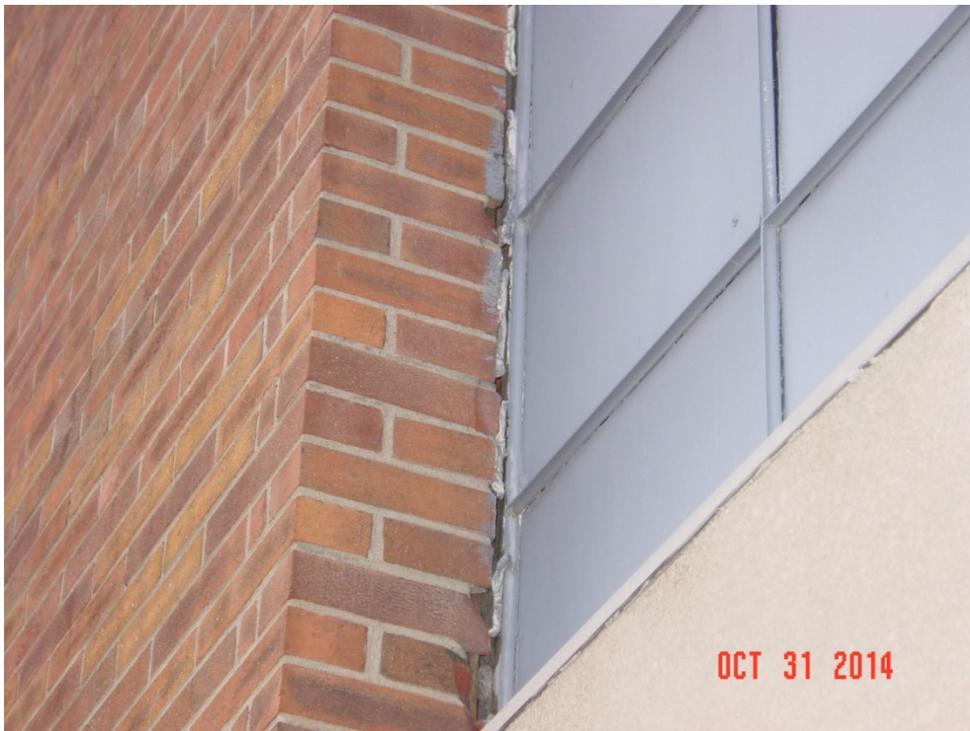
**Brick / window joint on south wall of Gymnasium. Joint is failing and allow water to infiltrate which may be initiating internal corrosion. The Annex façade should be maintained if short or long-term continued occupancy is anticipated.**

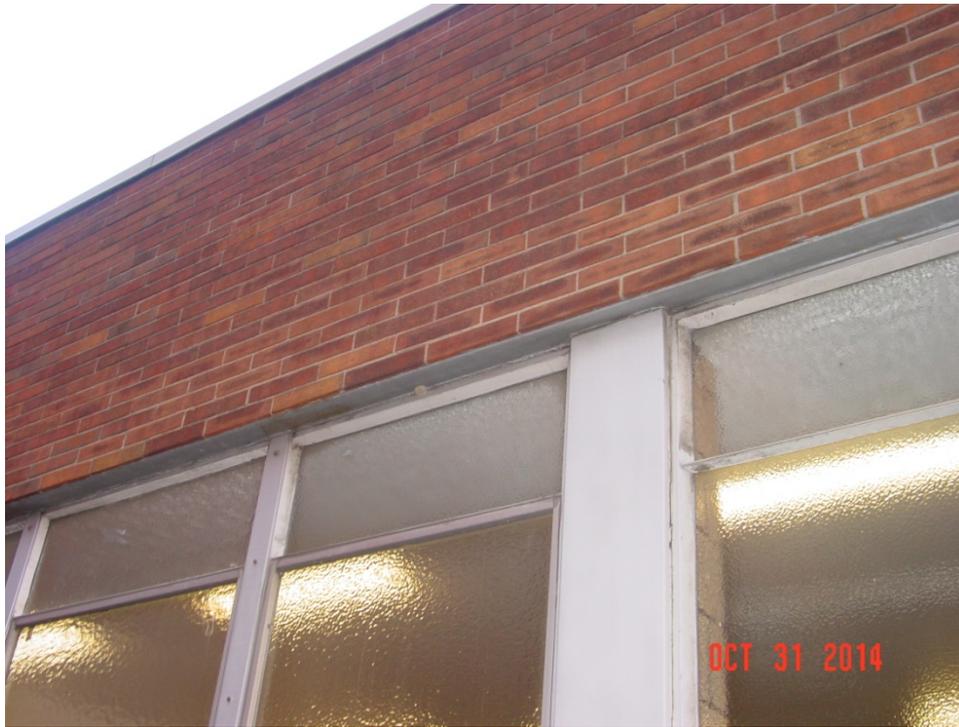
**West wall of Annex is in fair to good condition. There is currently no visible lintel corrosion. Brick re-pointing is recommended to maintain the condition of the joints and supporting steel.**

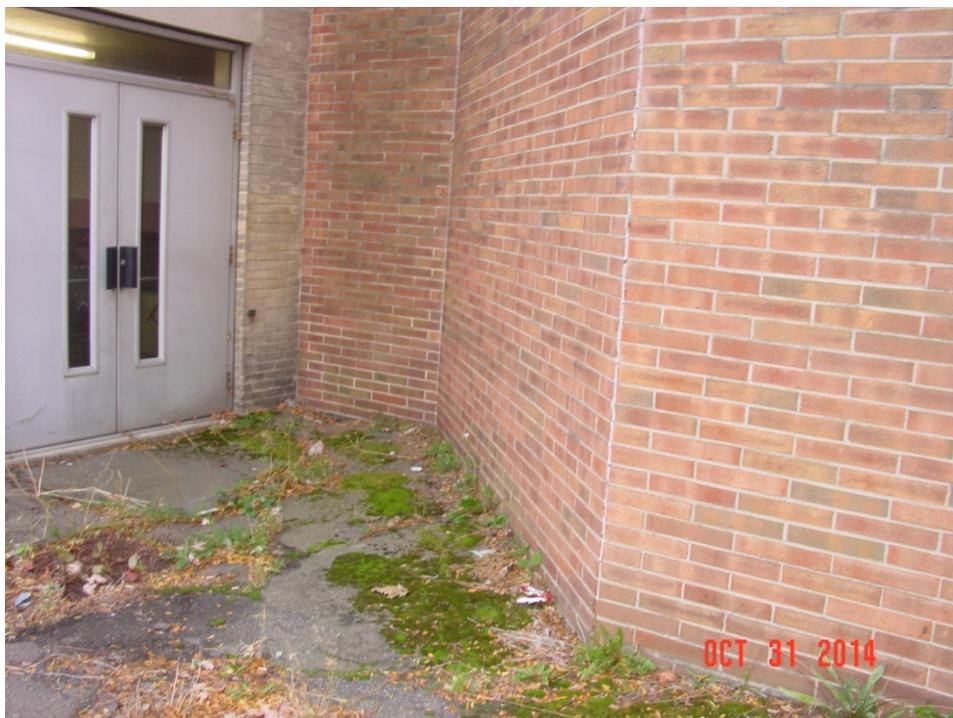
**Single story tie-in of Annex and original school Auditorium area. Note corner joints beginning to fail.**

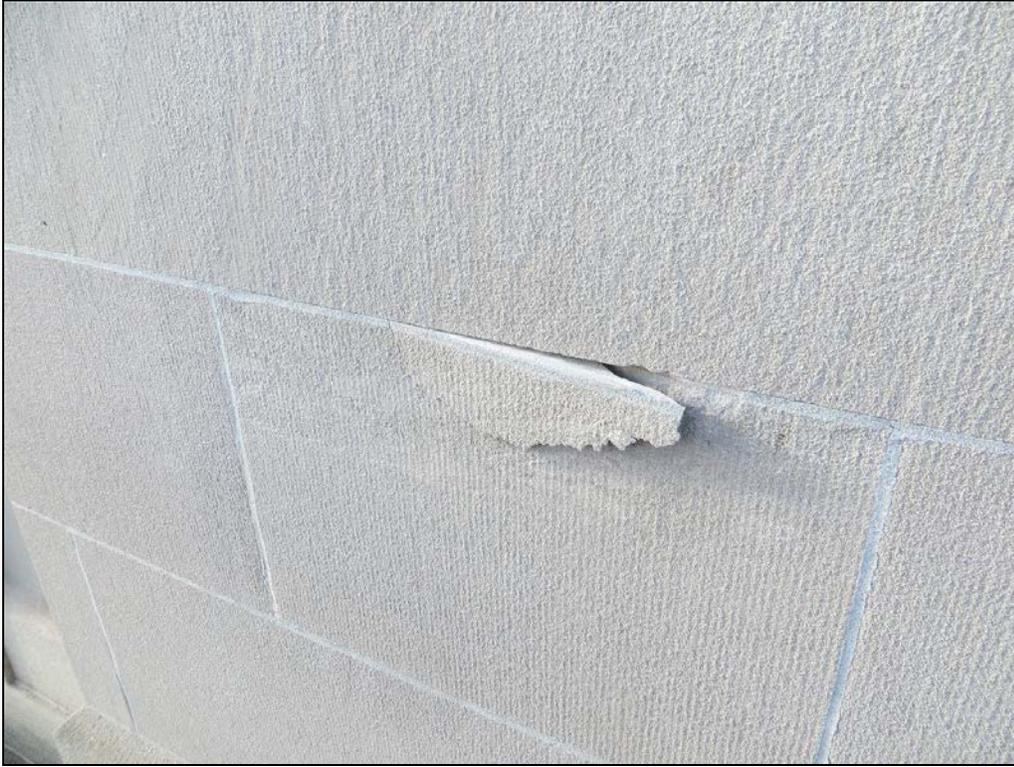
**Photograph 3:**

Typical crescent shaped spall ready to fall from the building.

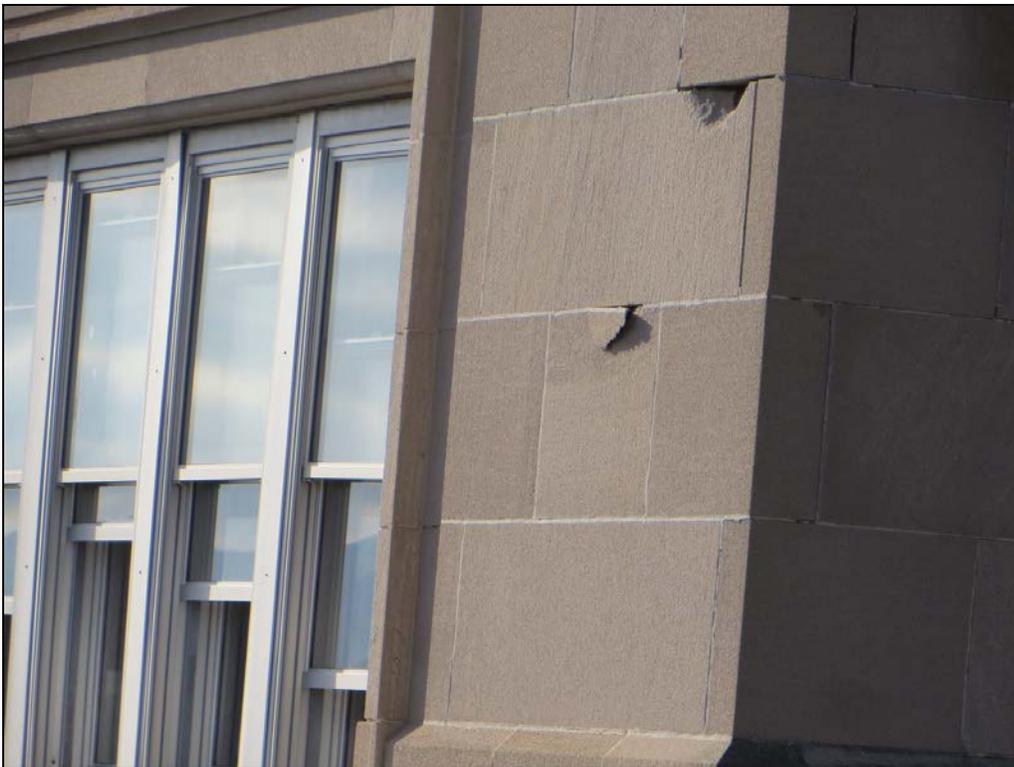
**Photograph 4:**

One spall that already came loose from the building and one that is ready to fall.

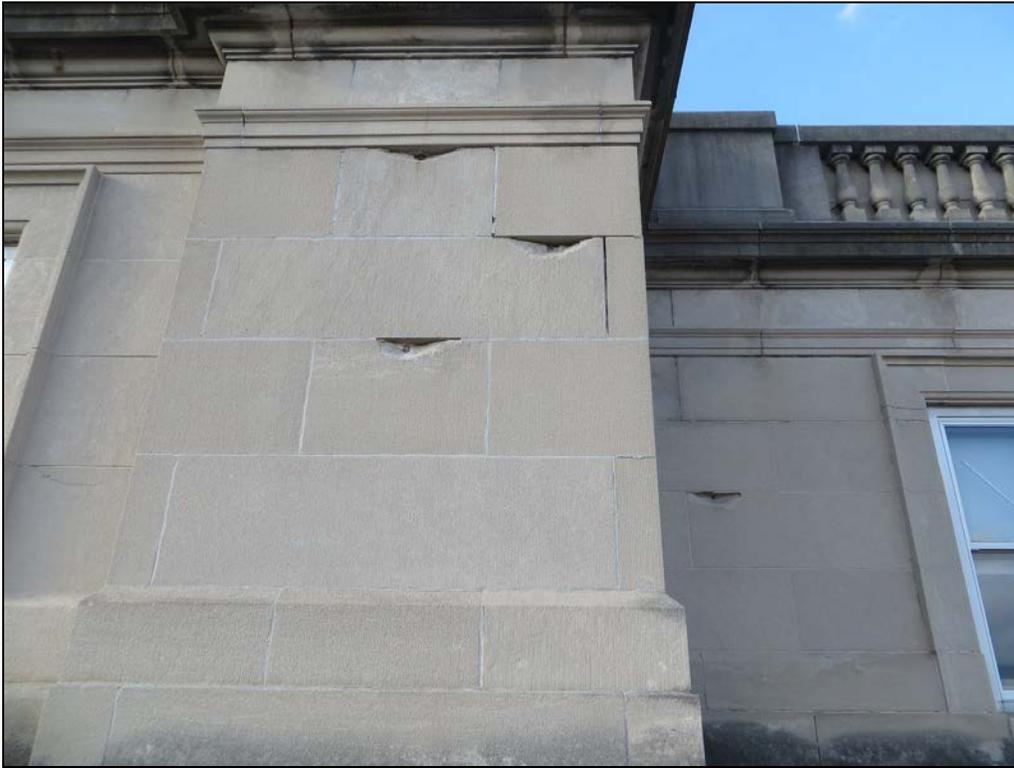
**Photograph 5:**  
Multiple spalls in  
close proximity to  
each other.

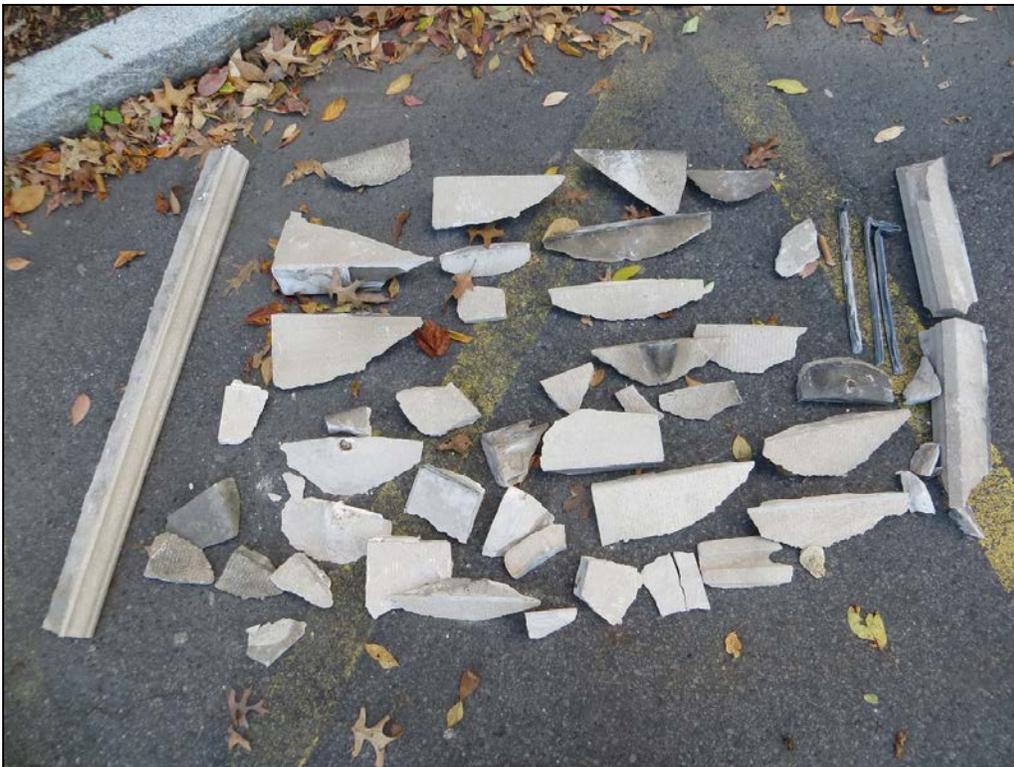
**Photograph 6:**  
MPS removed  
several pieces of  
stone from the  
building that were  
ready to fall. This  
picture does not  
include the  
multiple pieces of  
stone that have  
already fallen to  
the ground. The  
falling stone pieces  
prompted the  
installation of the  
fencing and  
overhead  
protection.

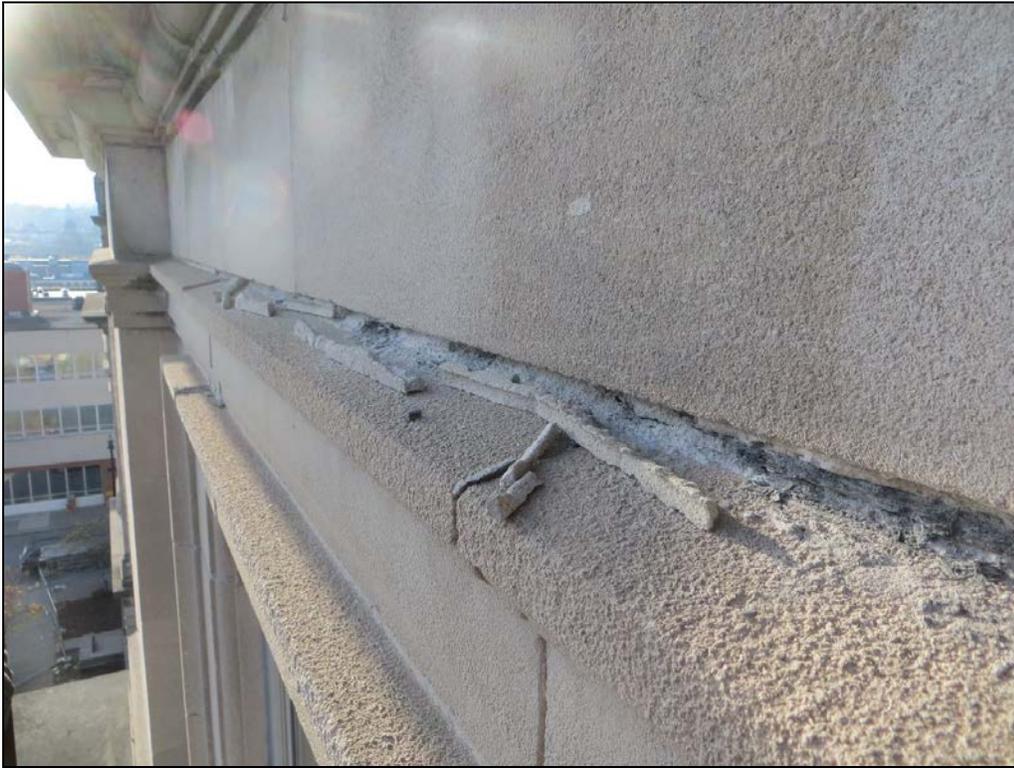
**Photograph 7:**

Deterioration of the mortar joints between the limestone panels is allowing excessive water to enter the wall assembly. Slate shims were exposed behind the failed mortar joint.

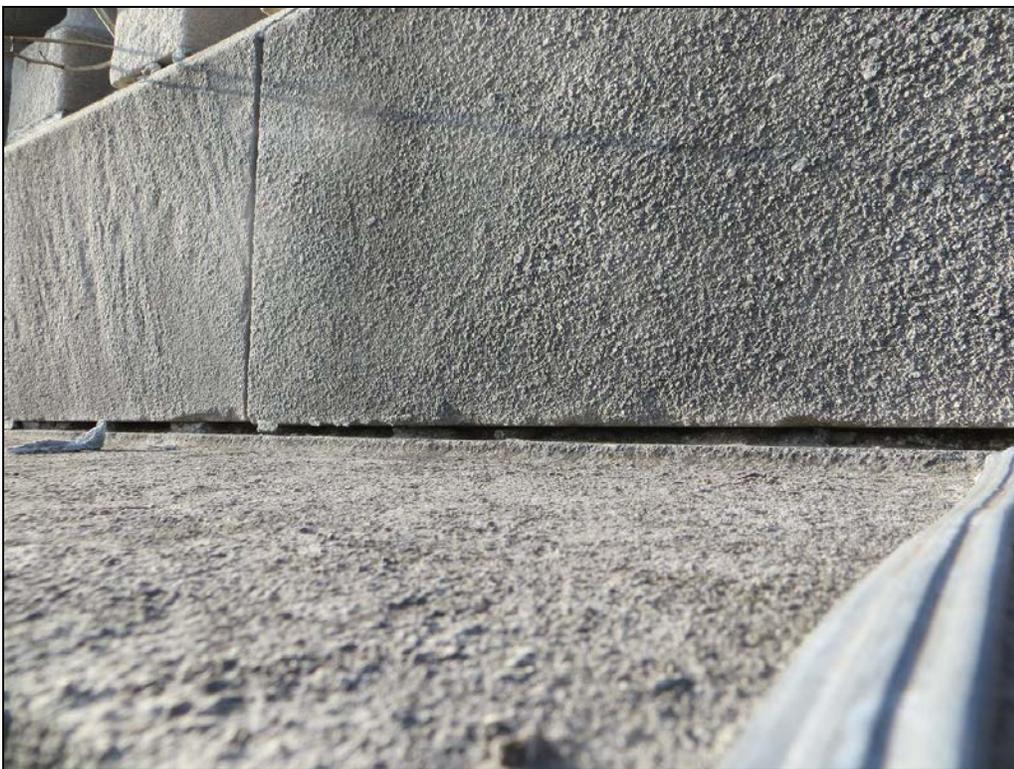
**Photograph 8:**

This joint with missing mortar is wide open, allowing large amounts of bulk rain water to enter the wall assembly.

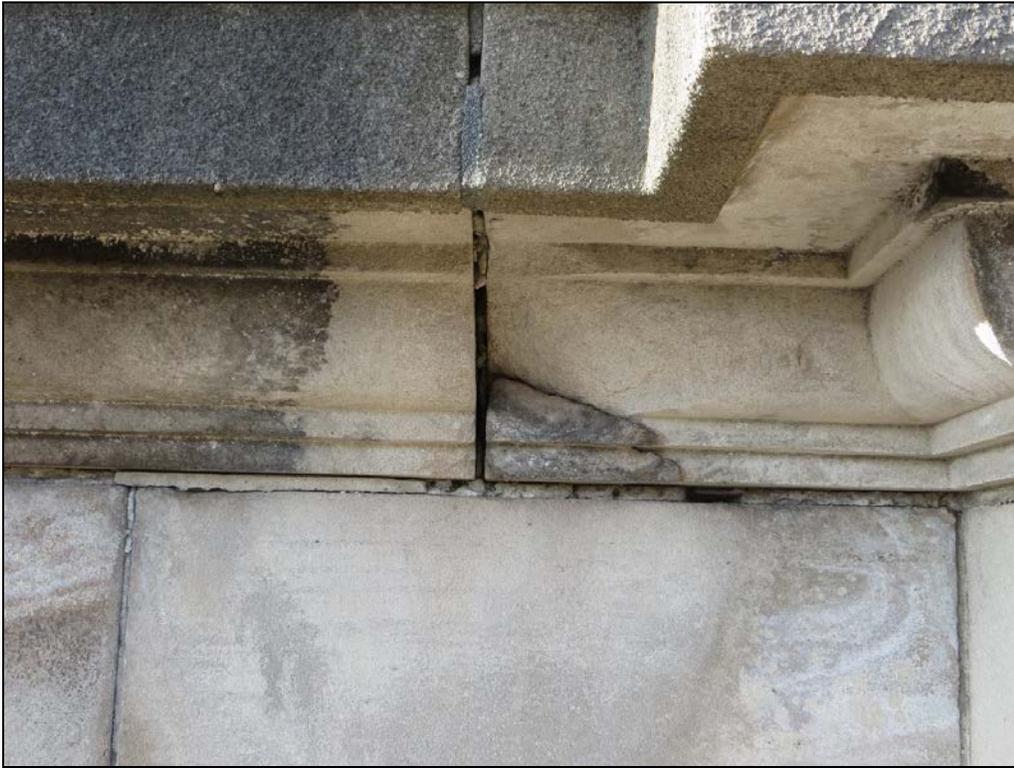
**Photograph 9:**  
Open mortar joint  
above an insipient  
spall.

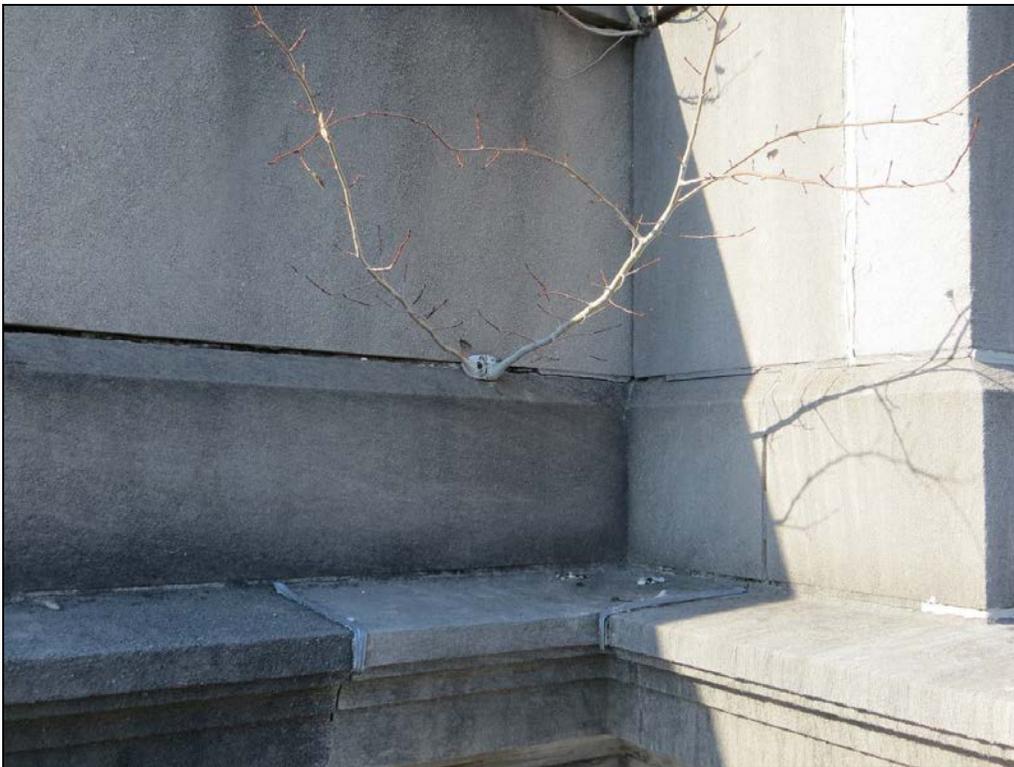
**Photograph 10:**  
The presence of  
plant growth is an  
indication the wall  
assembly is  
saturated.

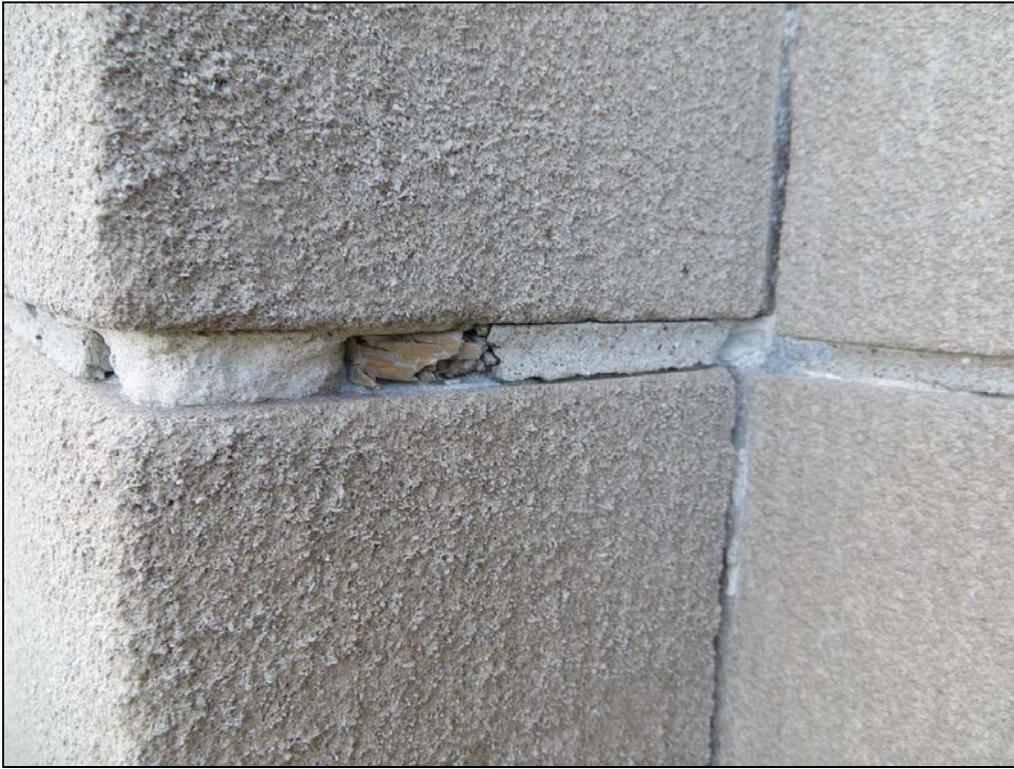
**Photograph 11:**  
An original wood shim at a failed mortar joint.

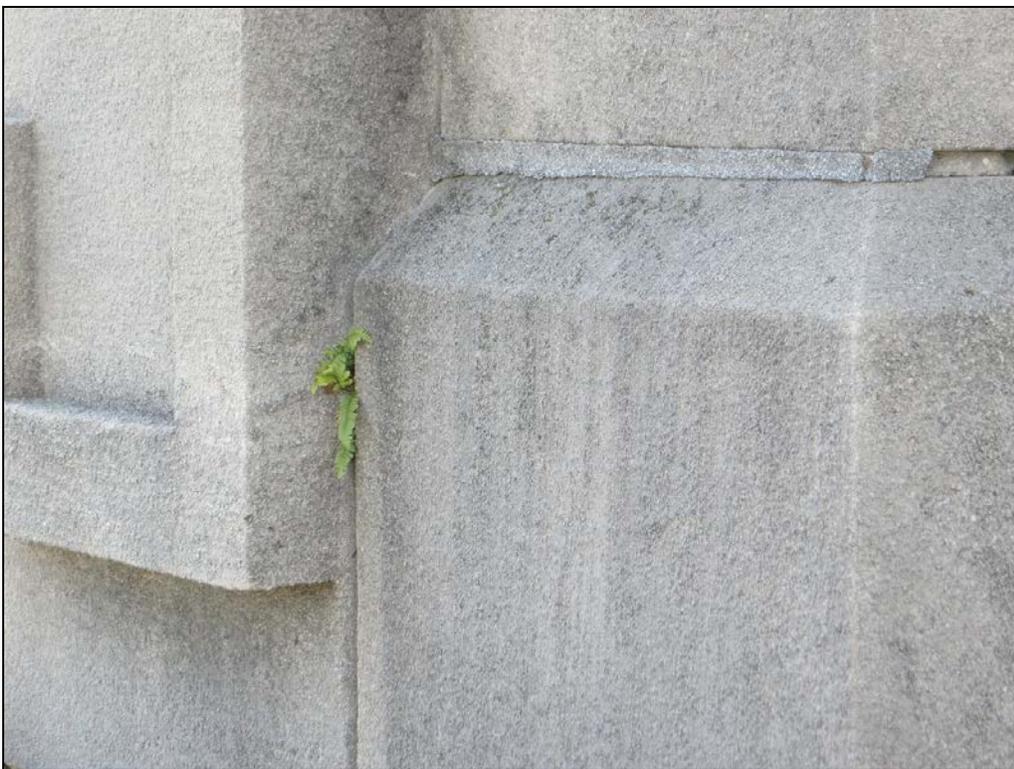
**Photograph 12:**  
More plant growth in an open mortar joint.

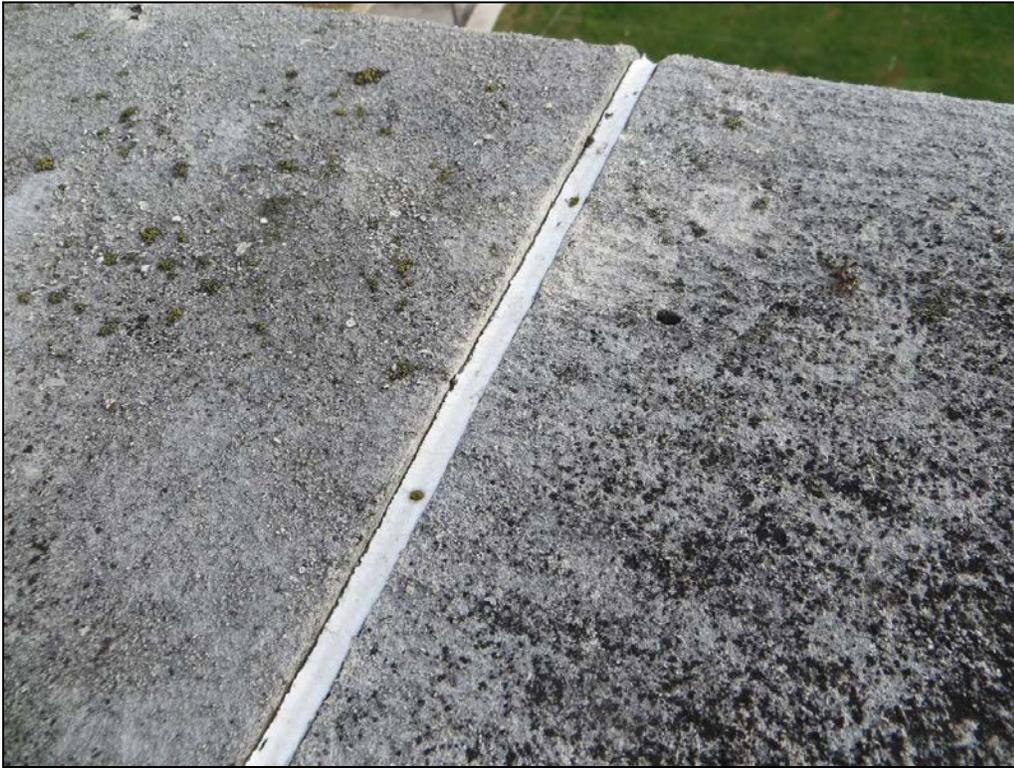
**Photograph 15:**  
Most of the sealant joints between the coping pieces were failed.

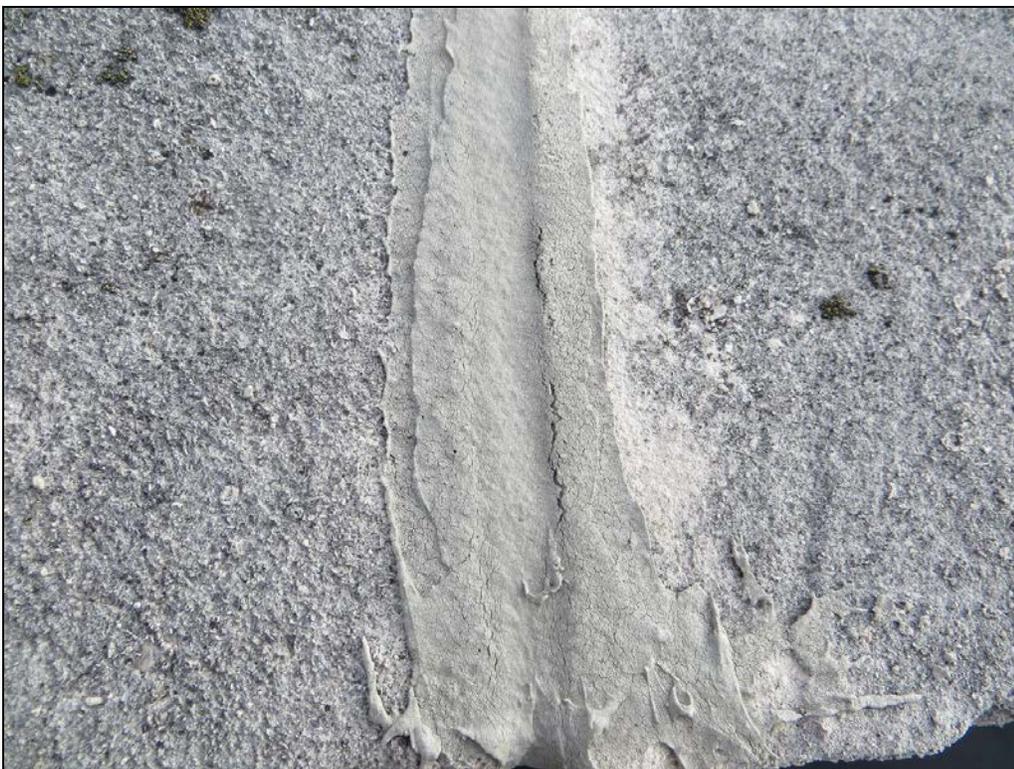
**Photograph 16:**  
Even newly replaced sealant joints were already beginning to fail.
