## WILKES-BARRE AREA SCHOOL DISTRICT STRUCTURAL EVALUATION OF JAMES M COUGHLIN HIGH SCHOOL

**Re: Structural Evaluation of Coughlin High School**

# Coughlin High School Structural Evaluation

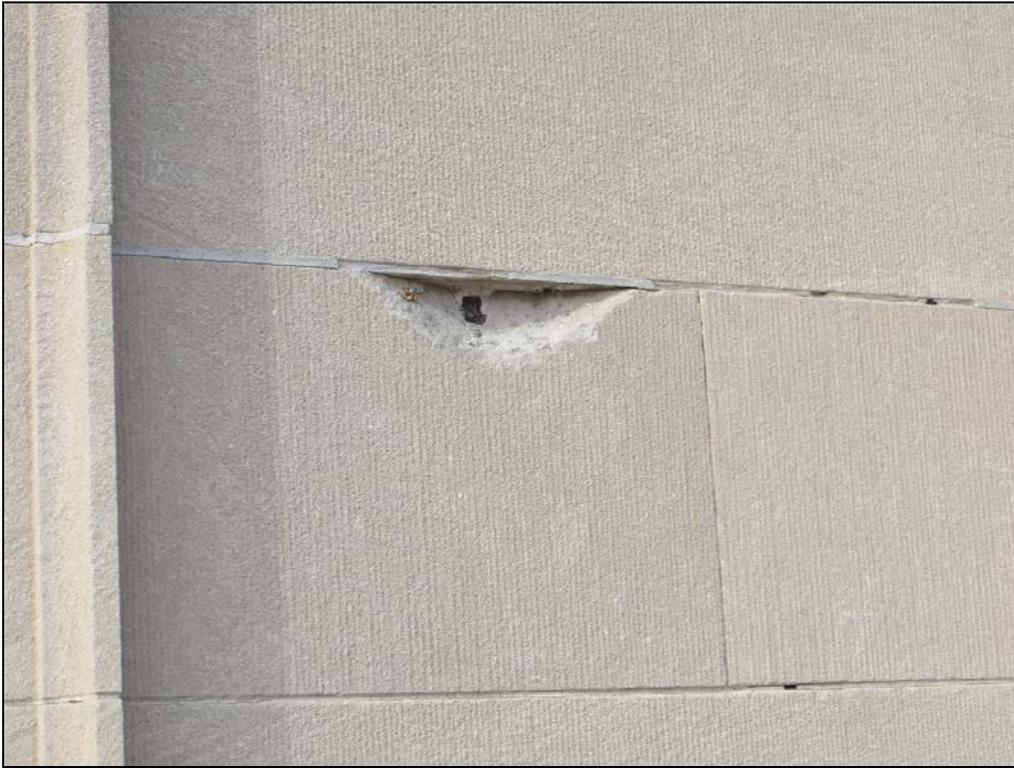
**Photograph 17:**  
The crescent shaped spalls were typically associated with corroded cramp anchors. The cramp anchors provide lateral support to the stone.

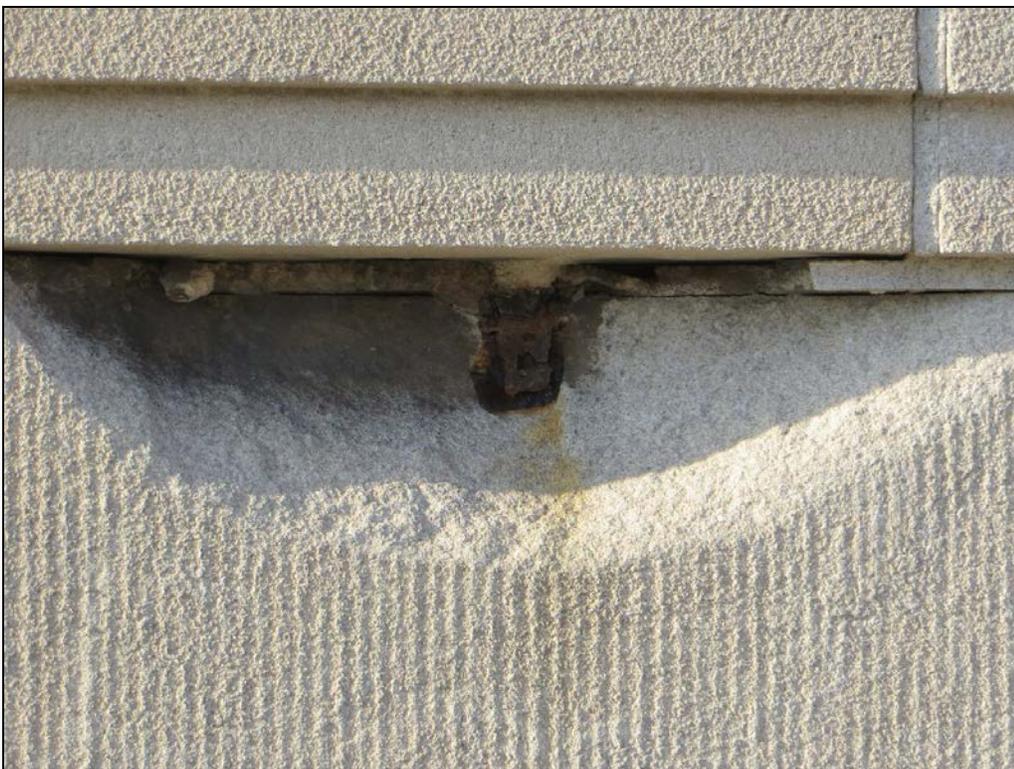
**Photograph 18:**  
Corrosion of the cramp anchor put pressure on the stone, eventually causing the spall.

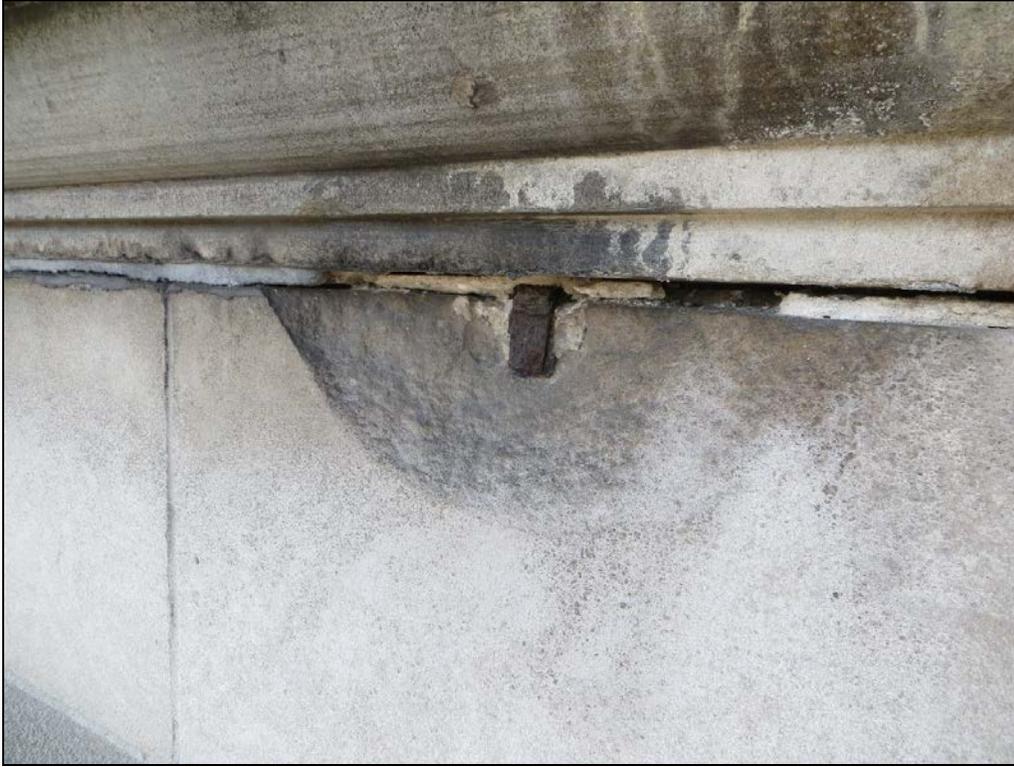
**Photograph 19:**  
Most of the anchors at the spall locations were heavily corroded.

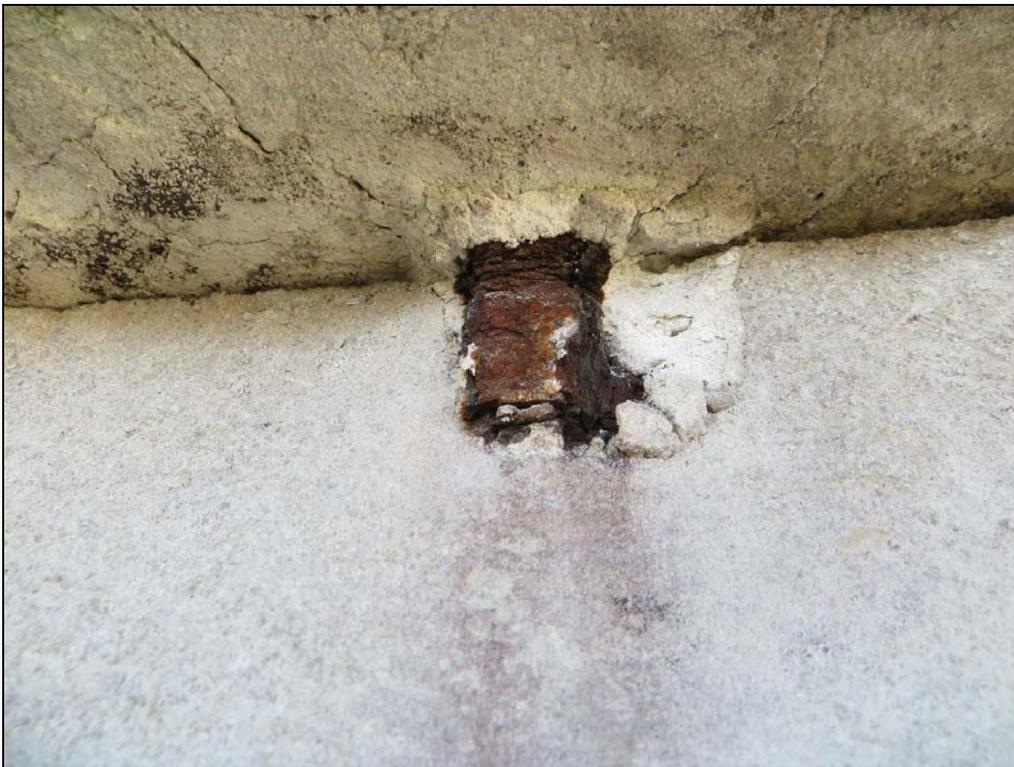
**Photograph 20:**  
The corrosion of the anchors is caused by water within the wall. As the walls take on more water the rate of corrosion of the anchors increases.

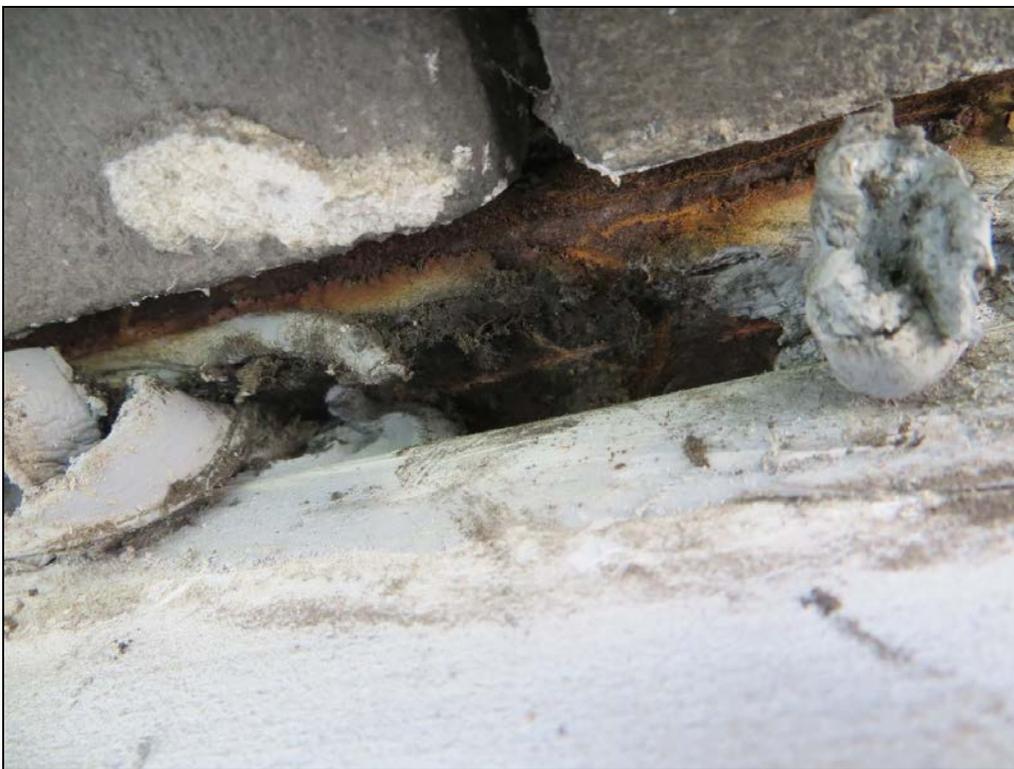
**Photograph 22:** Corrosion of the steel under the massive stone pieces. Some displacement of the stone pieces was noted, which will continue as the steel continues to corrode.

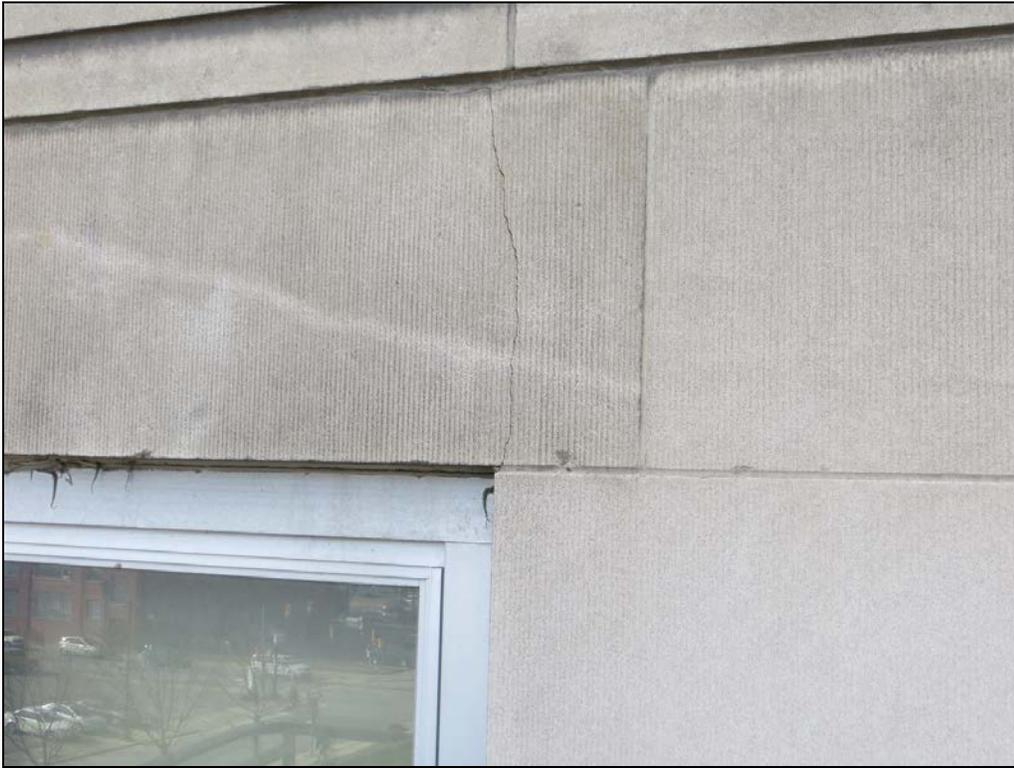
**Photograph 23:**  
Cracked stone pieces were noted above some of the windows.

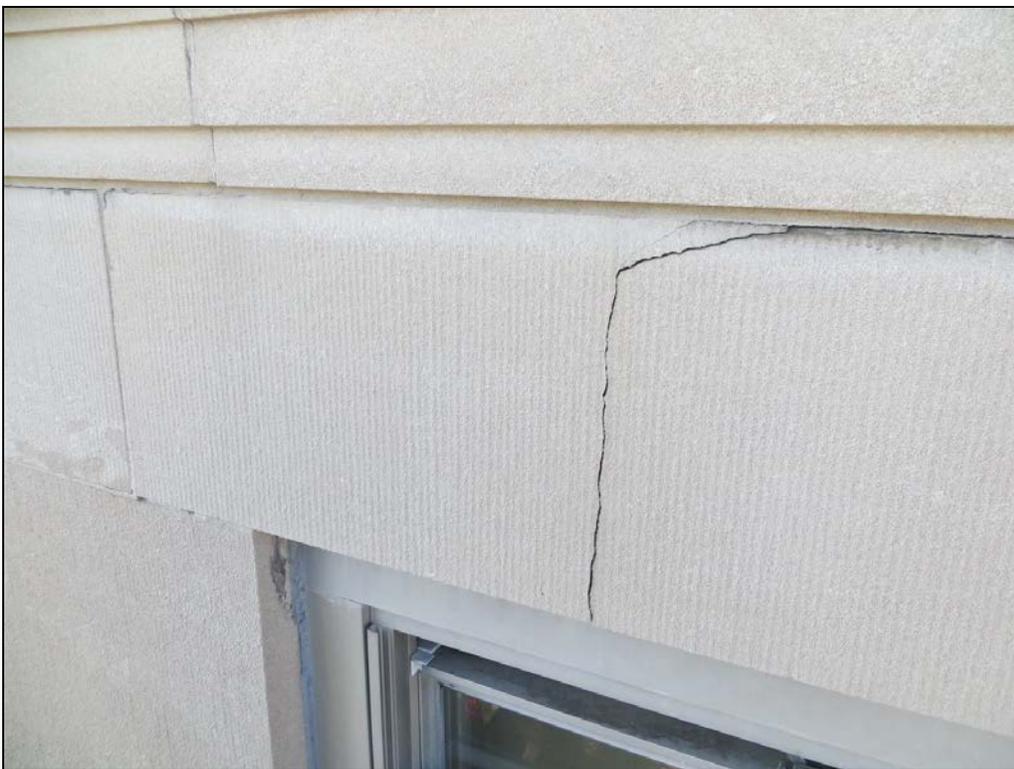
**Photograph 24:**  
Some of the cracks were significant, indicating the stone was under significant stresses caused by the corrosion of the steel below.

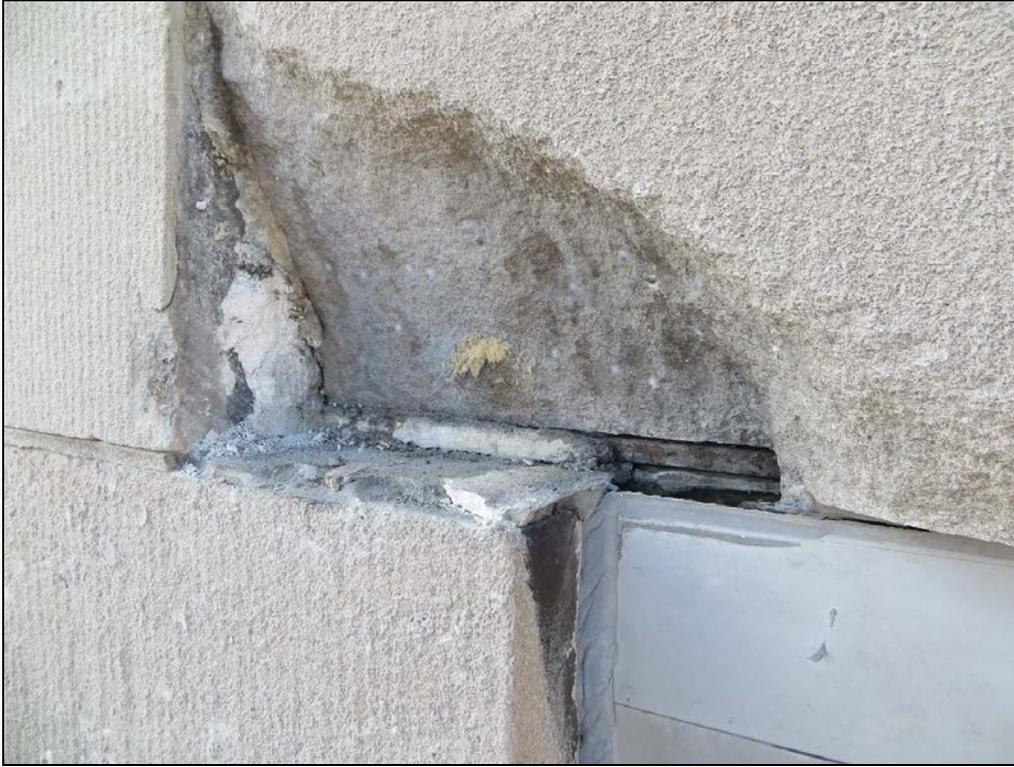
**Photograph 25:**  
At other locations the corrosion of the steel caused the stone to spall.

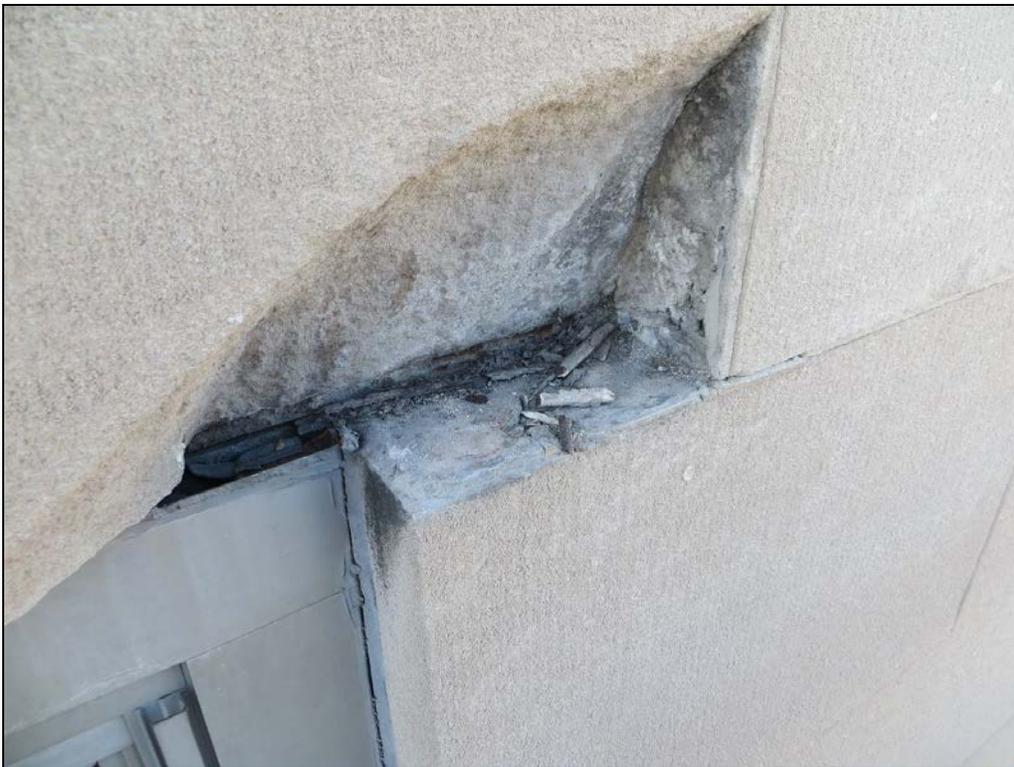
**Photograph 26:**  
The spalls tended to occur above the window jambs, where the steel was fully embedded in the masonry, and therefore, subjected to more trapped water.

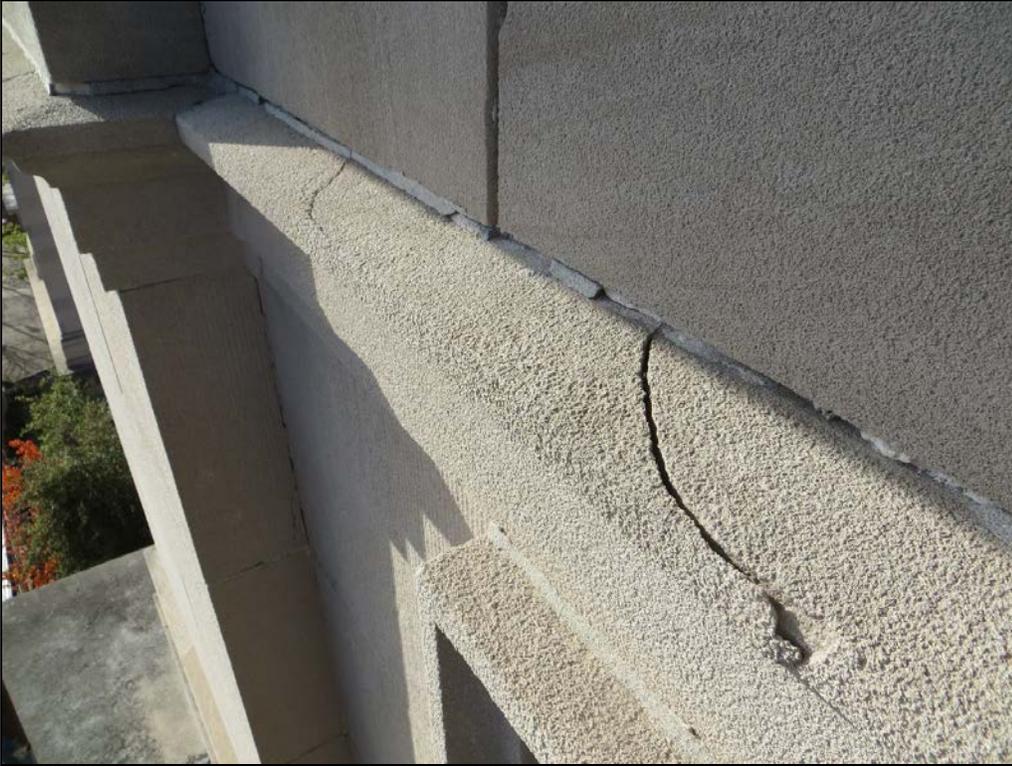
**Photograph 27:**  
Cracks in the molding just above a window opening appeared to be caused by the same steel assembly that supports the stone above the window openings.

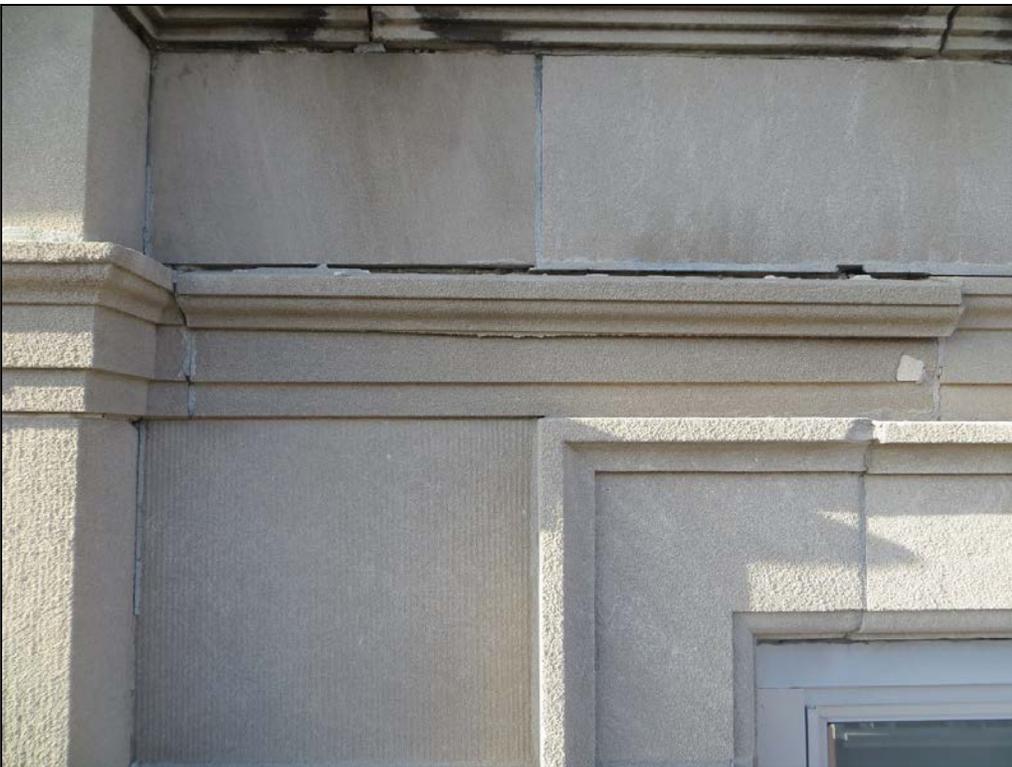
**Photograph 28:**  
This molding piece was ready to fall. Without drawings we do not know the configuration of the steel at the window heads, but the proximity of the steel directly above the window to the steel behind the molding indicates they may be part of the same assembly.

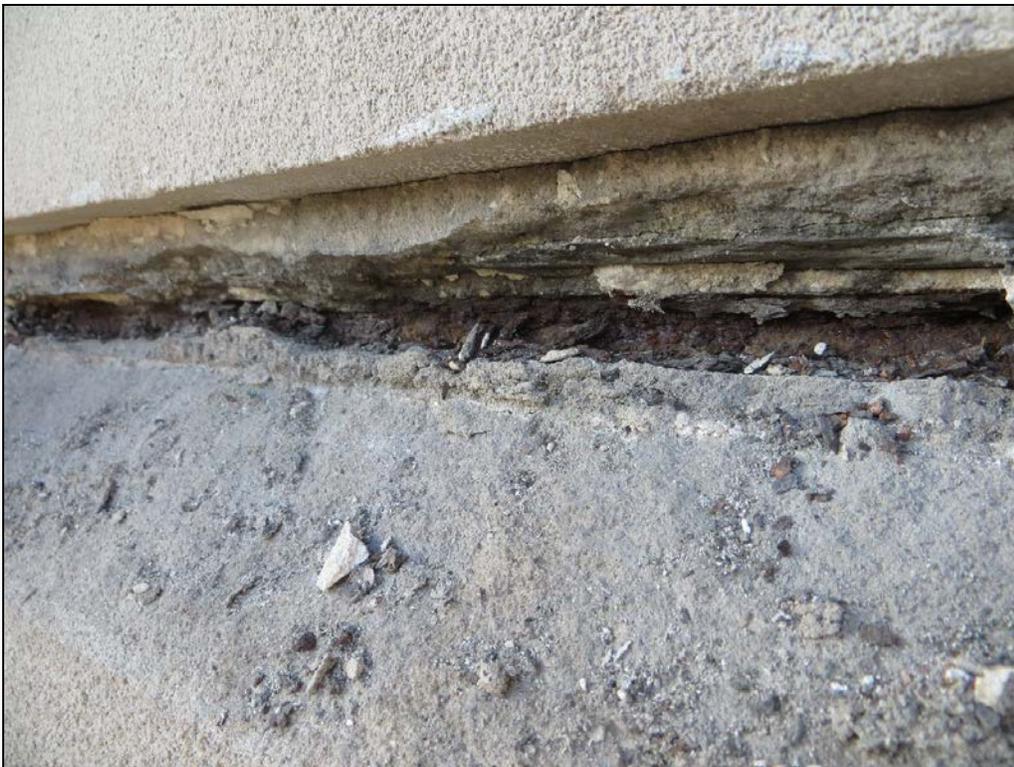
**Photograph 30:**  
The steel behind the molding piece was heavily corroded.

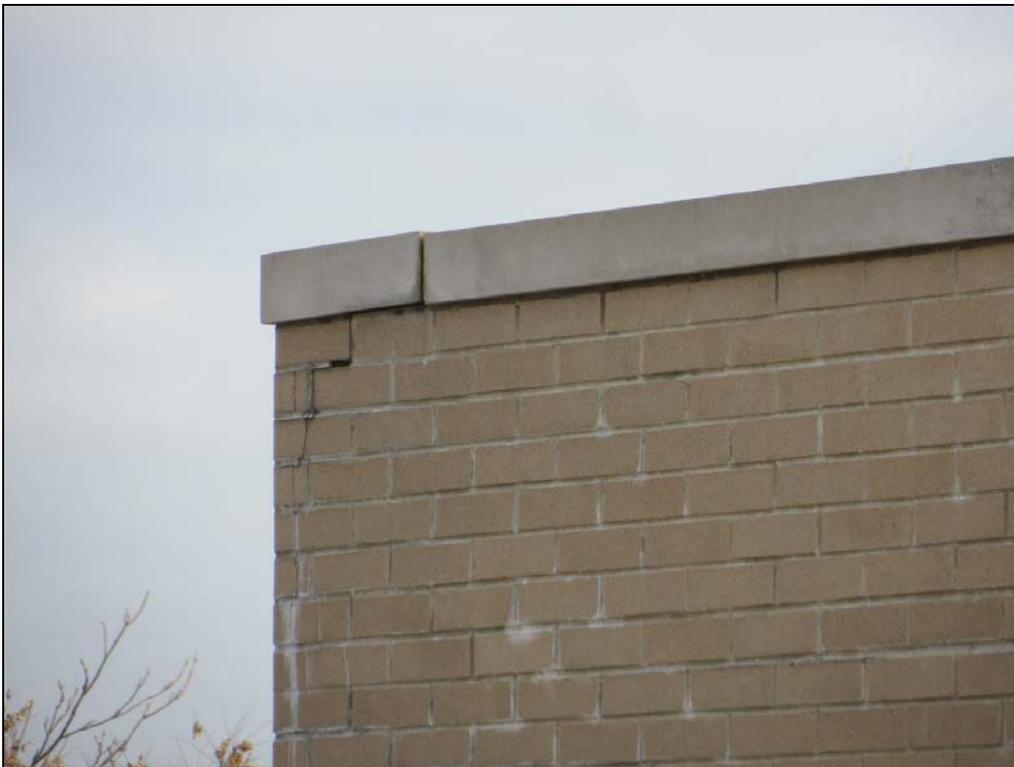
**Photograph 34:**  
The chimney was in fair condition, but we did not see some cracking and displacement at the upper corner.

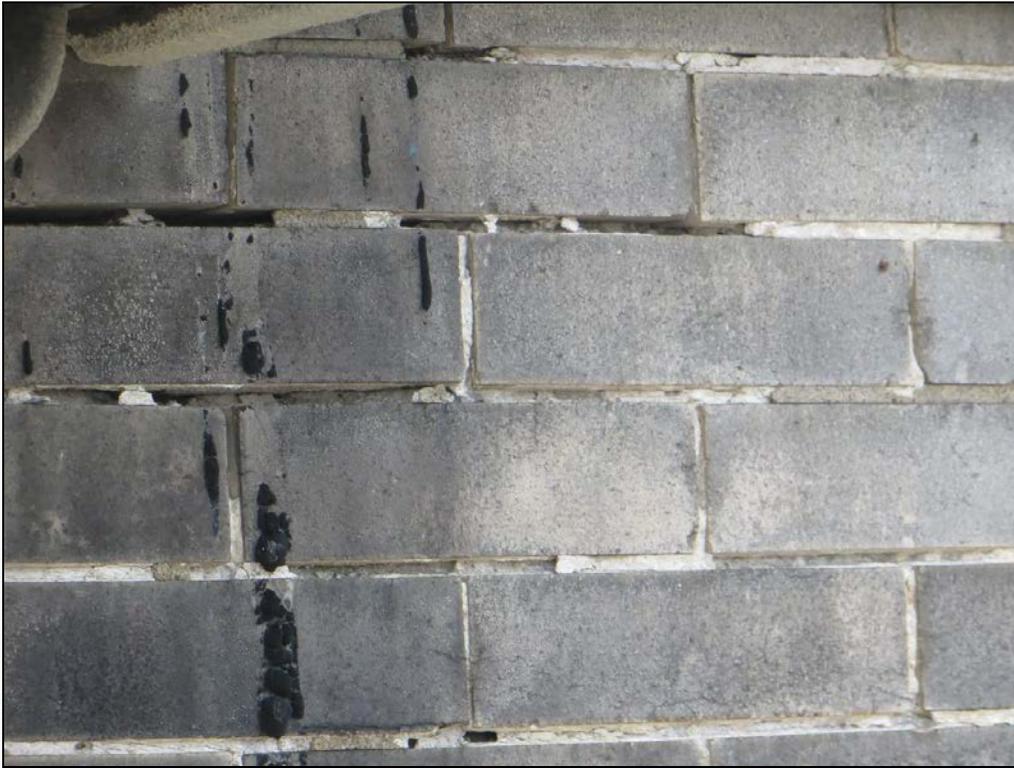
**Photograph 35:**  
The mortar joints on the rear of the building were in poor condition.

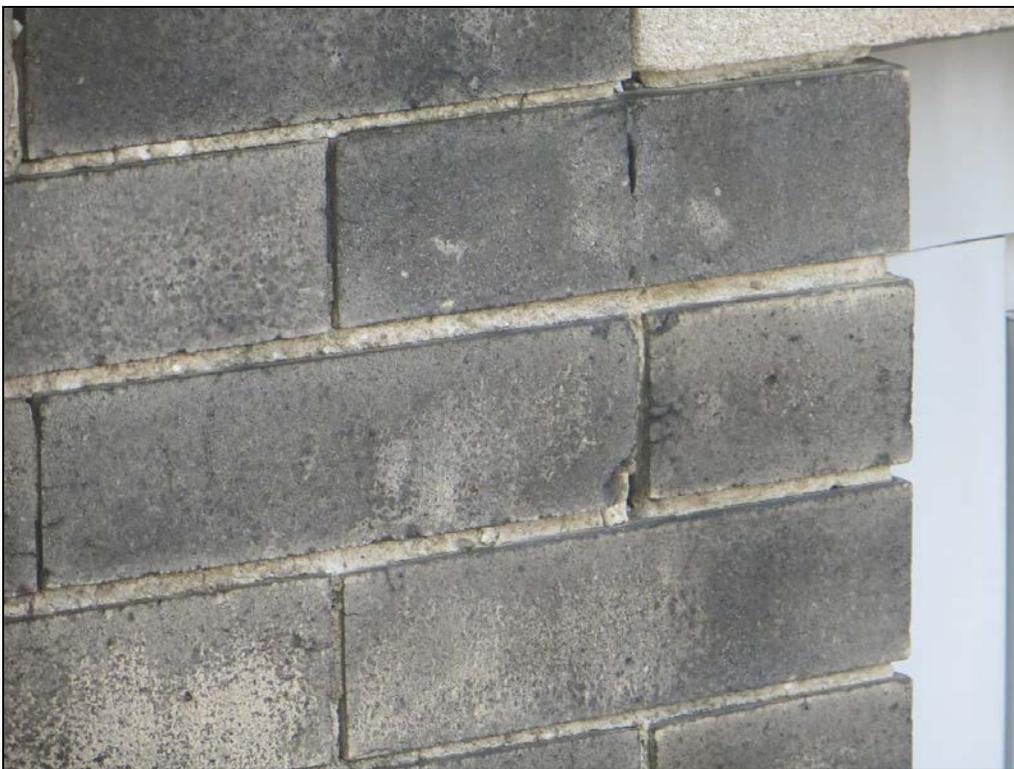
**Photograph 36:**  
The weathered joints expose the tops of the brick, which creates a lip to catch water, increasing the rate of water penetration.

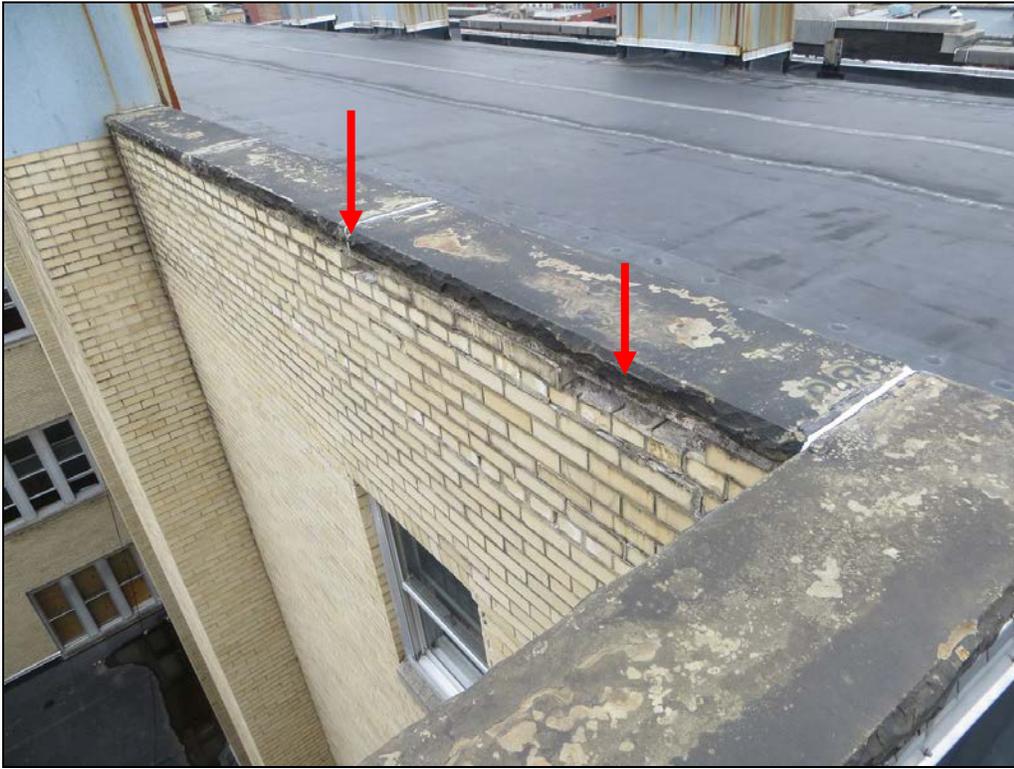
**Photograph 37:**  
The brick veneer on the courtyard elevations was in poor condition, particularly at the parapets. Note the missing brick under the coping.

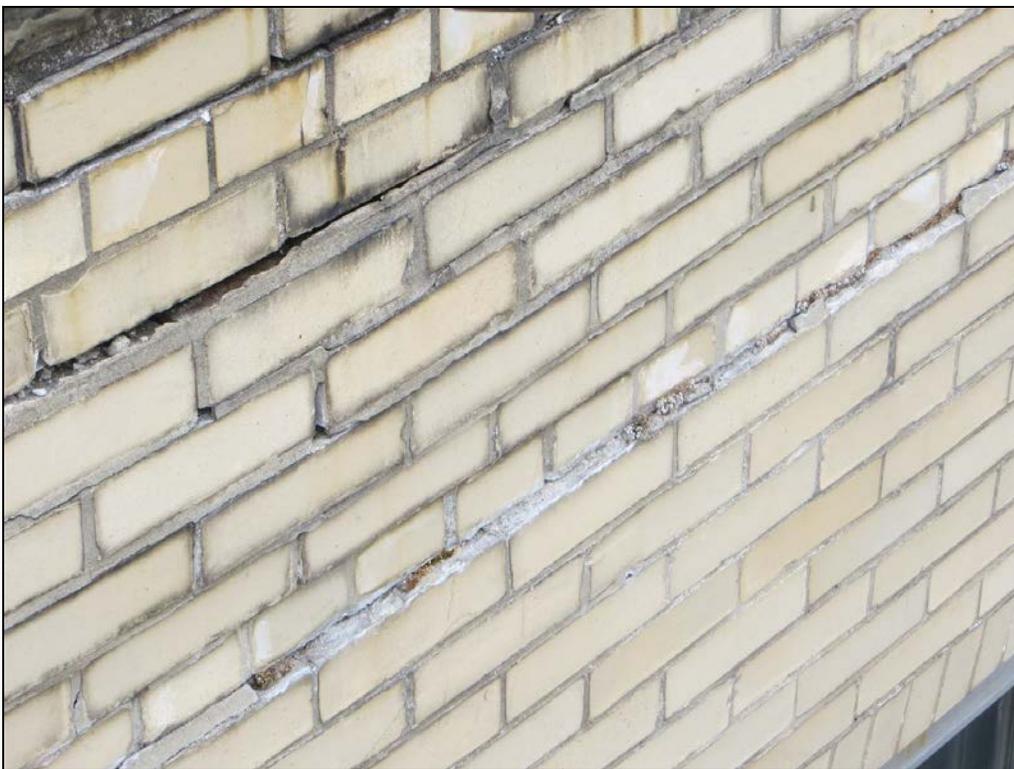
**Photograph 38:**  
Cracked and displaced brick were observed at multiple locations.

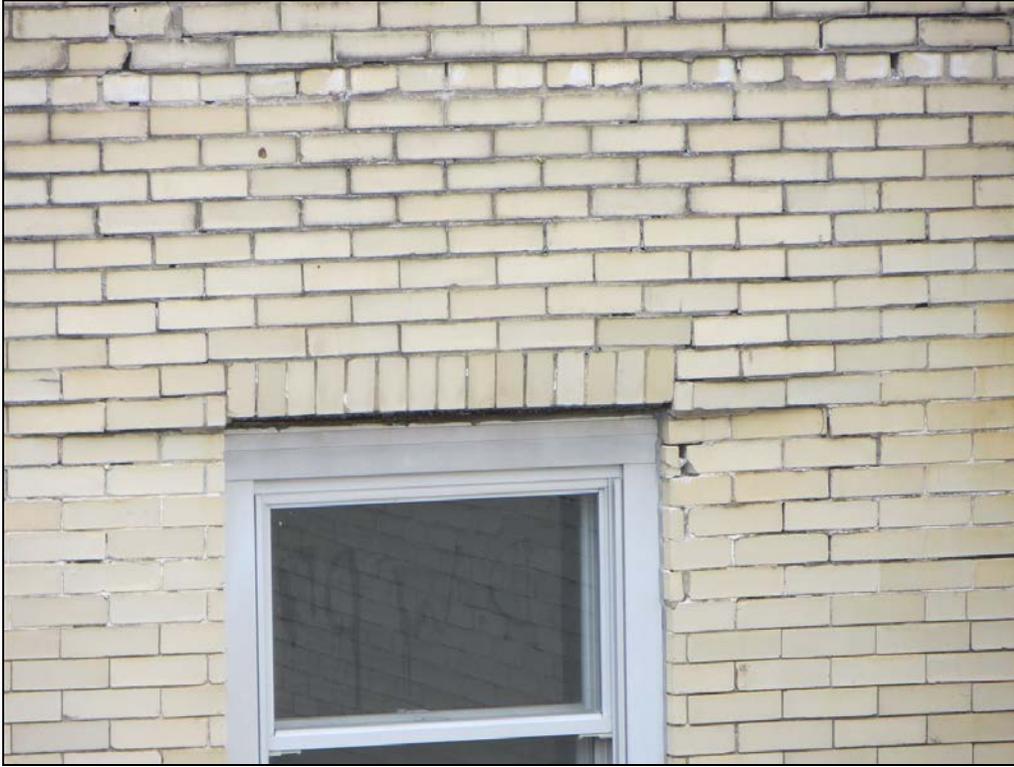
**Photograph 39:**  
Corrosion of the window lintels is causing the brick cracking and displacement.

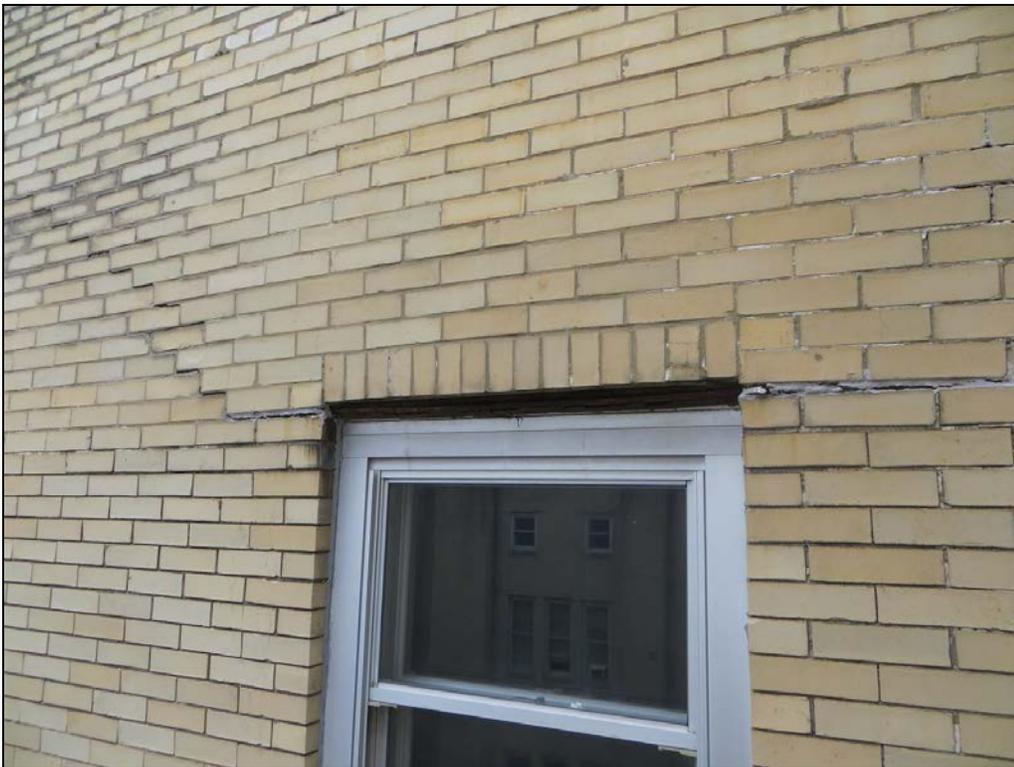
**Photograph 40:**  
The heavy corrosion of the lintels caused substantial damage to the surrounding masonry.

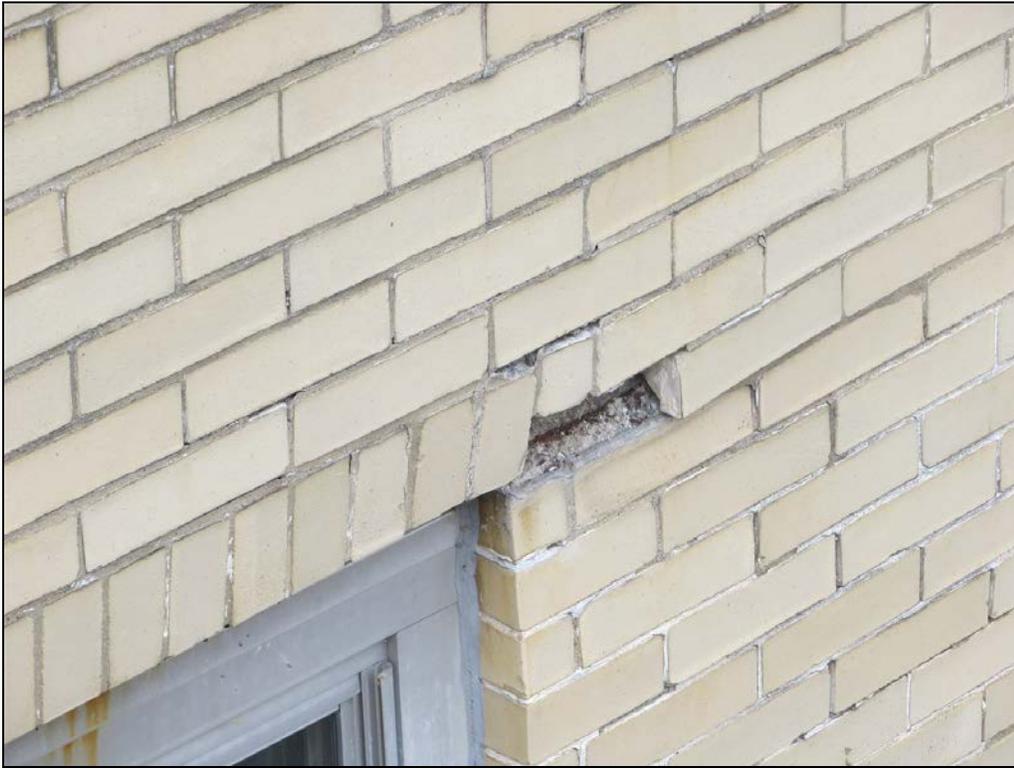
**Photograph 41:**  
At this lintel a brick was pushed off the wall from the corroding lintel.

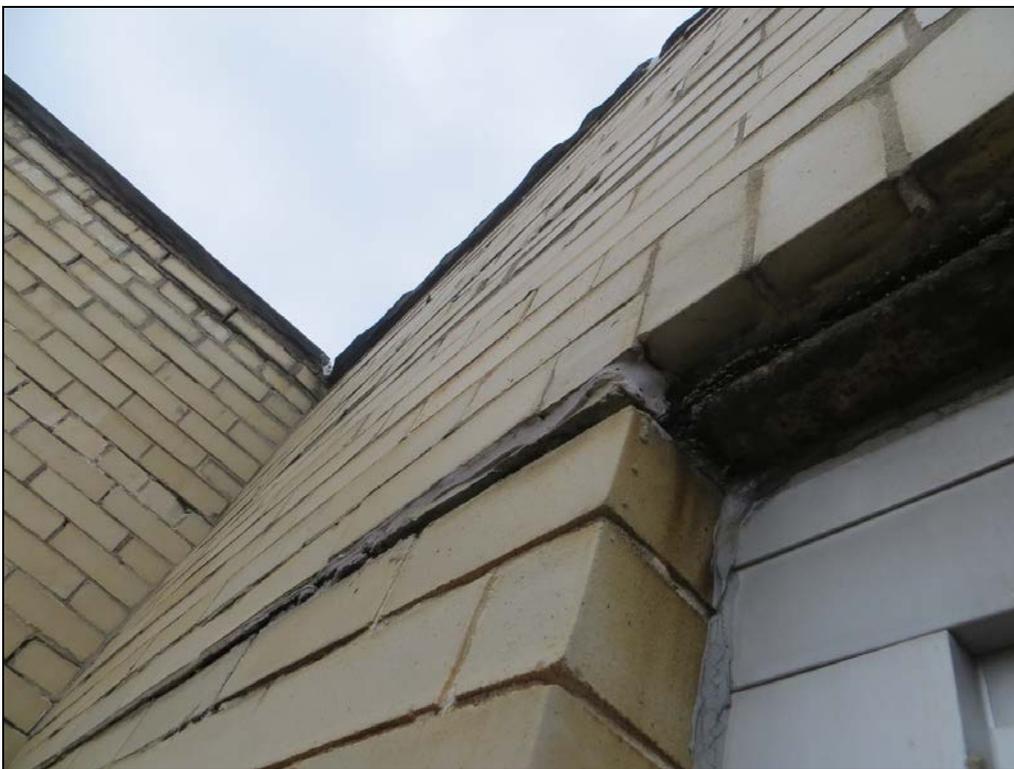
**Photograph 42:**  
The brick above the lintel has displaced outward.

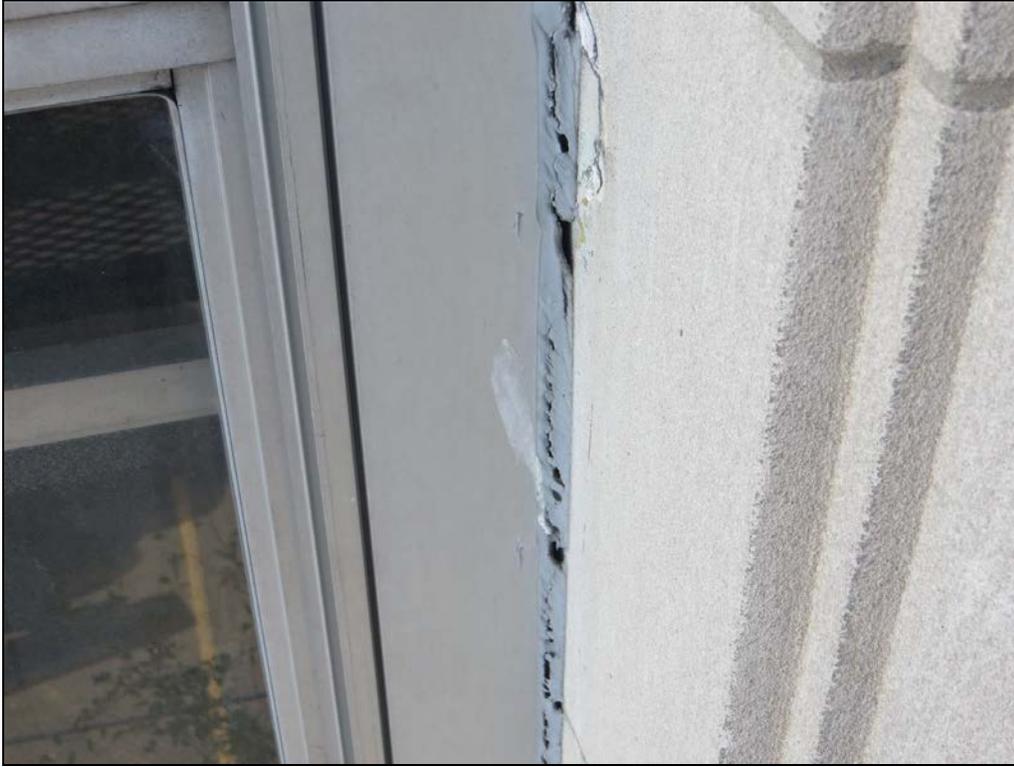
**Photograph 45:**  
Failed sealant at  
the window  
perimeter.

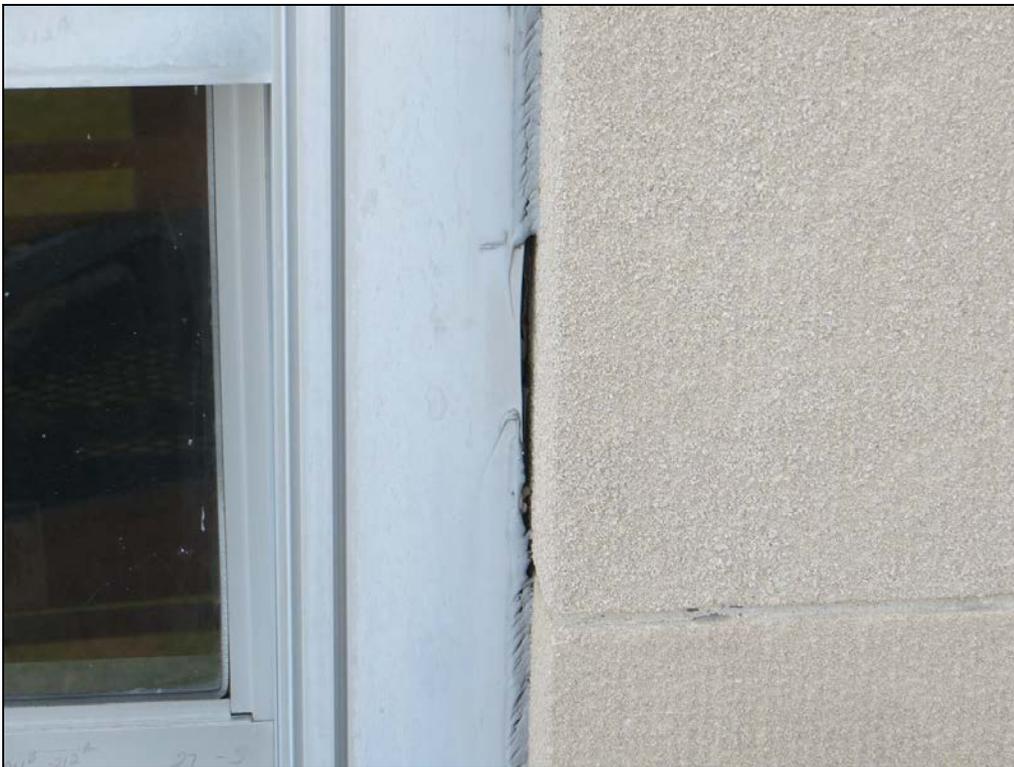
**Photograph 46:**  
Sealant was not  
installed at a  
section of the  
window perimeter.

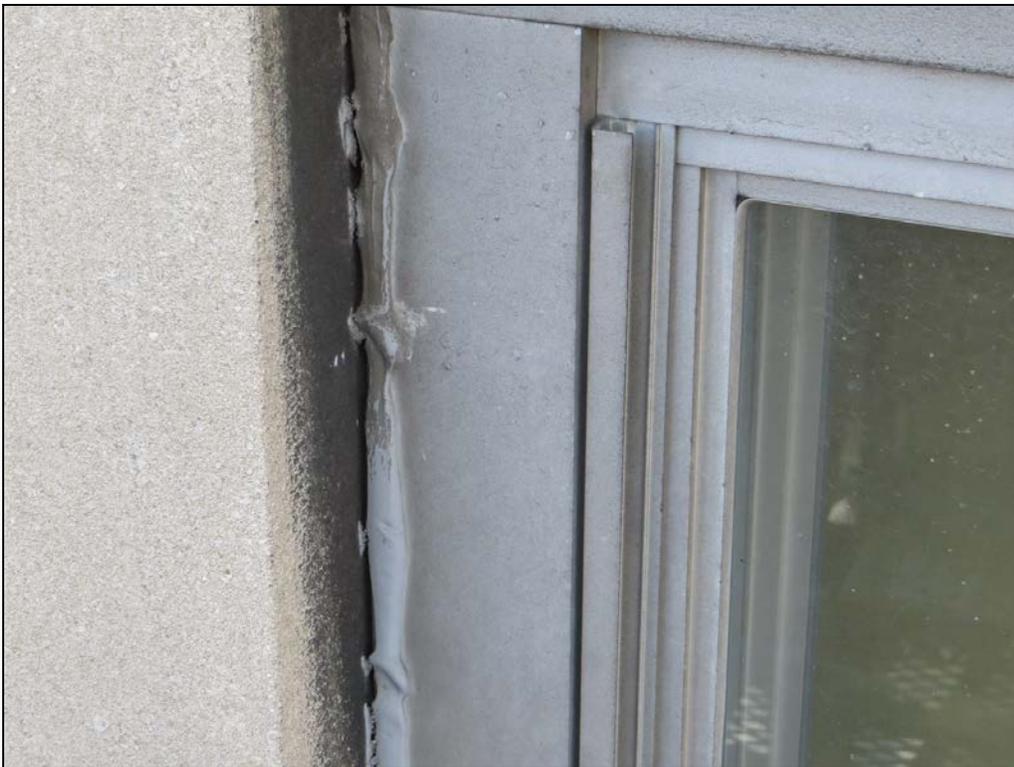
**Photograph 48:**  
Sealant has failed the entire height of the window jamb.

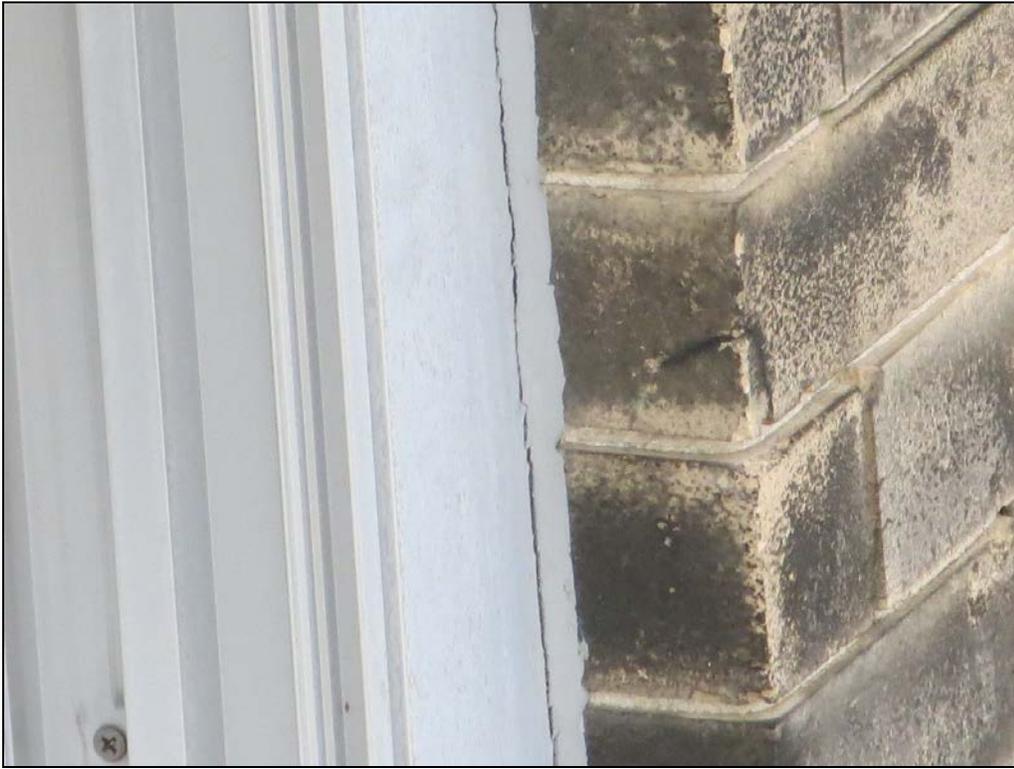
**Photograph 49:**  
Failed sealant on the rear elevation of the building.

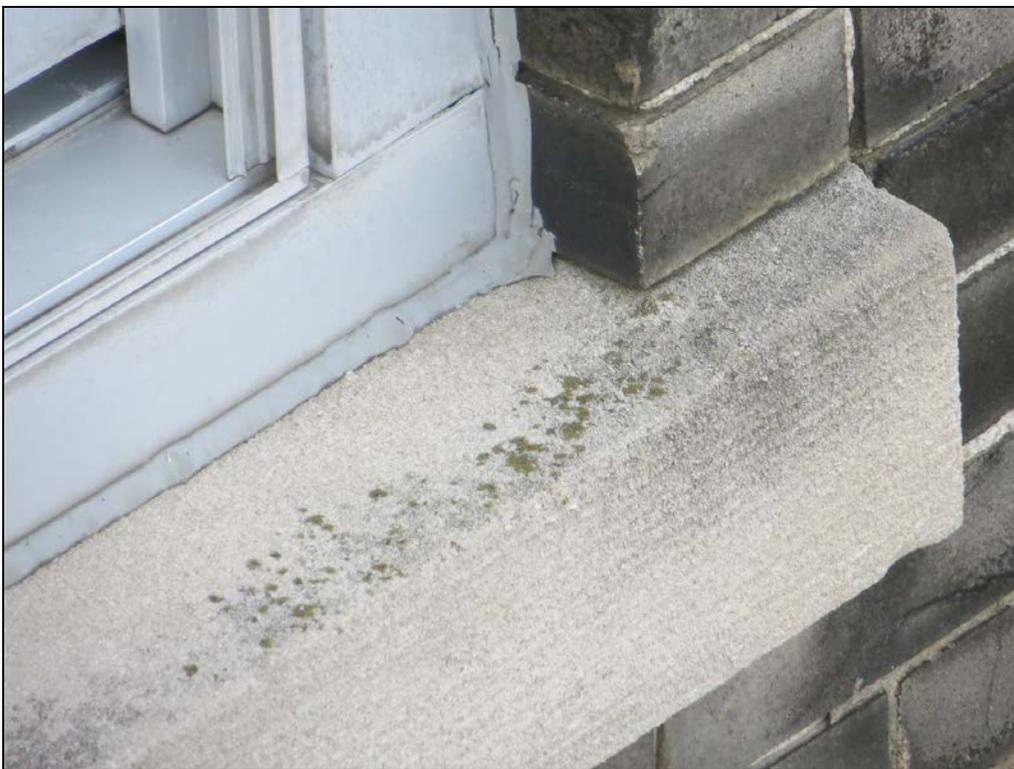
**Photograph 50:**  
Sealant on the window sill was never properly tooled, greatly reducing the performance of the sealant.
