WILKES-BARRE AREA SCHOOL DISTRICT STRUCTURAL EVALUATION OF JAMES M COUGHLIN HIGH SCHOOL

December 8, 2014

Re: Structural Evaluation of Coughlin High School

Coughlin High School Structural Evaluation

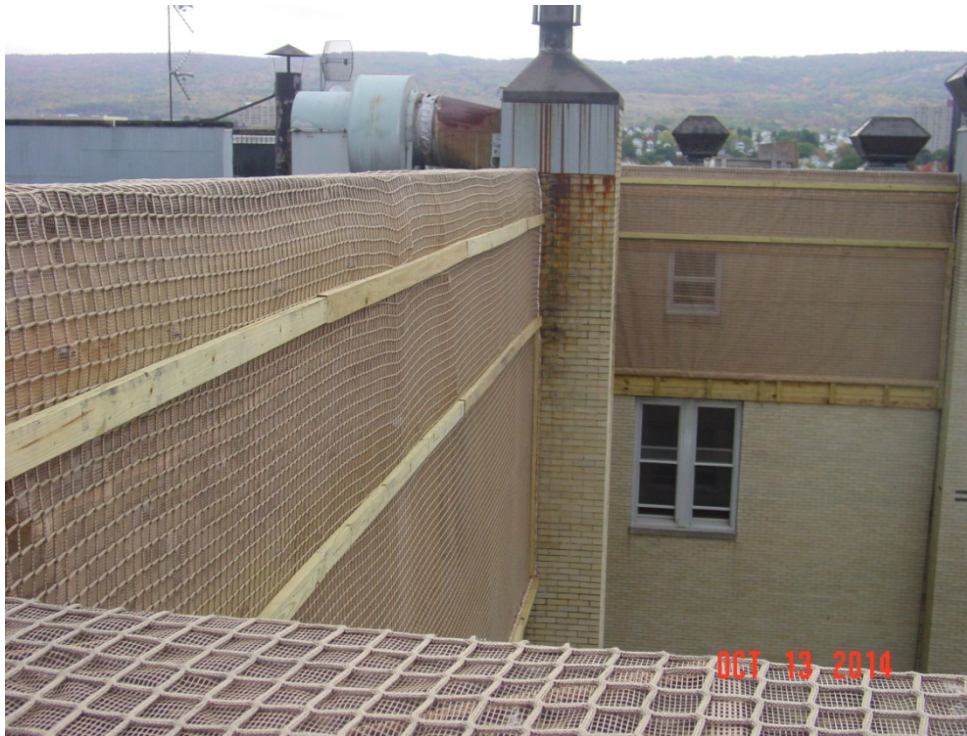
**View of completed
containment netting
installation.**

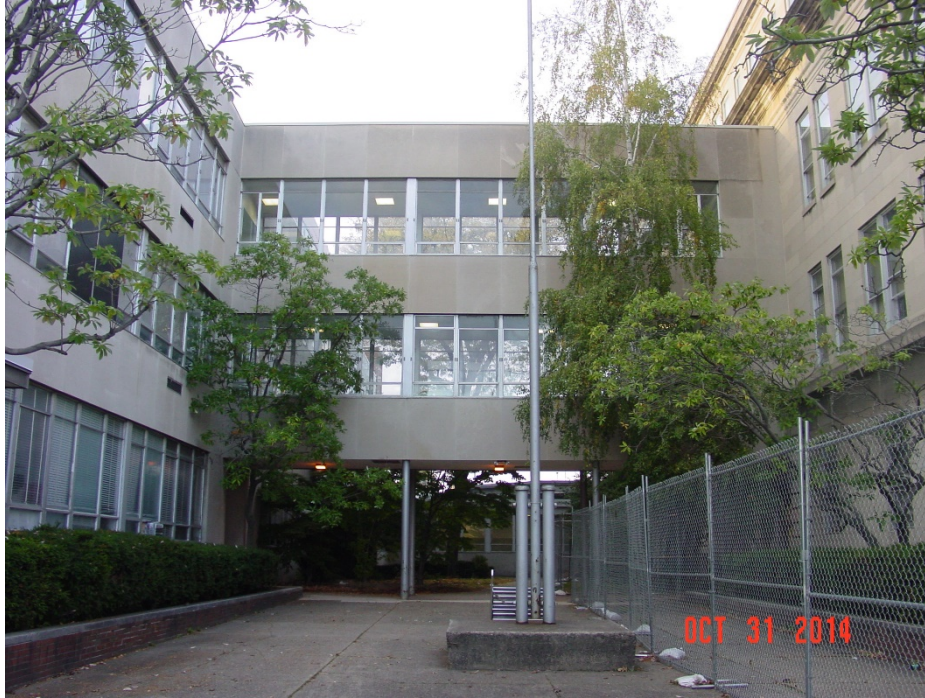
**Bridge Connecting Annex
(left) to Original School
(right)**

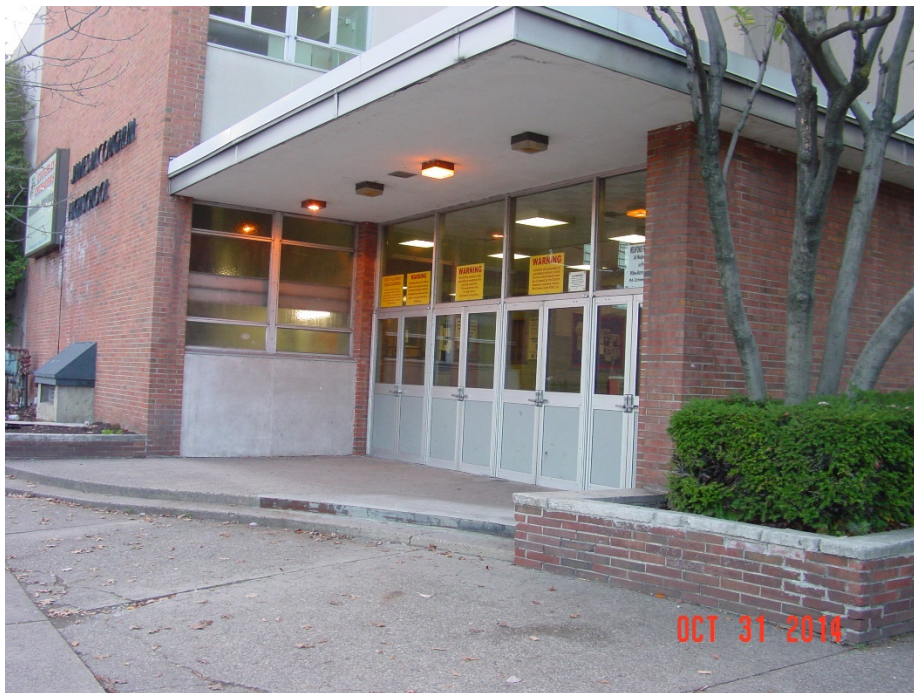
**Annex Main Entrance on
Washington Street**

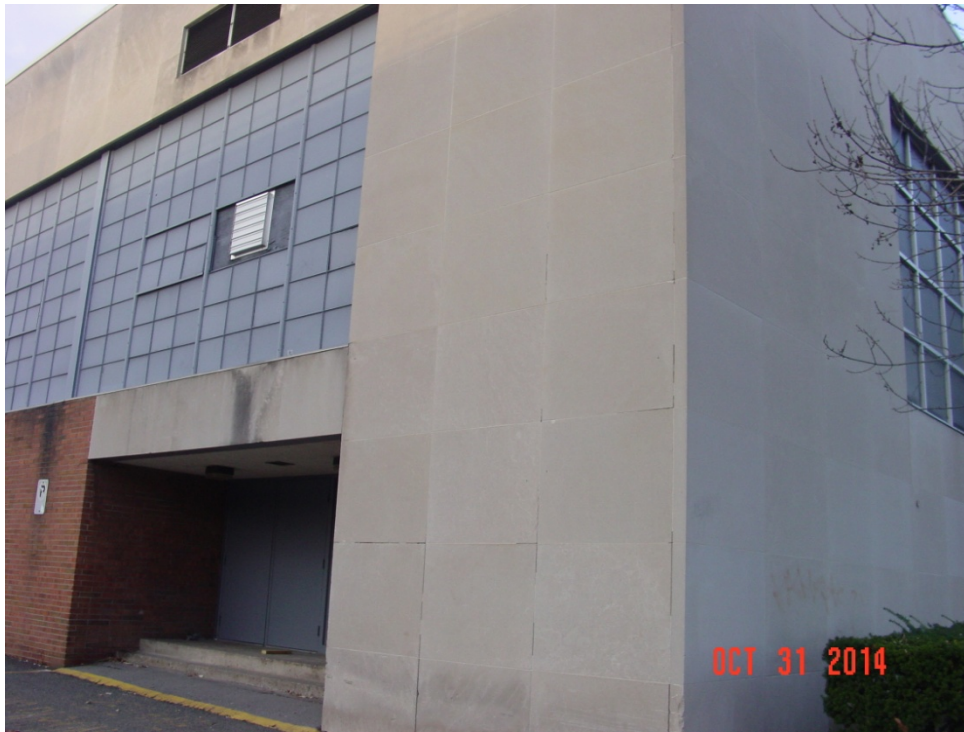
Southeast corner of Annex (Gymnasium). Note the loss of mortar is numerous stone panel joints.

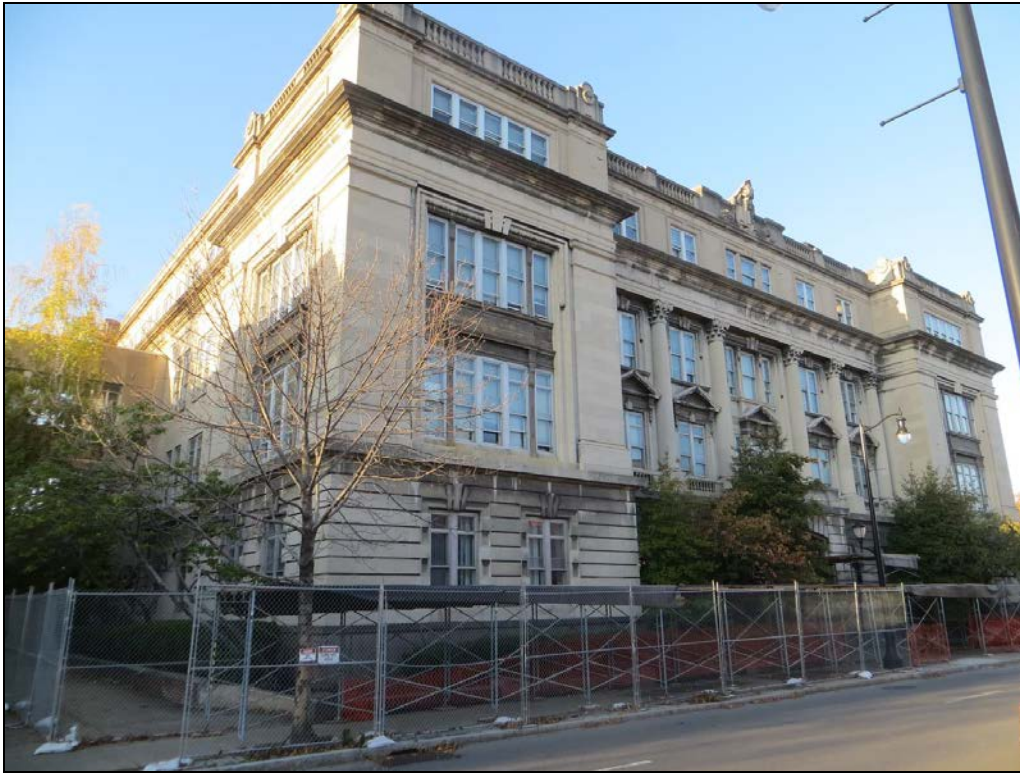
Photograph 1:

Overview of the east (front) elevation of the building. Note the fencing and overhead protection in place.

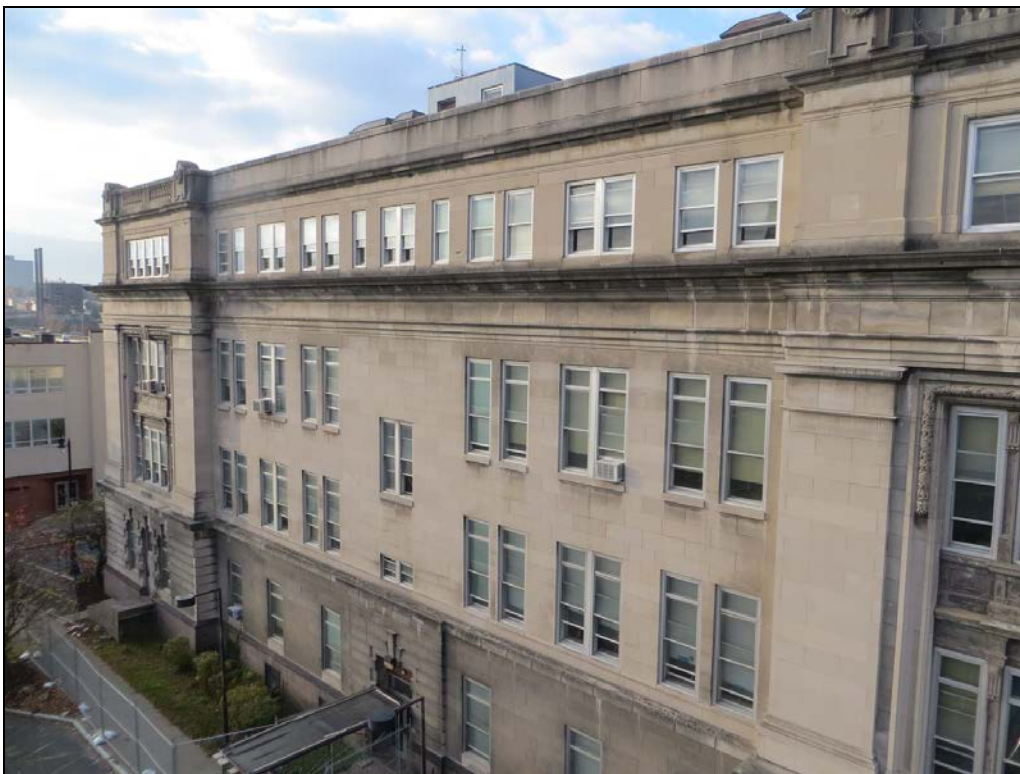
Photograph 2:

Overview of the north (side) elevation of the building.

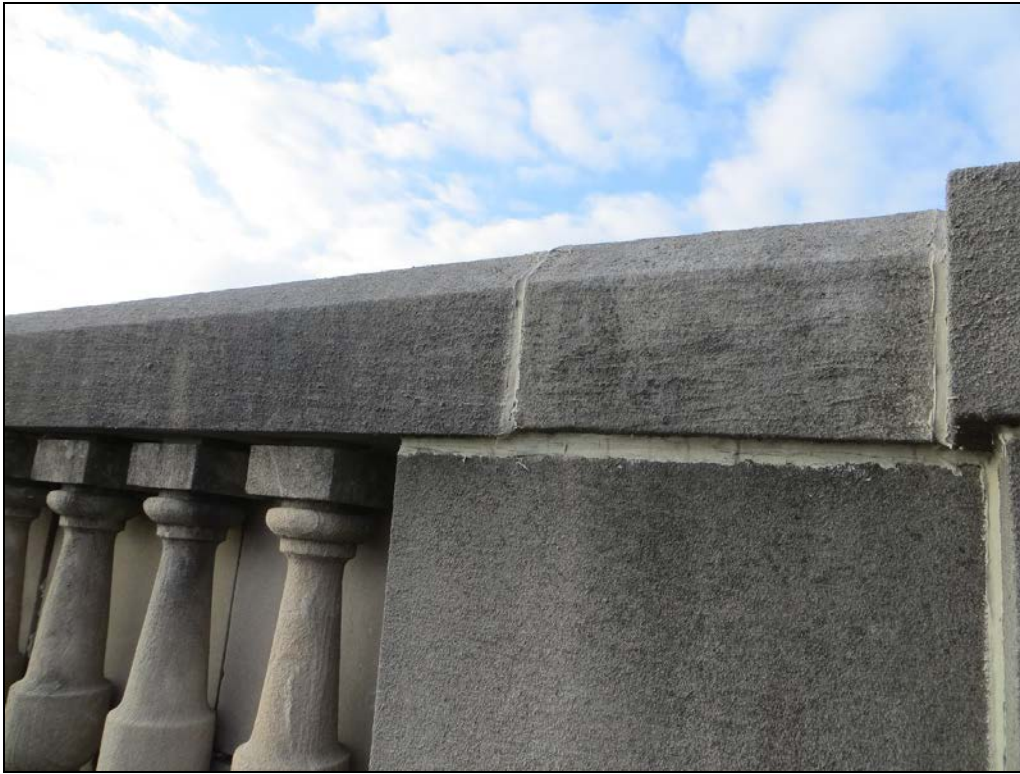
Photograph 13:

There was no evidence of flashing below the copings. Without proper flashing, large quantities of bulk rain water can enter the wall assembly.

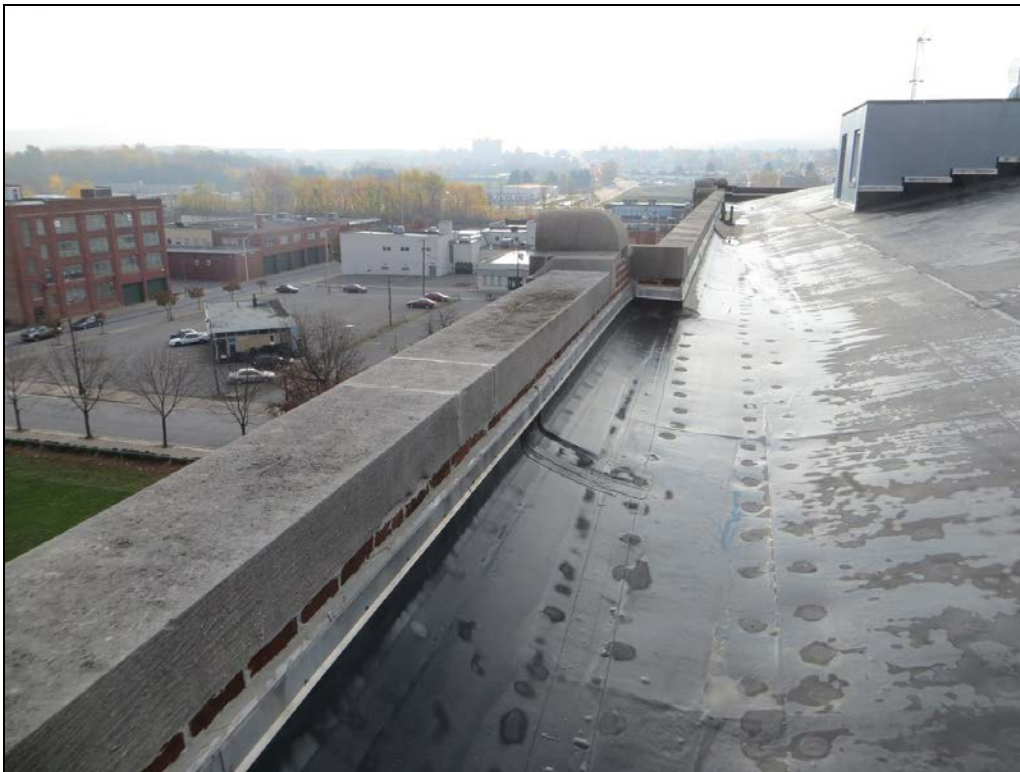
Photograph 14:

The roof counterflashing on the rear elevation of the parapet extends into the masonry less than one inch.

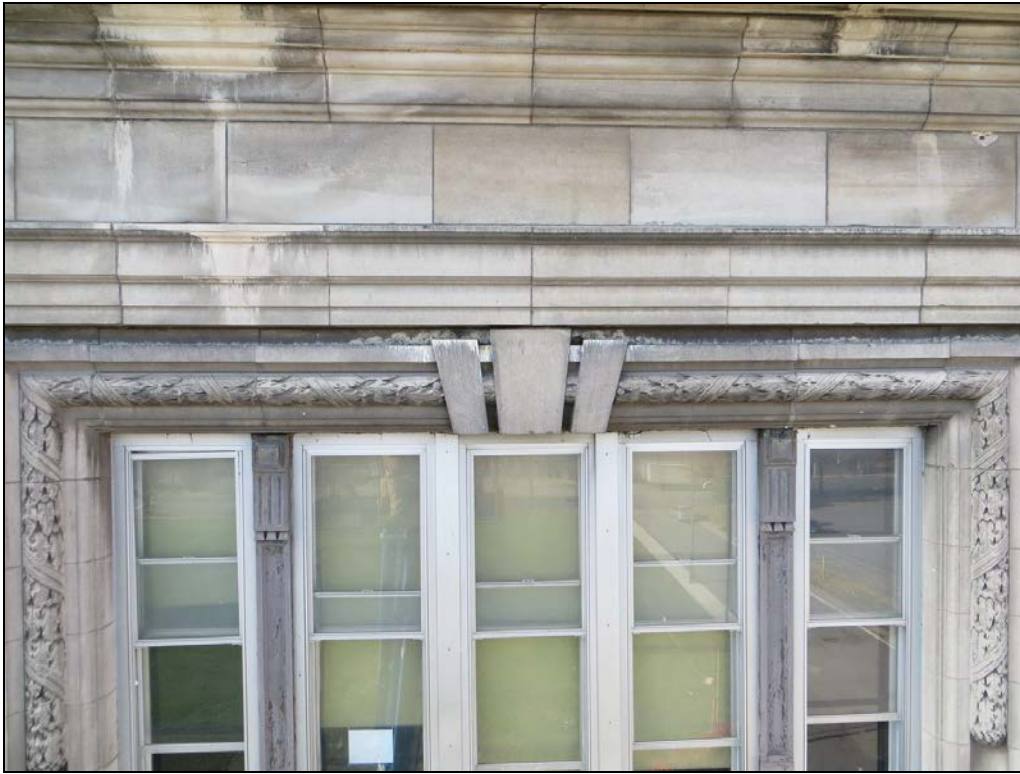
Photograph 21:

All of the stone at the window heads was supported by a steel member, even the massive pieces above the large window openings at the ends of each elevation.

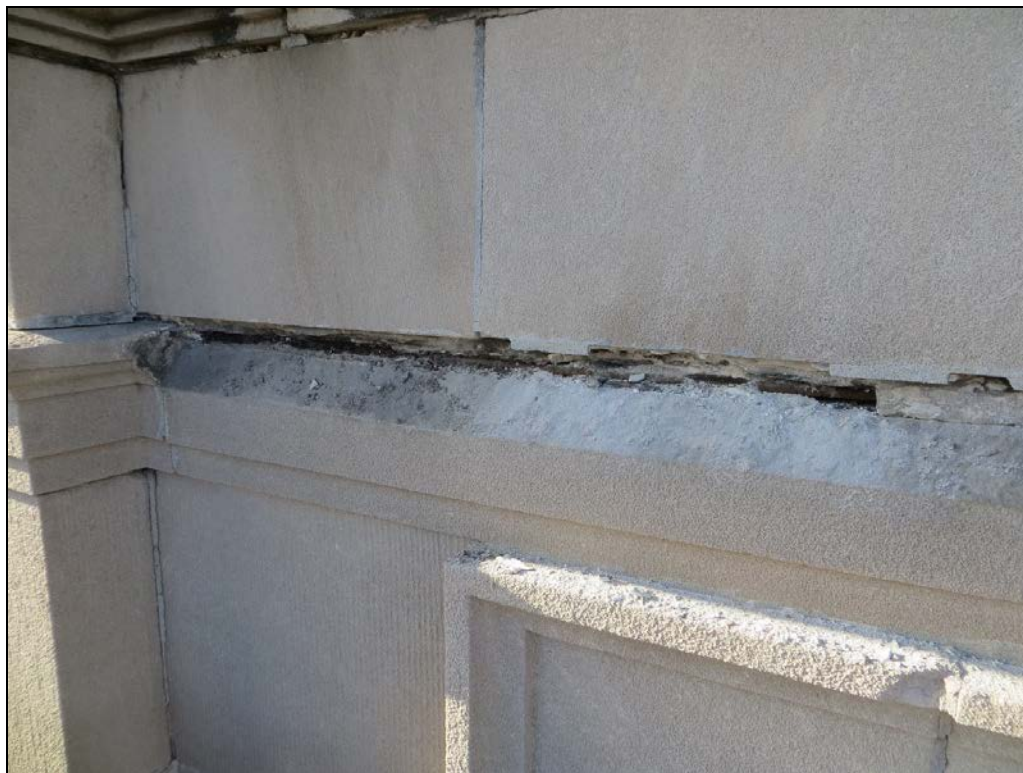
Photograph 29:
The entire molding piece was removed by hand without the use of any tools.

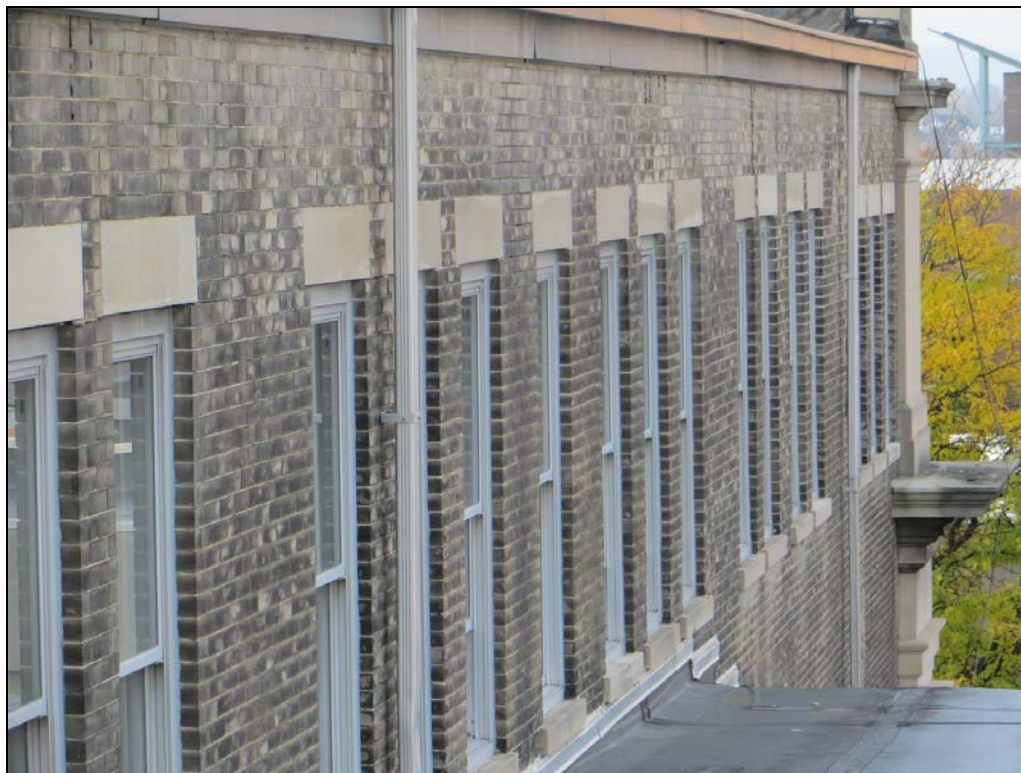
Photograph 31:
View of the rear
elevation of the
building. Note the
stone lintels over
the window
openings.

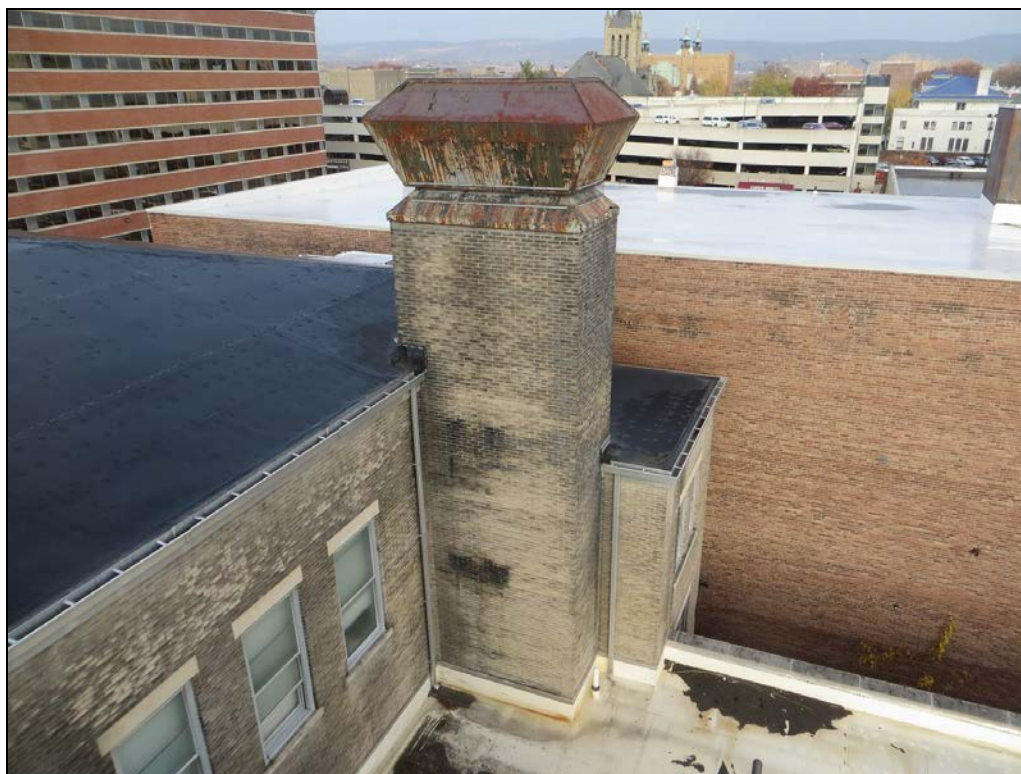
Photograph 32:
View of a one of
the chimneys on a
lower level at the
rear of the
building.

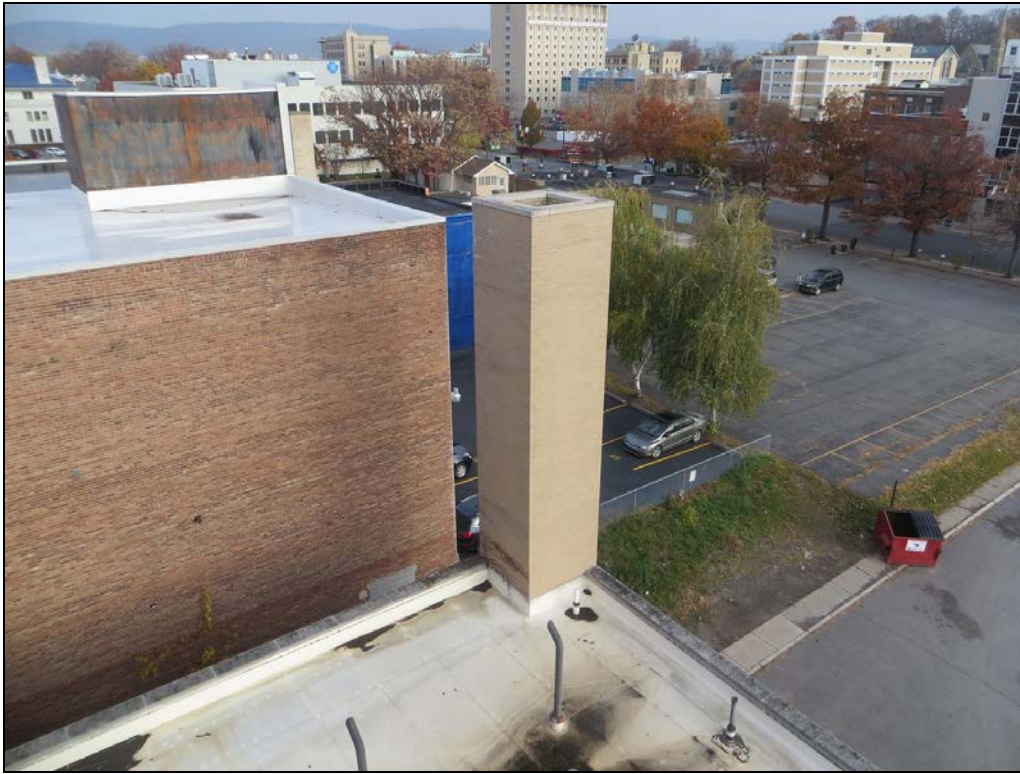
Photograph 33:
Chimney at an
addition to the
building.

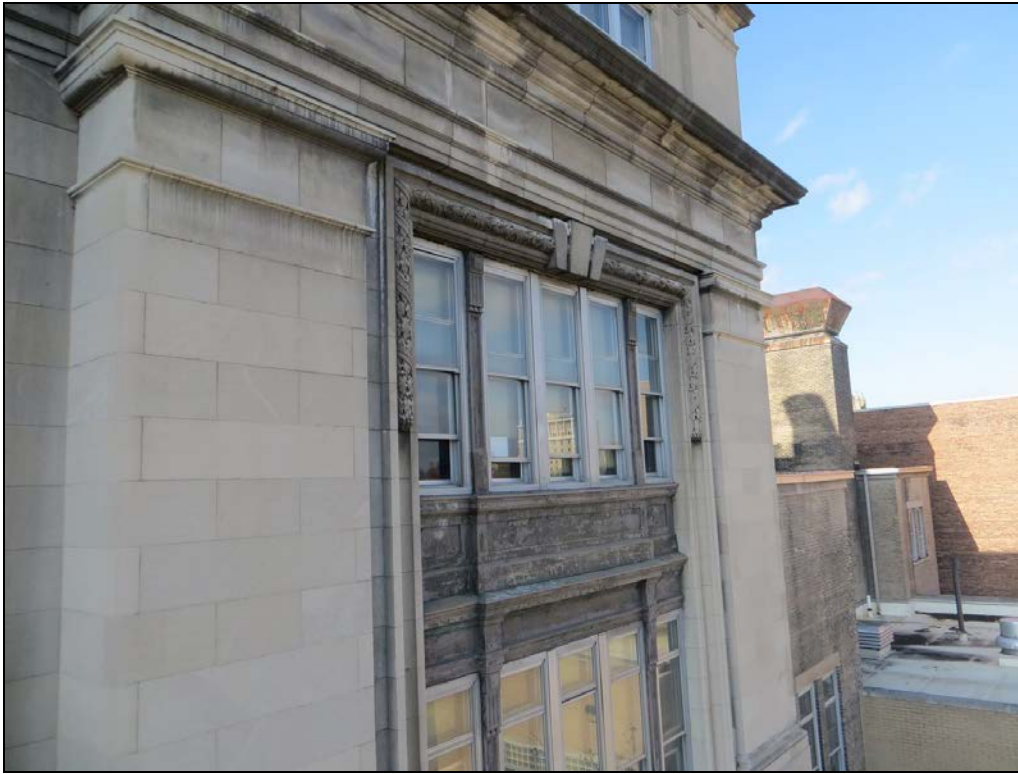
Photograph 43:
Copper sheet metal over wood framing was used at the large windows at the end of each elevation.

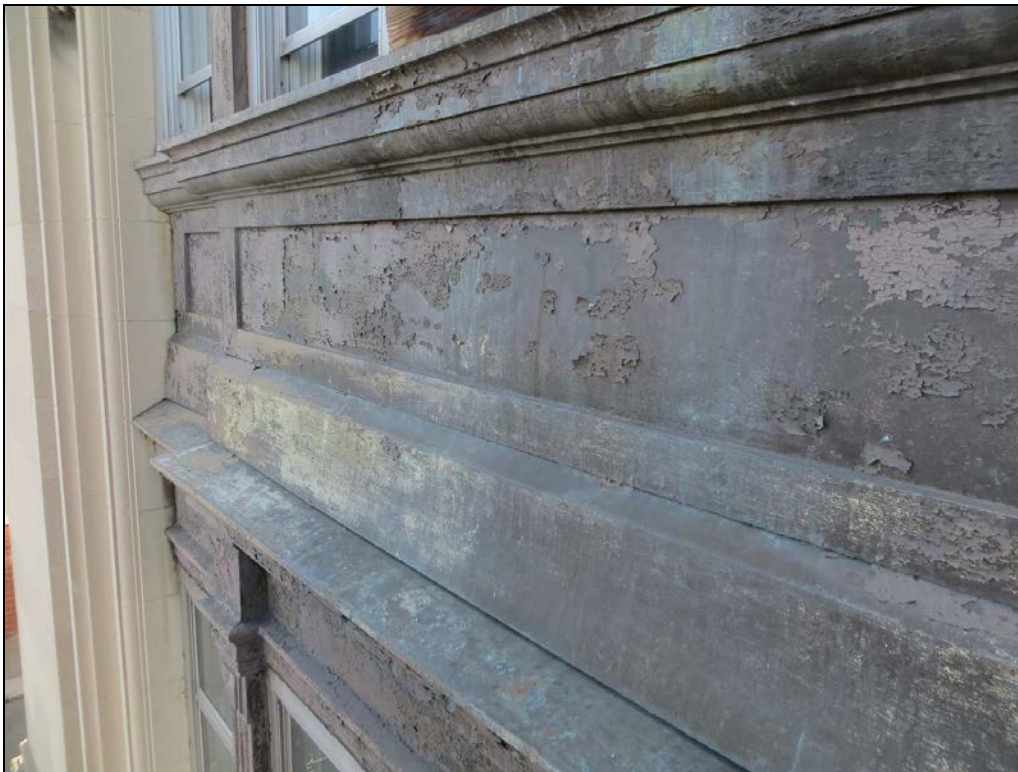
Photograph 44:
The copper sheet metal was painted. The paint is now peeling at most locations.

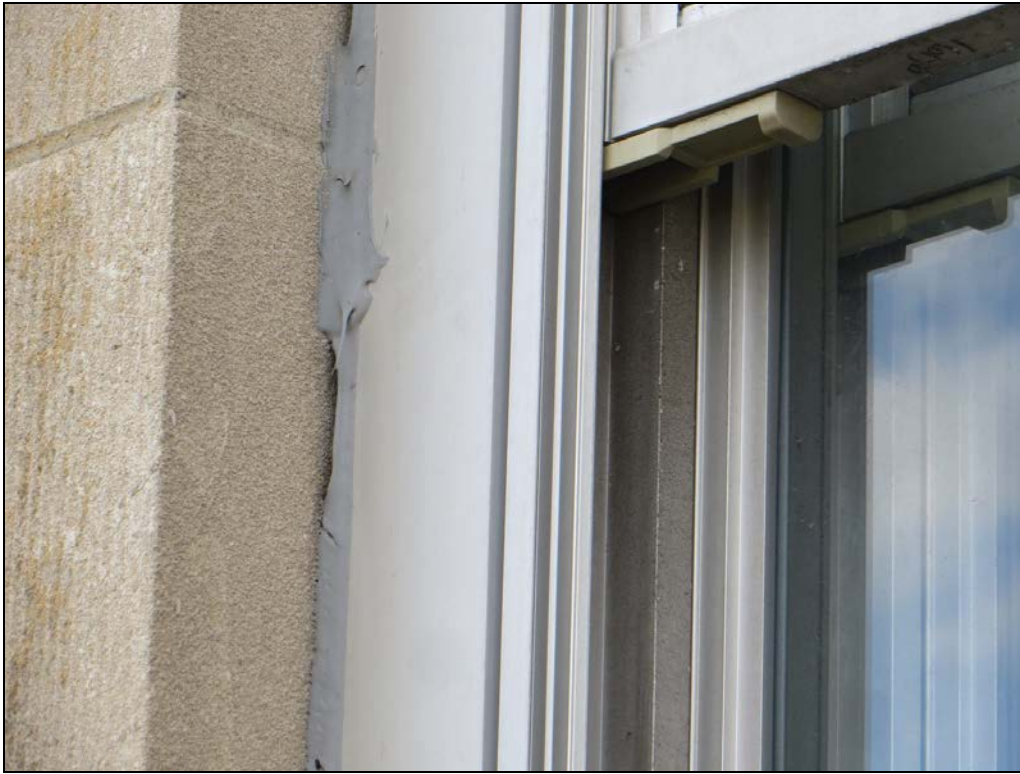
Photograph 47:
Poorly installed sealant has lost adhesion to the stone.

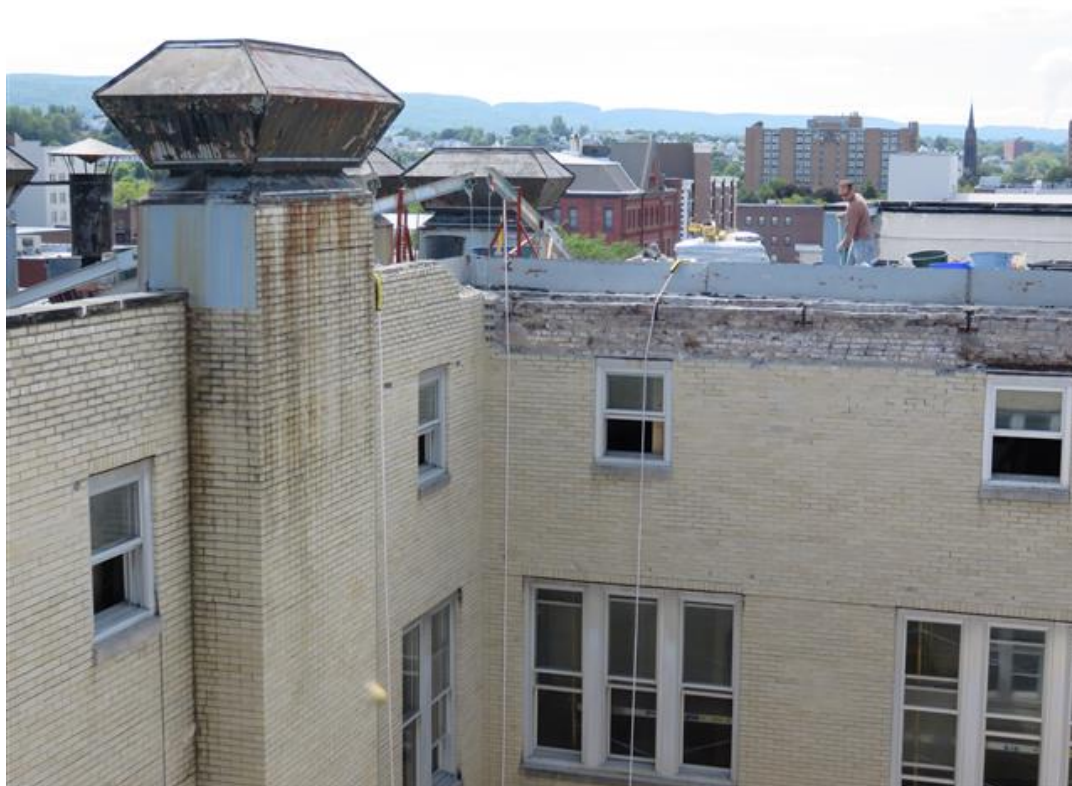
Photograph 1:

- MPS was on-site to review masonry stabilization, demolition and containment efforts underway.
- a) Brick parapet demolition had started along the south and intersecting east parapets. Reportedly, only hand tools were required to remove the brick masonry components. Refer to Photograph 1.

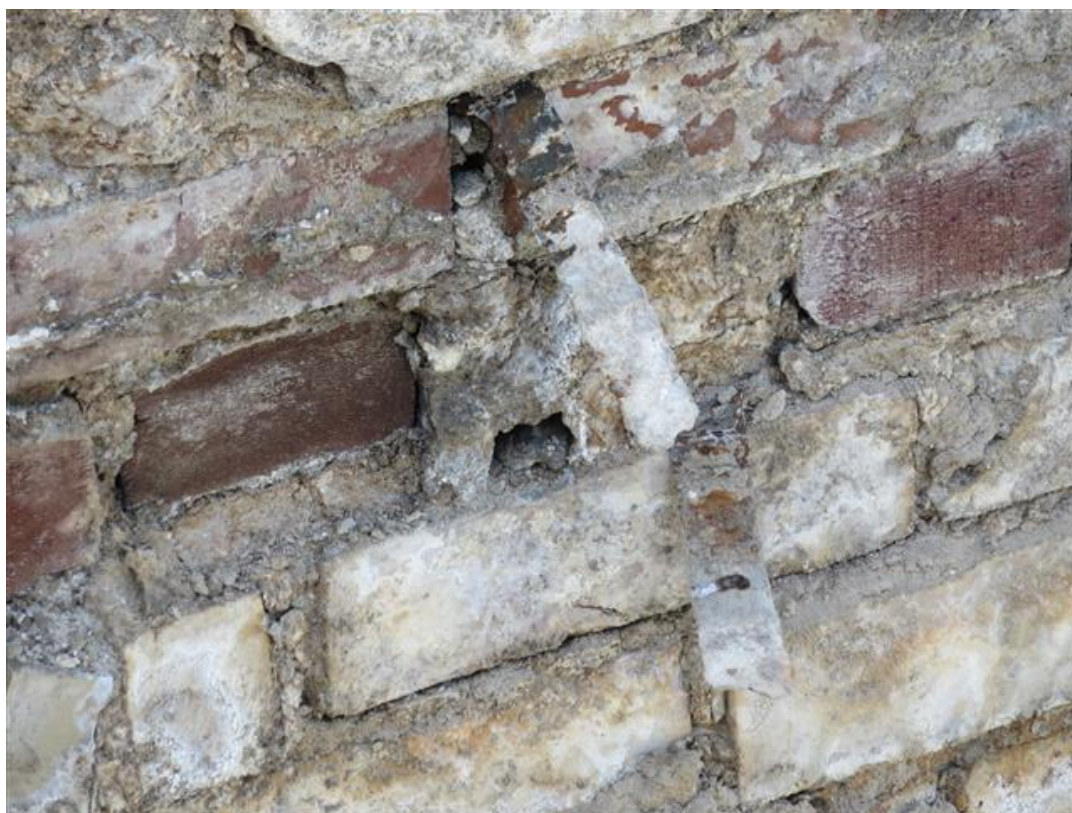
Photograph 2:

- b) A majority of the masonry brick ties were consumed by rust. Refer to Photograph 2.
- c) The attic level window relief angle exhibited advanced oxide jacking and/or was consumed by rust contributing to vertical displacement of the parapet's outer wythe of brick. Refer to Photograph 3.

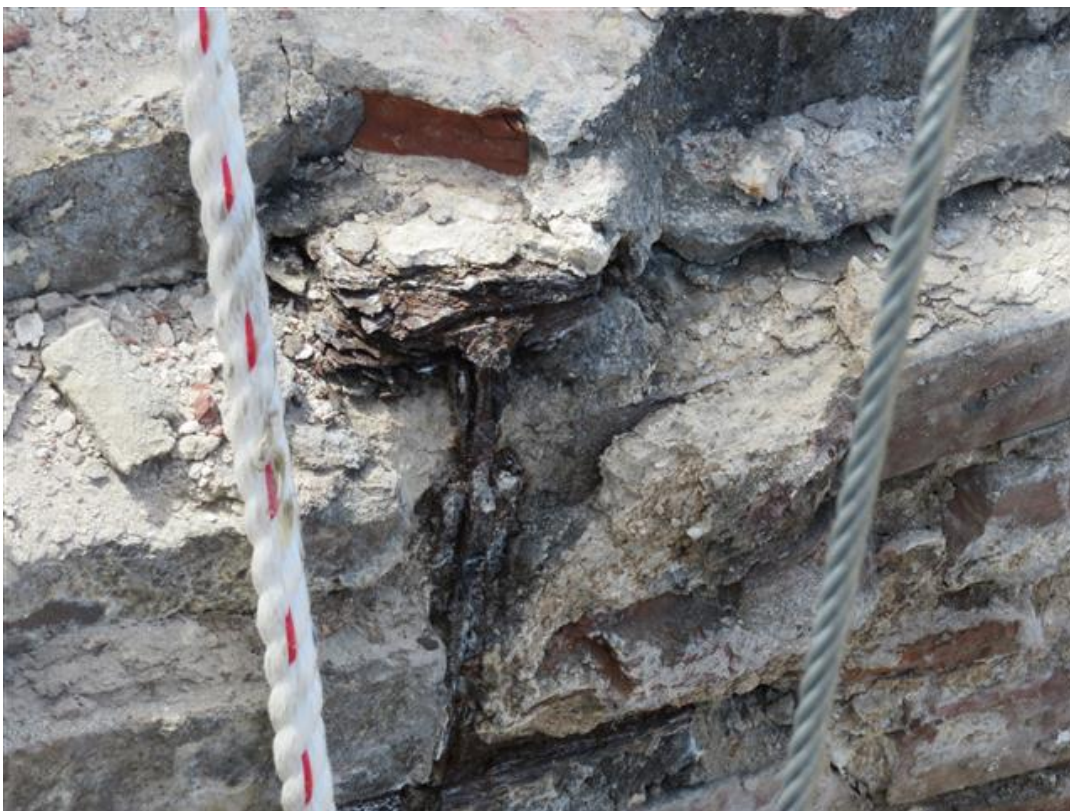
Photograph 4:

- d) The 7" X 3 5/8" roof slab support beam end exhibited complete section loss at its interface with the parapet's outer brick wythe. The corroded section (beam flange) measured in excess of 2 1/2" which is approximately 7 times its original thickness of 3/8". This expansion displaced the parapet masonry both vertically and horizontally. Refer to Photograph 4.

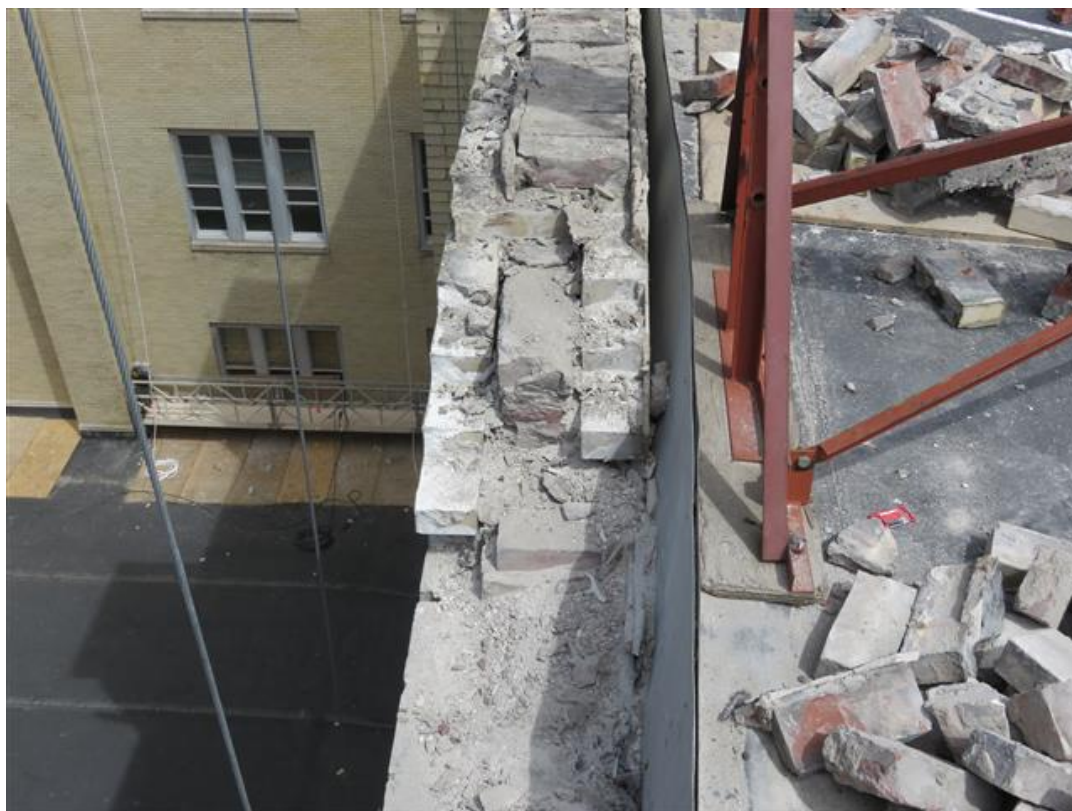
Photograph 5:

- e) The original parapet coursing included headers from both the exterior and interior wythes directly below the coping, along with additional interior headers below. Refer to Photograph 5.

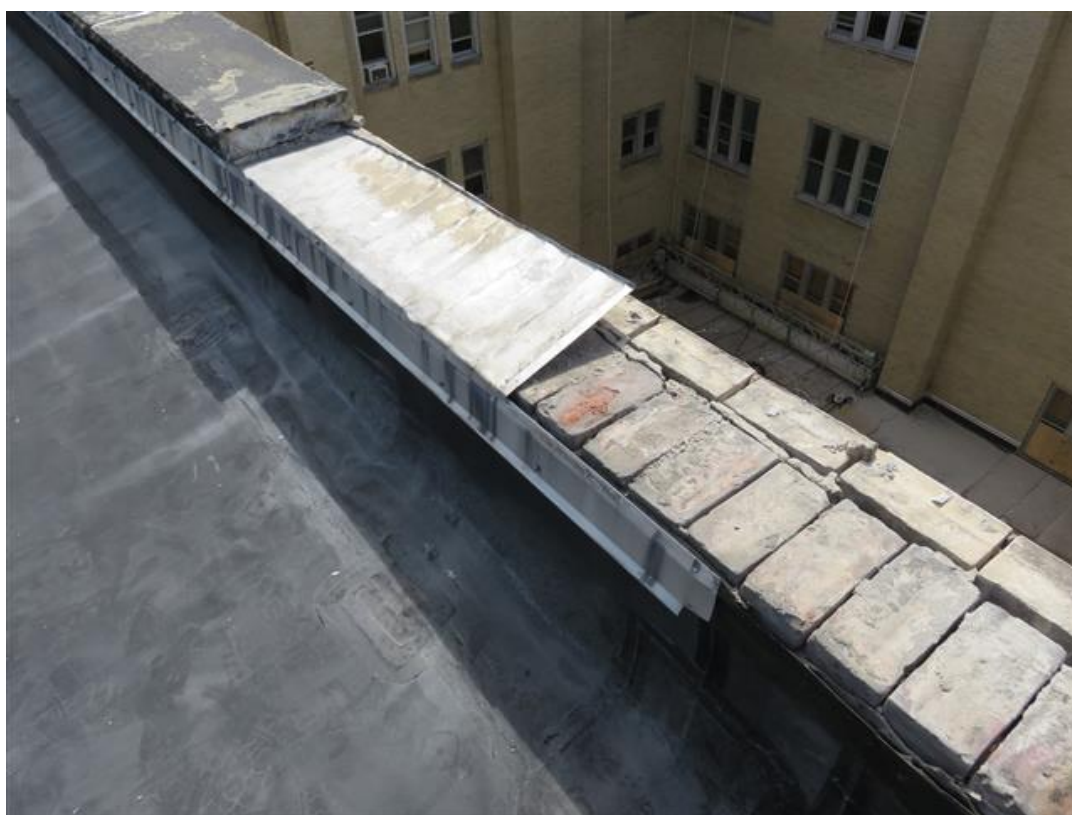
Photograph 6:

- f) The coping stones were removed along the north and intersecting west parapets. Remedial flashing and interior counterflashing was observed. Refer to Photograph 6.

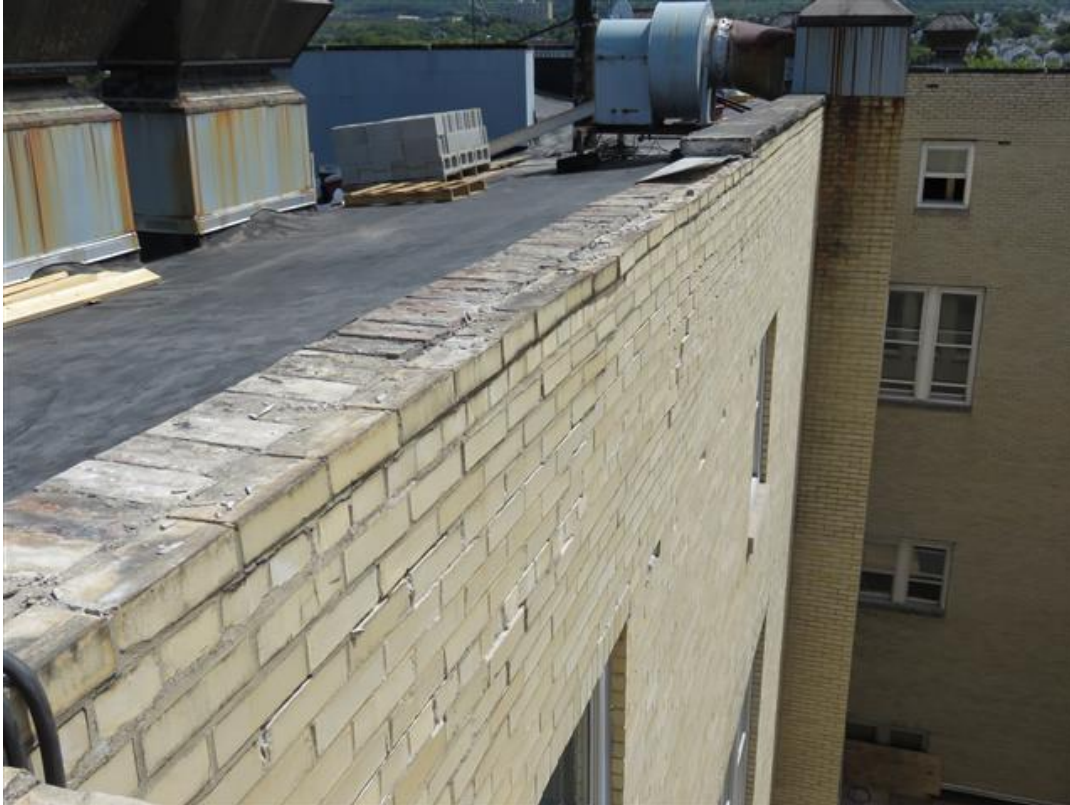
Photograph 7:

- g) Again, as observed on the southeast corner, the northwest corner parapet is unbonded, vertically and horizontally displaced and can be removed by hand. This indicates complete loss of mortar/cementitious bond which is required for masonry assemblies to act as a monolithic wall. Refer to Photograph 7.

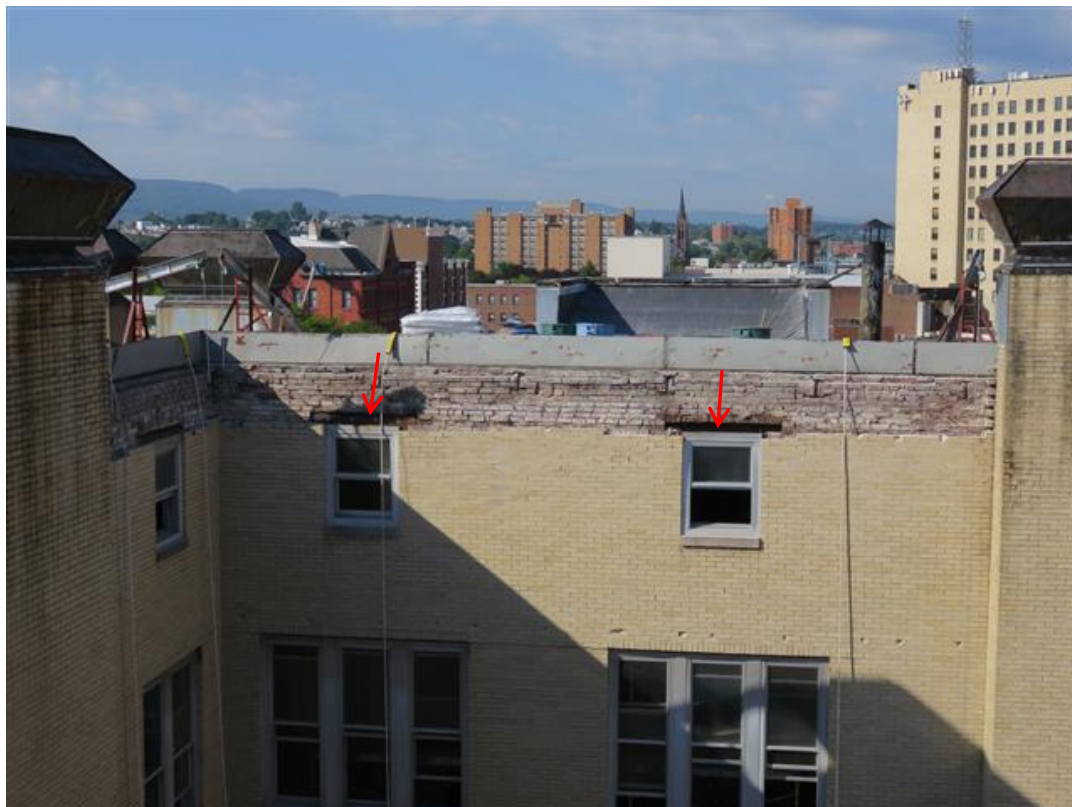
Photograph 1:

- a) Portions of the steel channel/lintel attic floor window head support steel were removed during demolition. Refer to Photograph 1.
- b) The relief angles had lost significant original section and in some cases, were completely consumed by corrosion. Refer to Photograph 2.

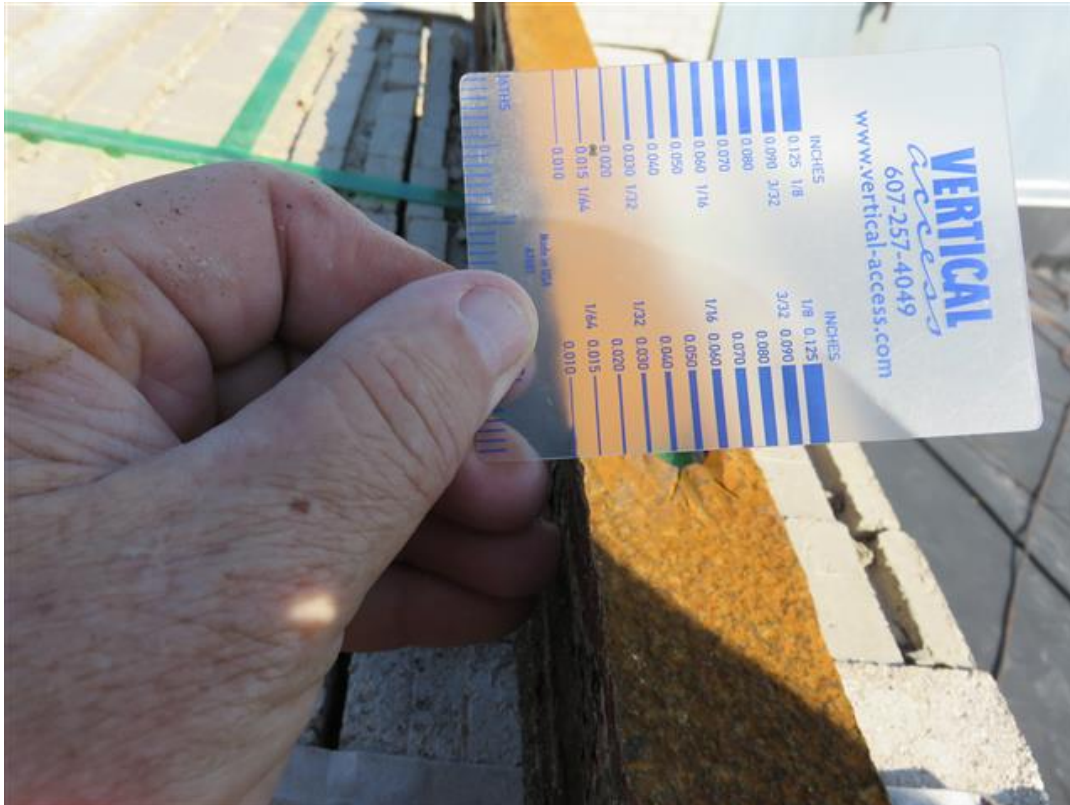
Photograph 3:

- c) Portions of the angle's horizontal leg exhibited complete section loss (a phenomenon known as knifing). Refer to Photograph 3.
- d) Overview of the area reviewed via swing stage including floors 2, 3, 4 and attic. Refer to Photograph 4.

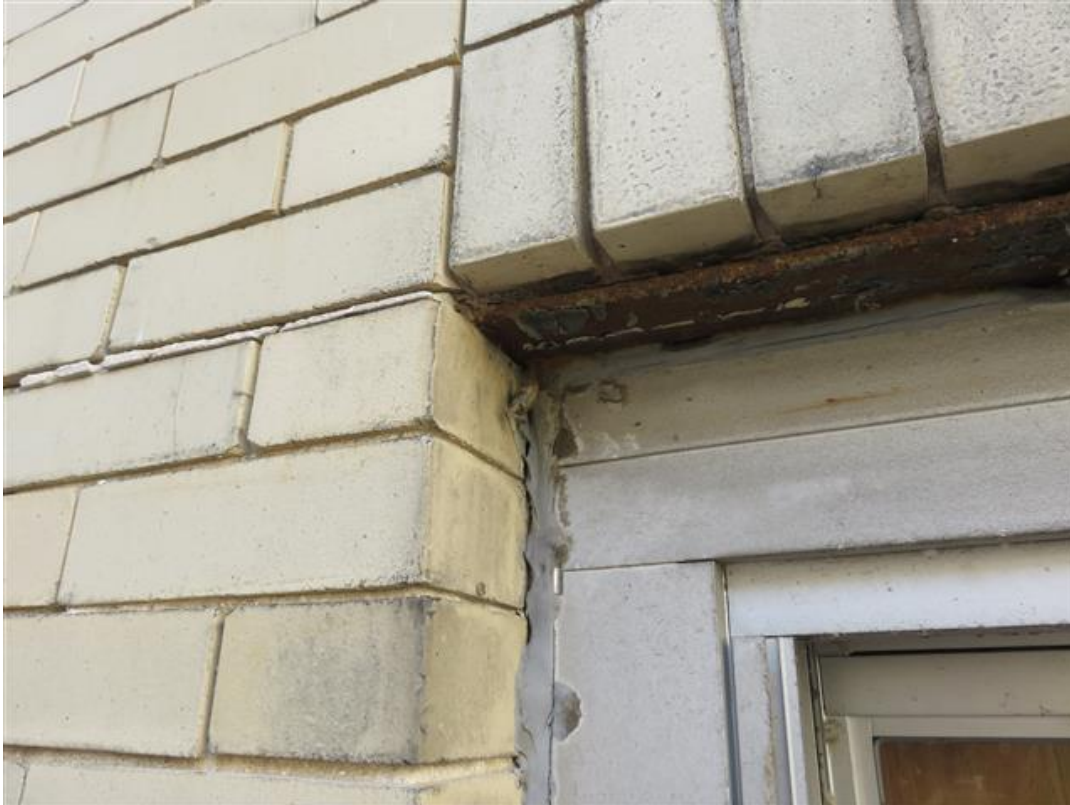
Photograph 5:

- e) The 2nd floor window head exhibited corrosion build-up (oxide jacking) above the window head relief angle and compressive displacement of masonry above and below the lintel at bearing areas. Refer to Photograph 5.

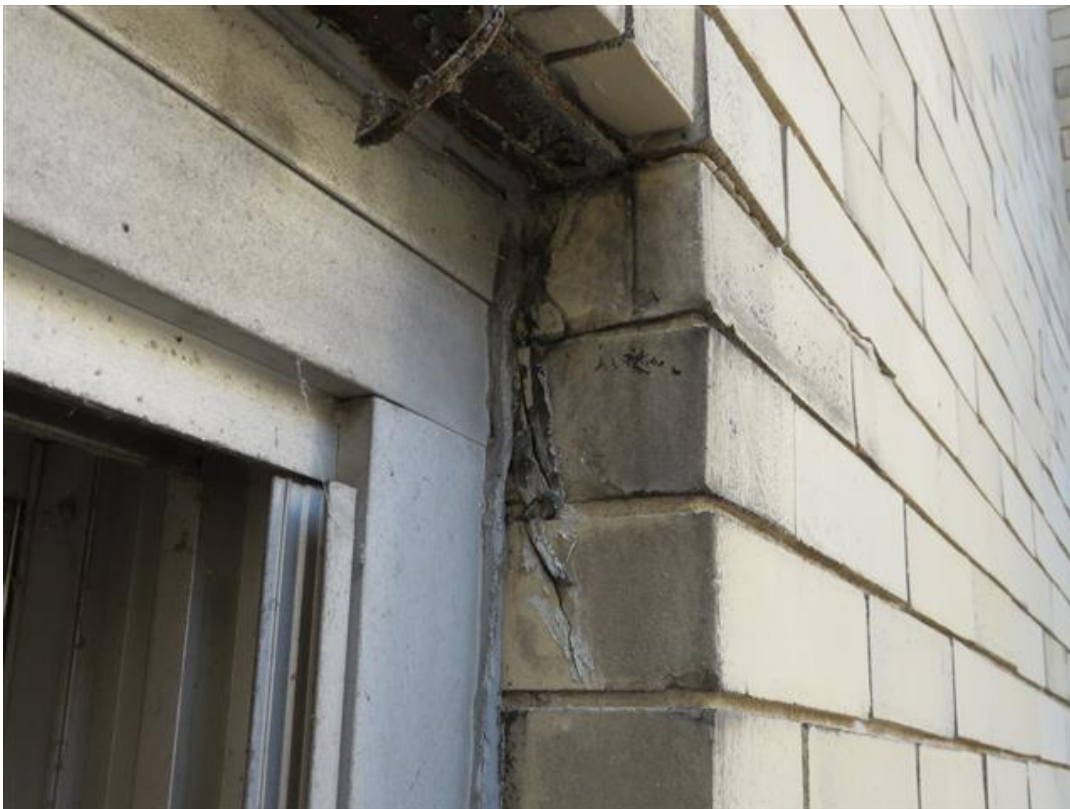
Photograph 6:

- f) More severe oxide jacking was noted at the 3rd floor window head including crushing of jamb brick beneath the lintel's bearing area. Refer to Photograph 6.

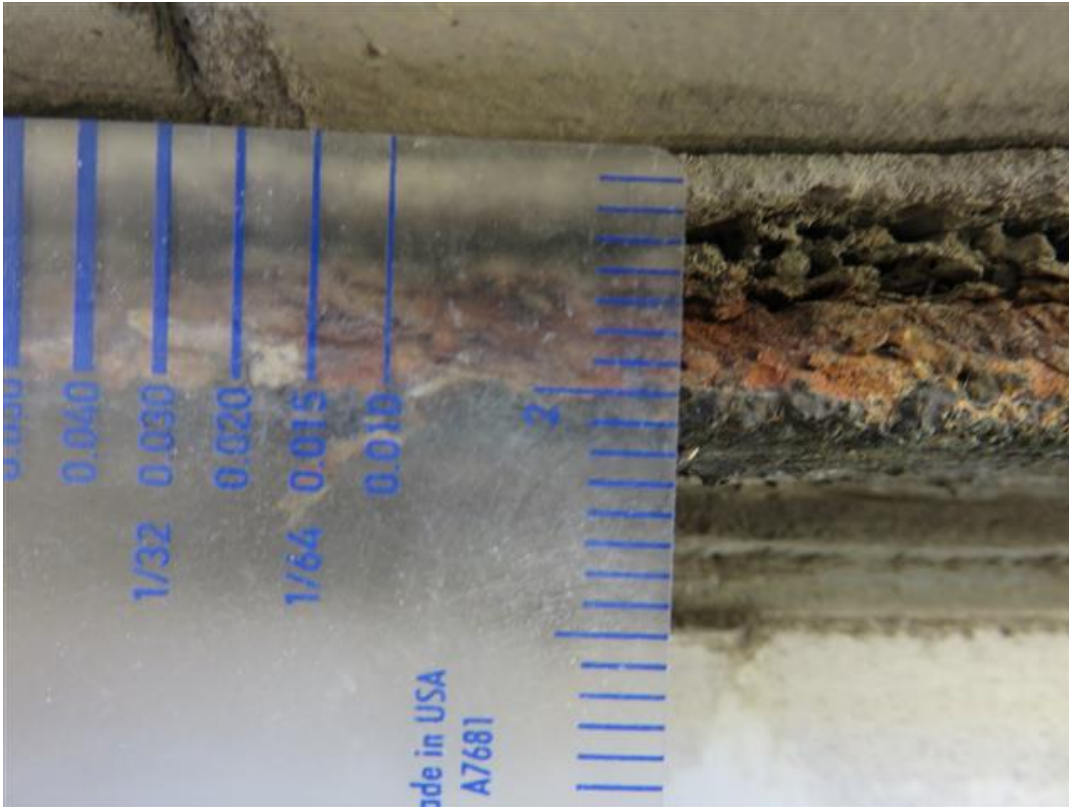
Photograph 7:

- g) Corrosion build-up exceeding ½" was noted at the 3rd floor. Refer to Photograph 7.
- h) Masonry displacement, both vertical and horizontal, along with exasperated brick spalling was noted at the 4th floor masonry window heads. Refer to Photograph 8.
