WILKES-BARRE AREA SCHOOL DISTRICT STRUCTURAL EVALUATION OF JAMES M COUGHLIN HIGH SCHOOL

December 8, 2014

Re: Structural Evaluation of Coughlin High School

Coughlin High School Structural Evaluation

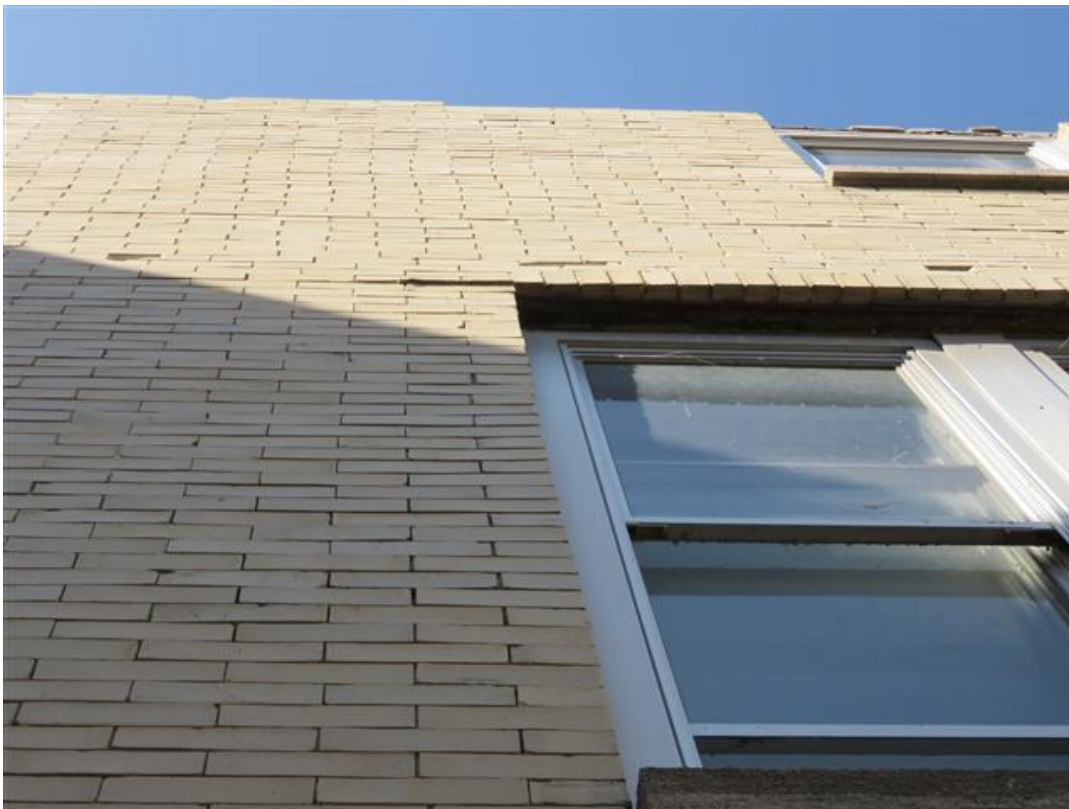
Photograph 8:

- g) Corrosion build-up exceeding ½" was noted at the 3rd floor. Refer to Photograph 7.
- h) Masonry displacement, both vertical and horizontal, along with exasperated brick spalling was noted at the 4th floor masonry window heads. Refer to Photograph 8.

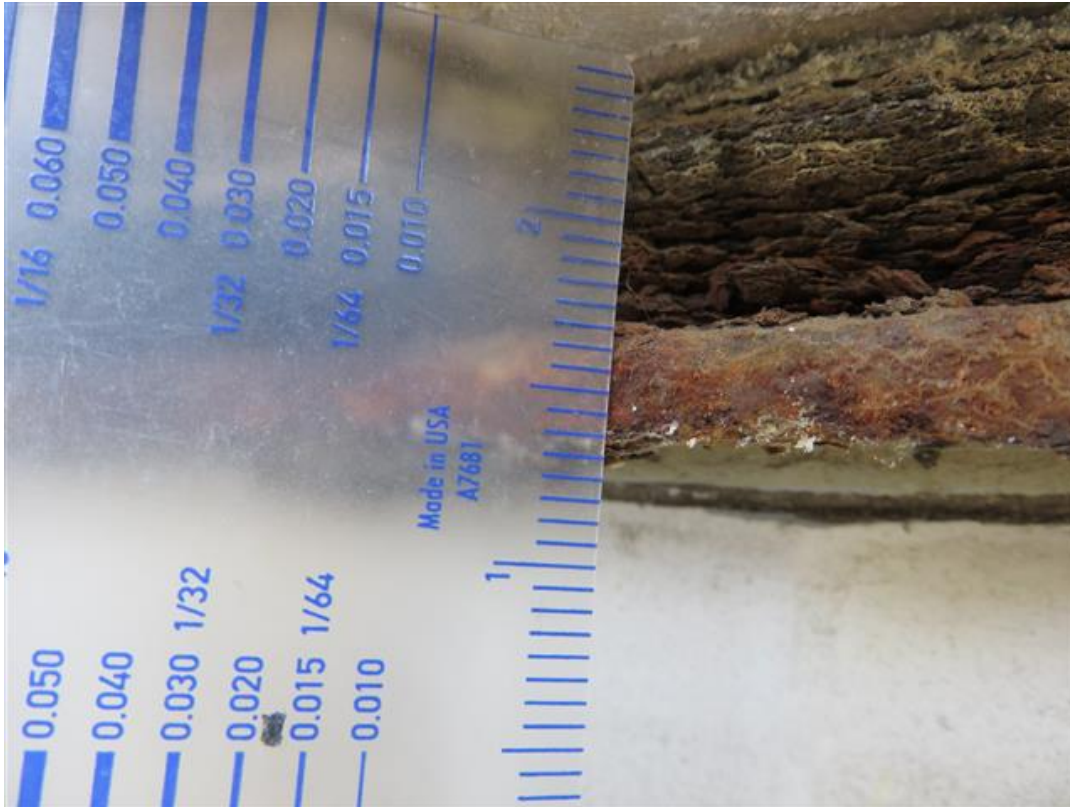
Photograph 9:

- i) Corrosion build-up exceeding 13/16" was noted at the 4th floor. Refer to Photograph 9.
- j) Masonry was removed to the attic level window head. Along the south elevation, both lintel/channel assemblies were removed due to loss of original steel section. Also note original wood window framing exposed behind the metal replacement window. See Photograph 10.

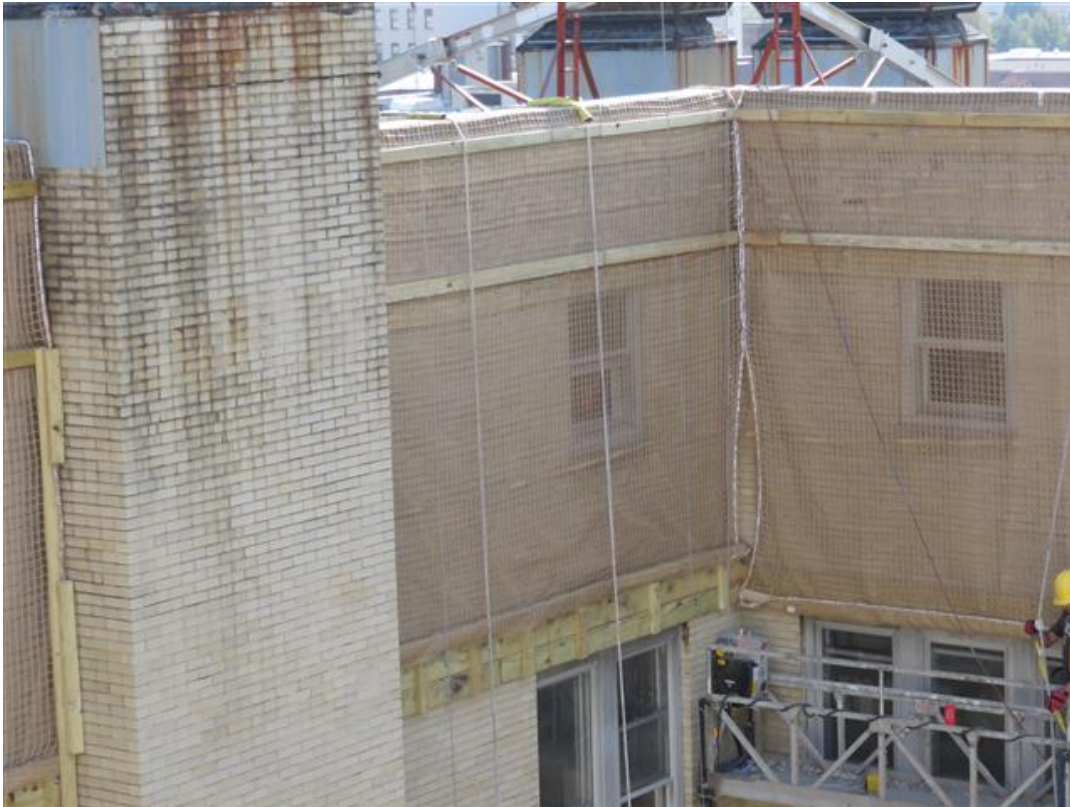
Photograph 1:

- MPS was on-site to inspect ongoing netting installation, wire mesh installation and masonry parapet rebuilding.
- a) Netting installation was completed or being finished except for the northwest corner where masonry parapets were being rebuilt. Refer to Photograph 1.

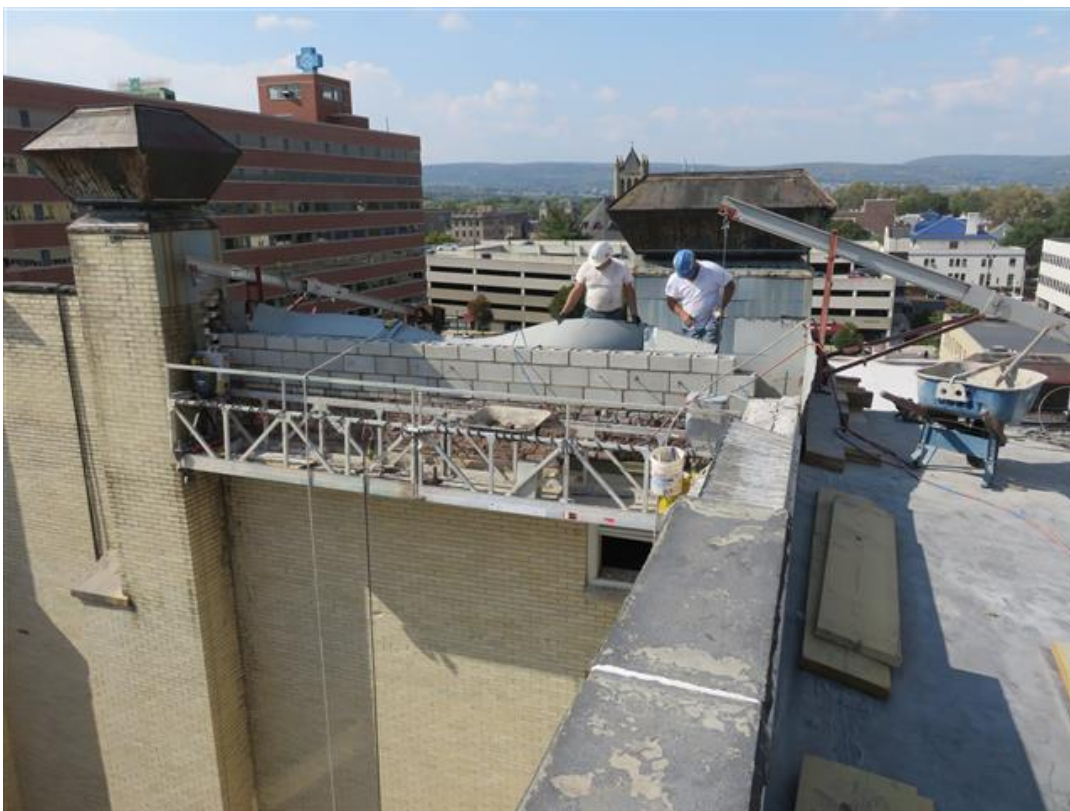
Photograph 2:

- b) The parapet west elevation north end was rebuilt including CMU back-up. Refer to Photograph 2.
- c) The back-up parapet masonry included through wall stainless steel all thread and adjustable veneer anchors. Refer to Photograph 3.

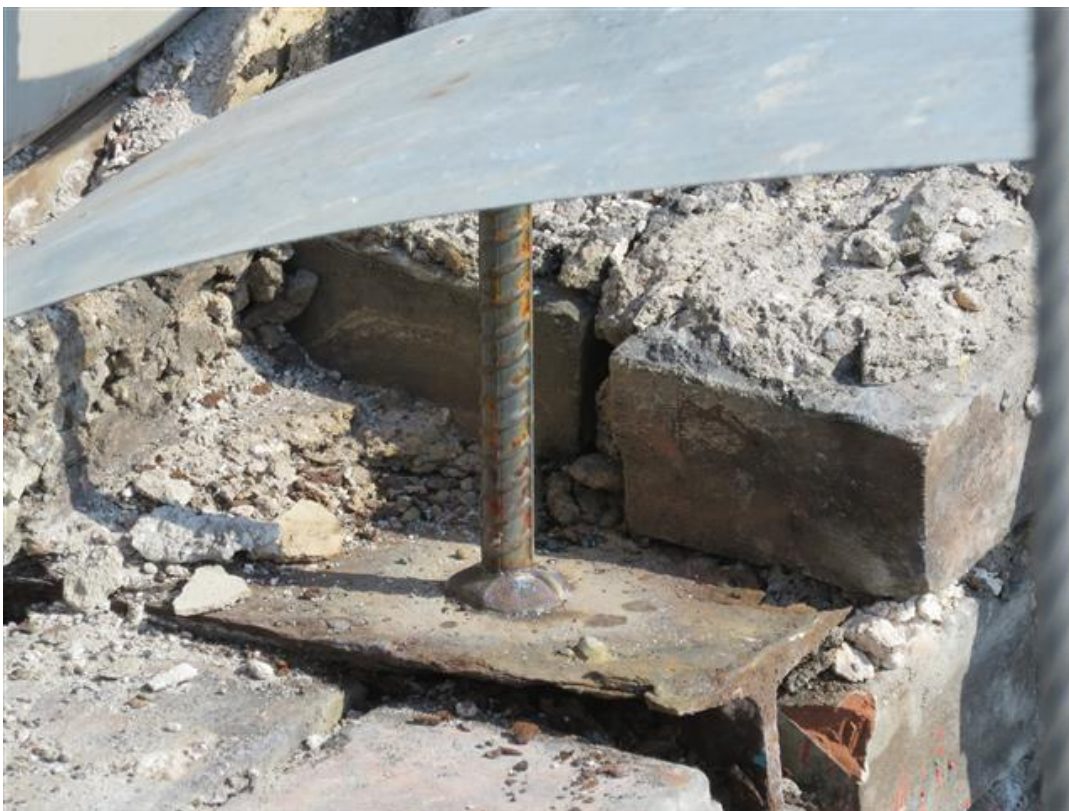
Photograph 4:

- d) Reinforcing bar had been welded onto the projecting roof support beam end along the north elevation where masonry demolition and rebuilding is scheduled to continue this week. Refer to Photograph 4.

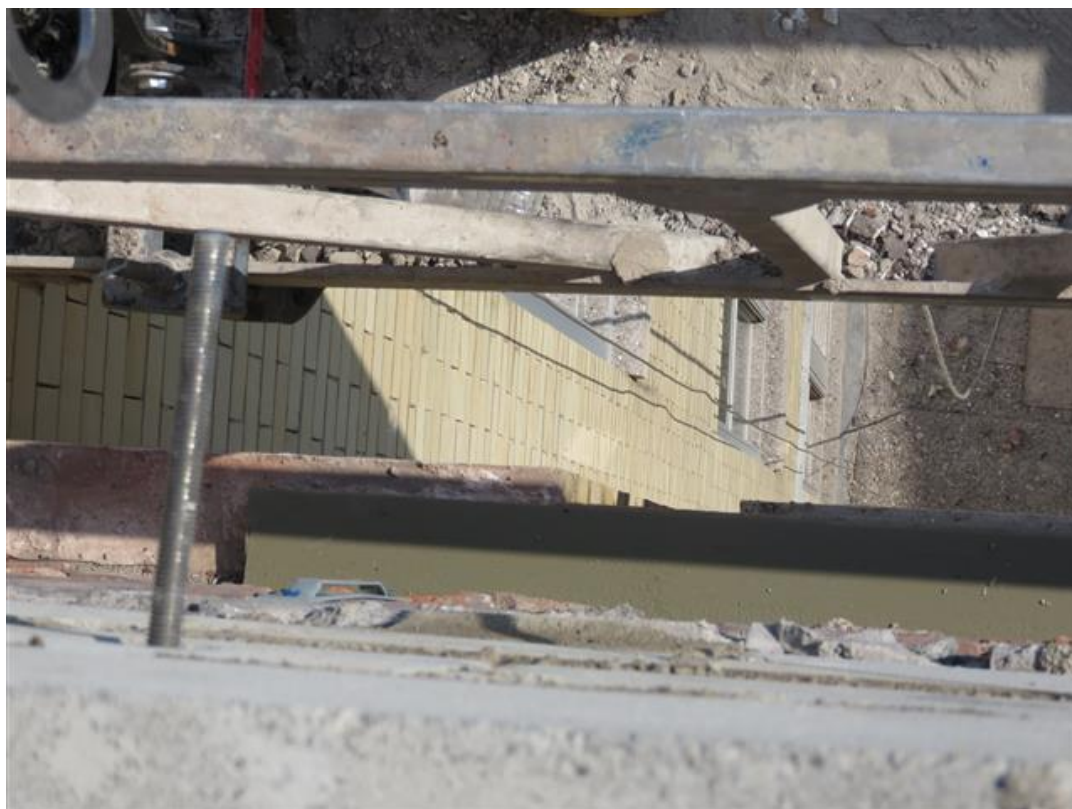
Photograph 5:

- e) A new steel window head lintel had been installed along the west elevation in preparation for the installation of the face brick. Refer to Photograph 5.

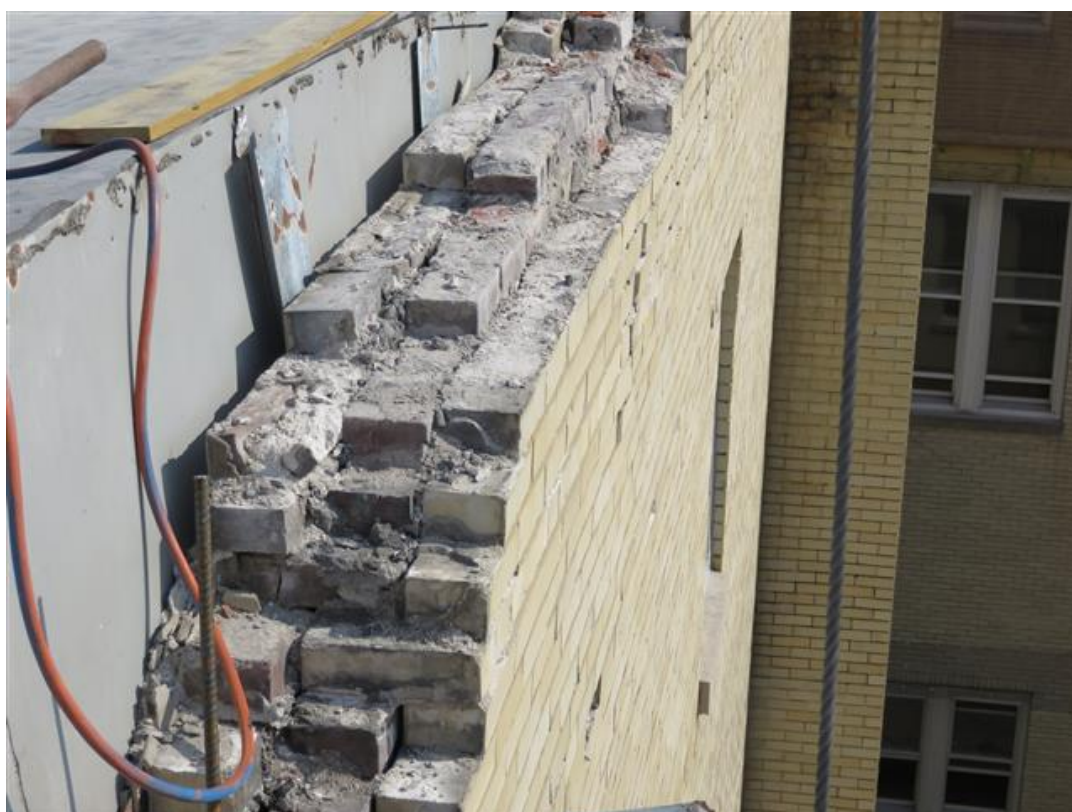
Photograph 6:

- f) A discussion regarding the parapet rebuild area included measurements to extend the rebuild to engage the 3rd projecting steel beam east of the northwest parapet intersection so the end CMU will engage a projecting welded vertical rebar. Refer to Photograph 6.

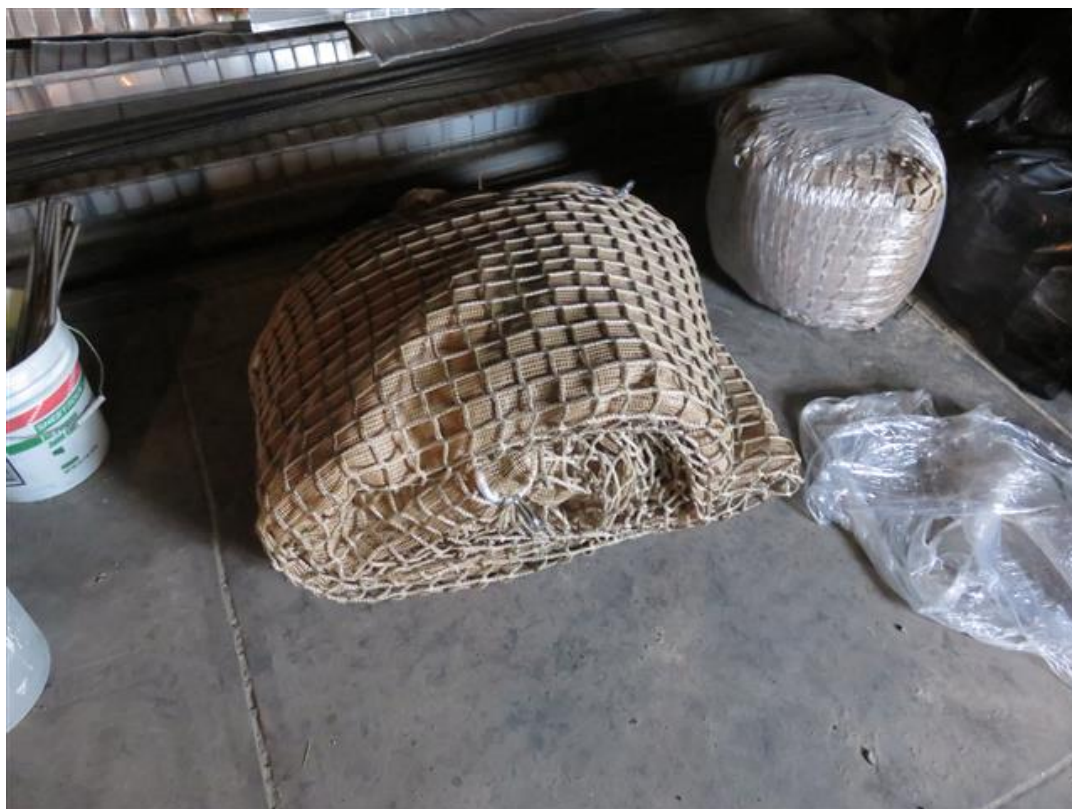
Photograph 7:

- g) Photograph of the structural netting prior to installation. Refer to Photograph 7.
- h) The rebuild parapet's heights were reduced to accommodate the netting securement requirements and lower the parapets to work with CMU coursing. The contractor will infill the parapet ends where projecting original masonry interfaced with the old parapet. Refer to Photograph 8.

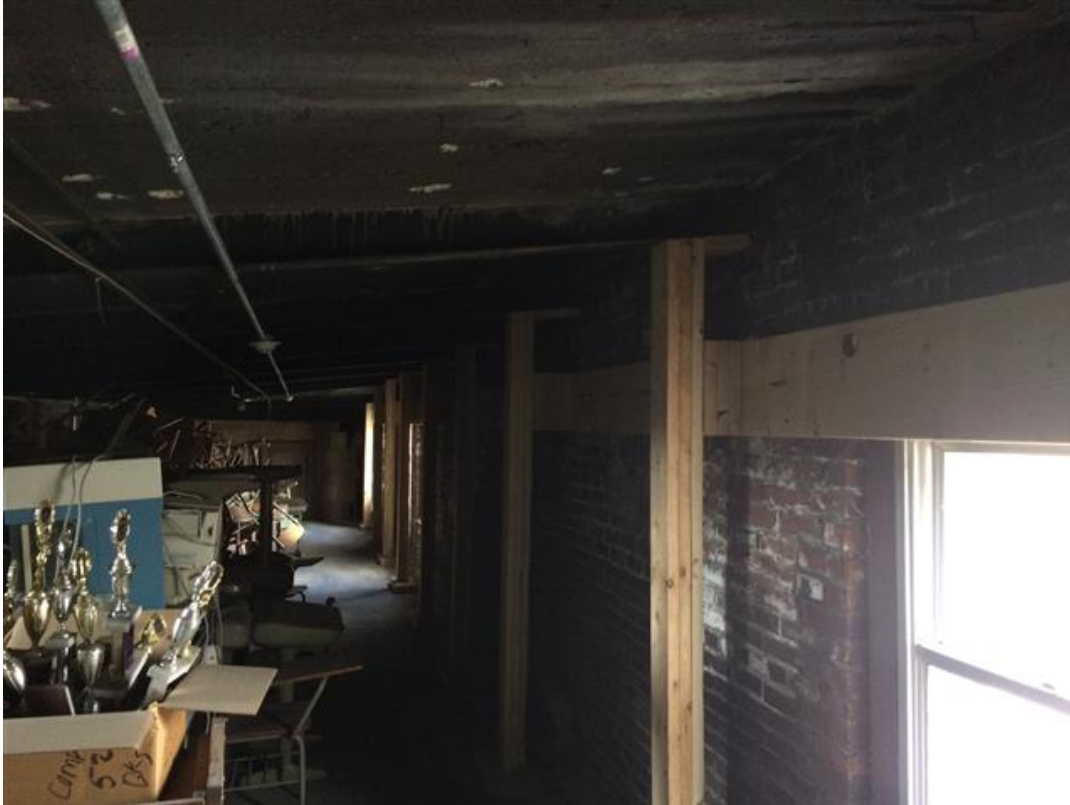
Photograph 1:

- a) Interior shoring posts located beneath roof slab support beams were in place. At most locations, the shoring posts were erected to interface with the attic window 2" X 12" interior bracing timber diaphragms. Refer to Photograph 1.

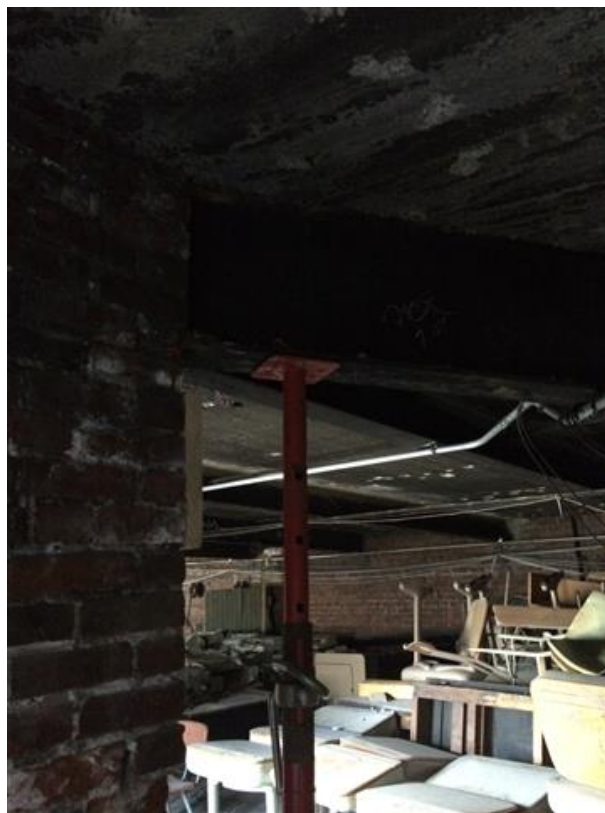
Photograph 2:

- b) At angled corner girders, steel shoring posts were added after extensive steel section loss was identified during exterior wythe brick demolition. This additional bracing was intended to augment loss of bearing surface noted during exterior demolition. Refer to Photograph 2.

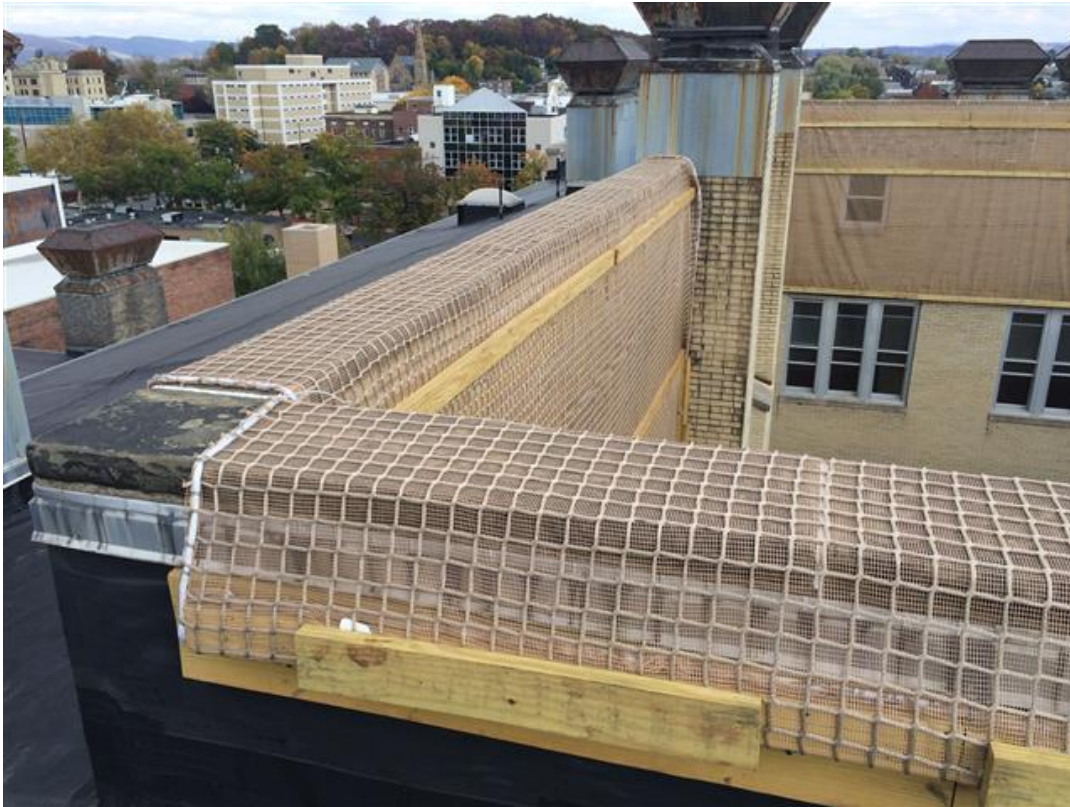
Photograph 3:

- c) Around the perimeter of the light well, 2" X 12" or 2" X 10" lumber was placed continuously and thru bolted at the existing or rebuilt masonry parapets. This diaphragm was compressed by placing thru bolts at 36" centers to brace the masonry assembly. Refer to Photograph 3.

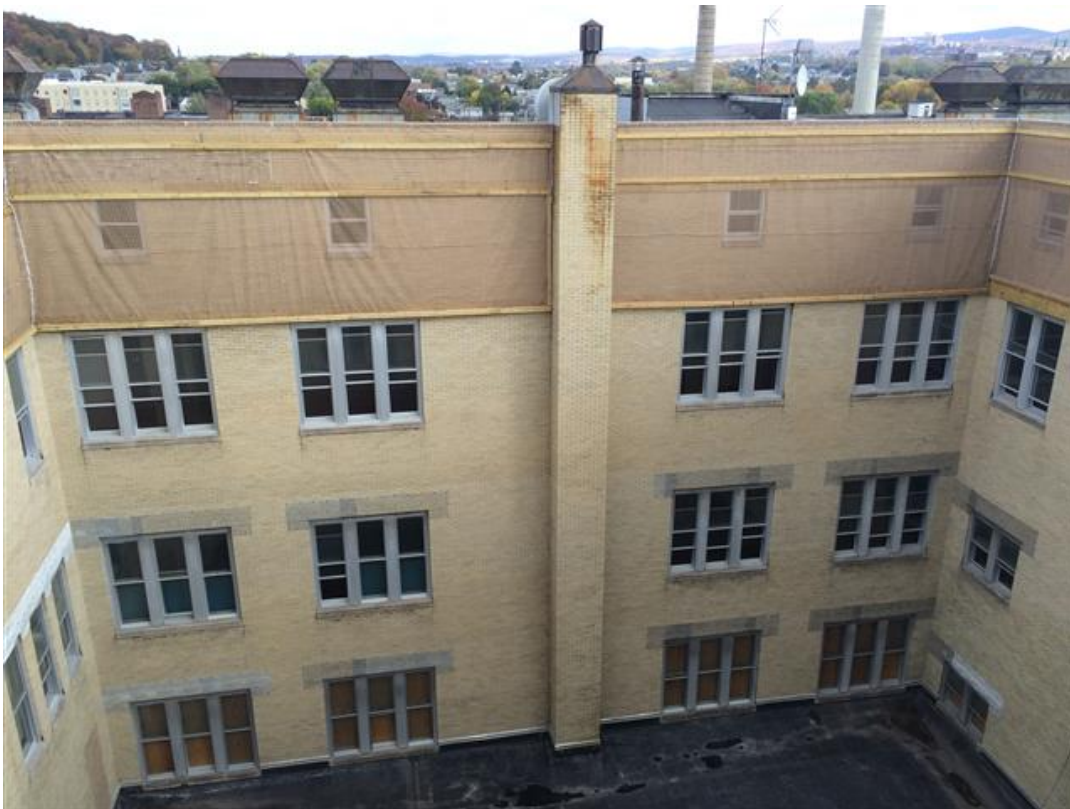
Photograph 4:

- d) At both the attic level window head and 4th floor window head elevations, continuous lumber diaphragms were installed and thru bolted to capture deteriorated and/or displaced masonry adjacent to steel lintel/girder assemblies built into the masonry walls to span the masonry openings. Refer to Photograph 4.

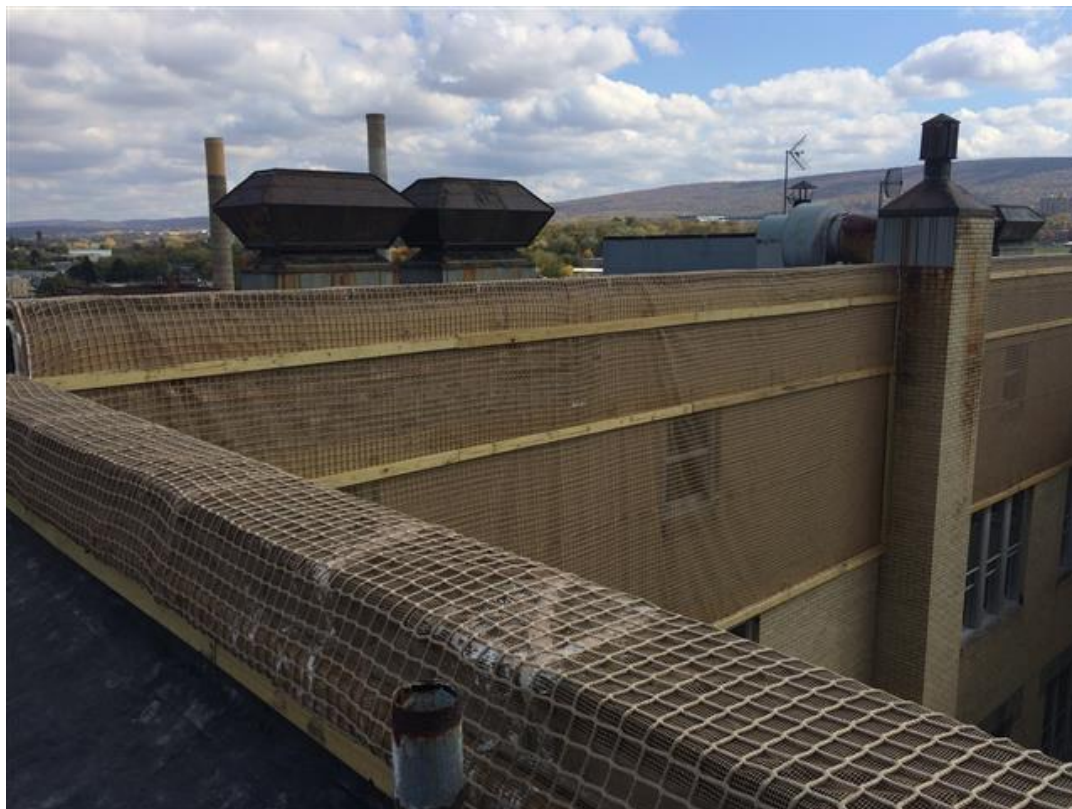
Photograph 5:

- e) Sections of the parapets intersecting north/west and south/east corners were demolished and rebuilt prior to installation of the timber compression diaphragms. Refer to Photograph 5.

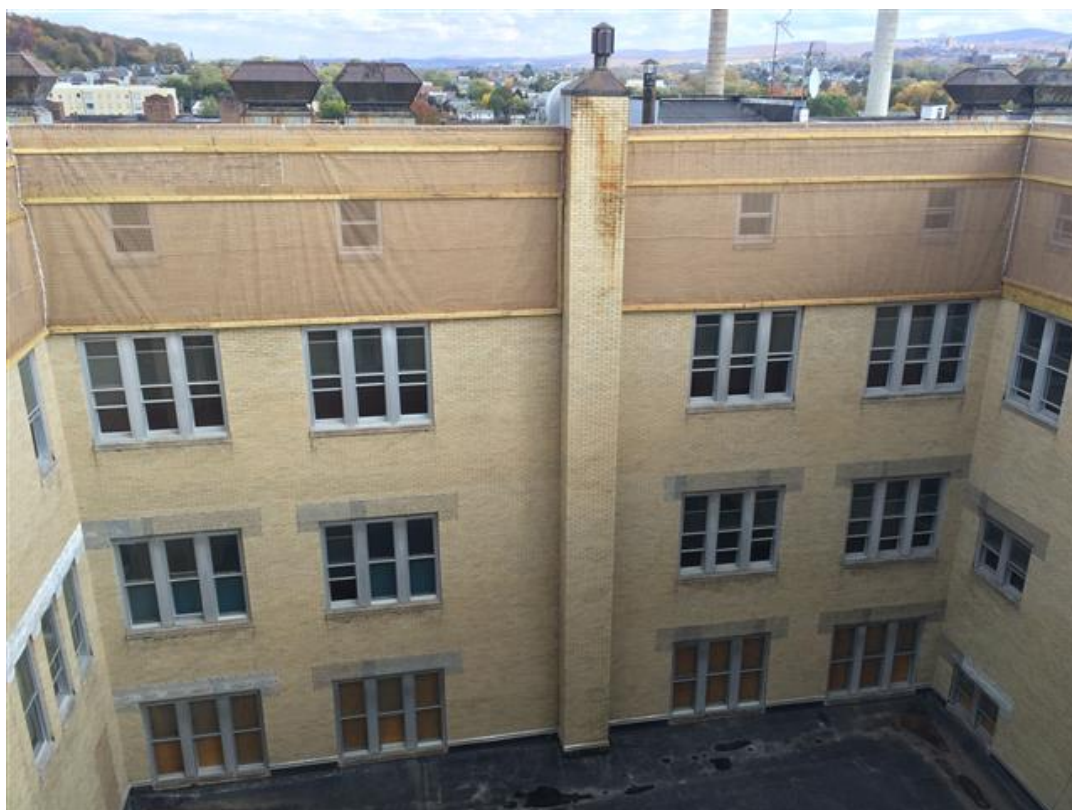
Photograph 6:

- f) After the parapets, attic and 4th floor window level diaphragms were installed, double level structural debris netting was attached. The netting was installed along the rear of the parapet and continued uninterrupted over the coping down to the 4th floor window heads. All netting was attached to the thru bolted timber diaphragms at three levels. Refer to Photograph 6.

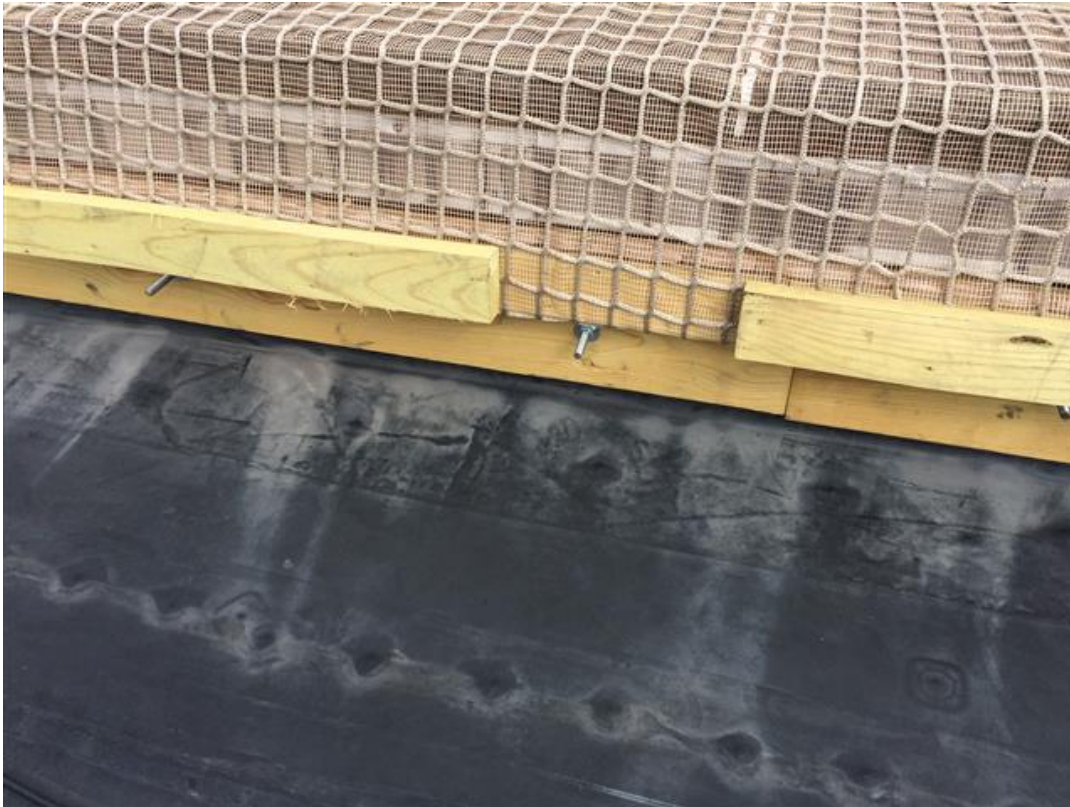
Photograph 7:

- g) The timber diaphragms were compressed using ½" diameter stainless steel all thread with washers and nuts located at the maximum spacing of 36" on center. Refer to Photograph 7.
