## WILKES-BARRE AREA SCHOOL DISTRICT STRUCTURAL EVALUATION OF JAMES M COUGHLIN HIGH SCHOOL

**Re: Structural Evaluation of Coughlin High School**

# Coughlin High School Structural Evaluation

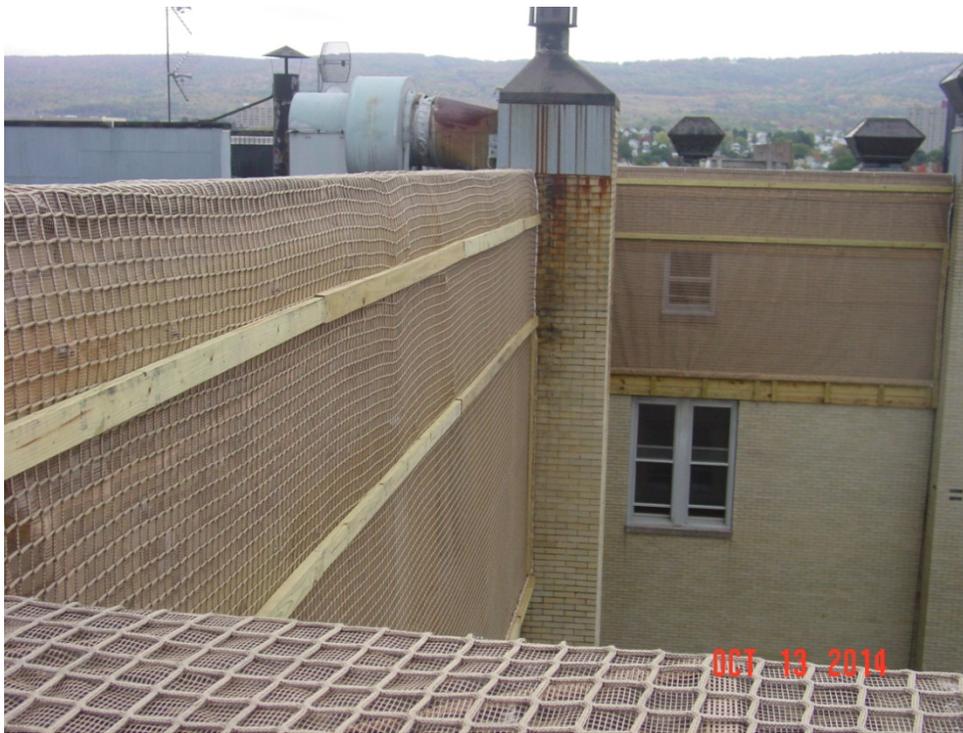
**View of completed containment netting installation.**

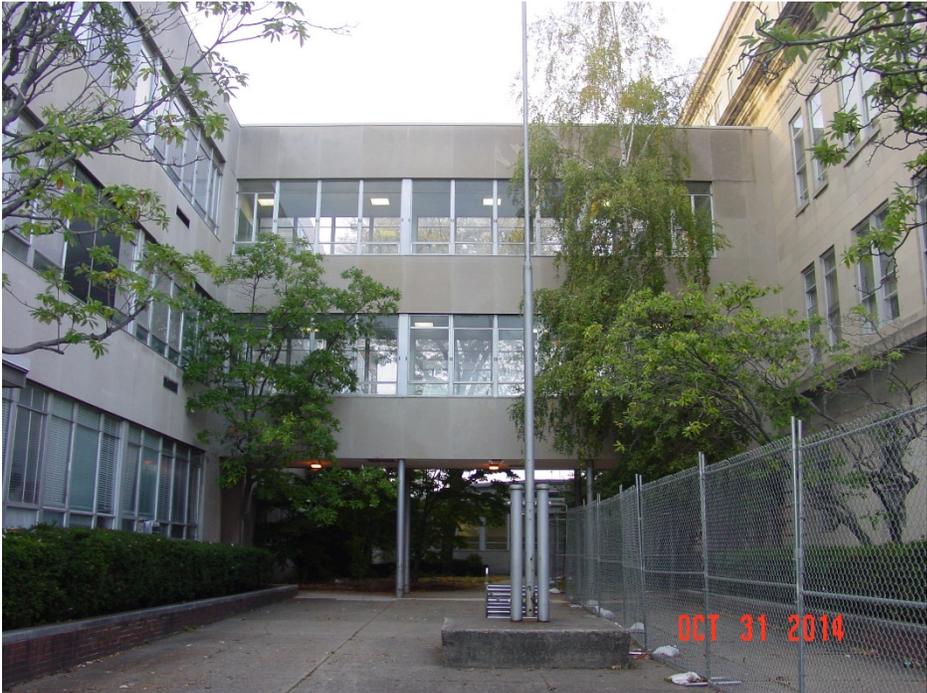
**Bridge Connecting Annex  
(left) to Original School  
(right)**

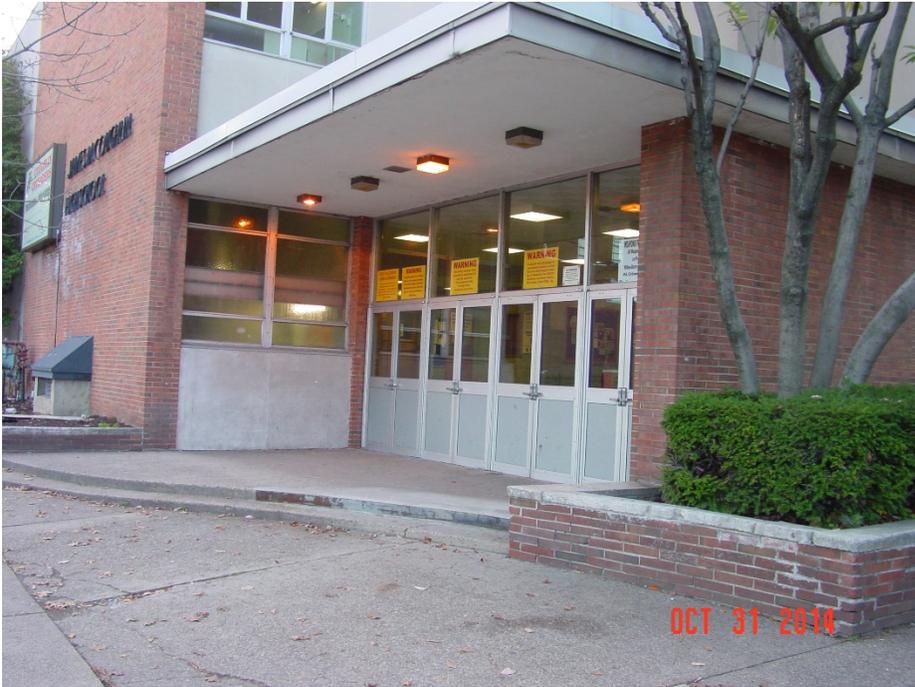
**Annex Main Entrance on  
Washington Street**

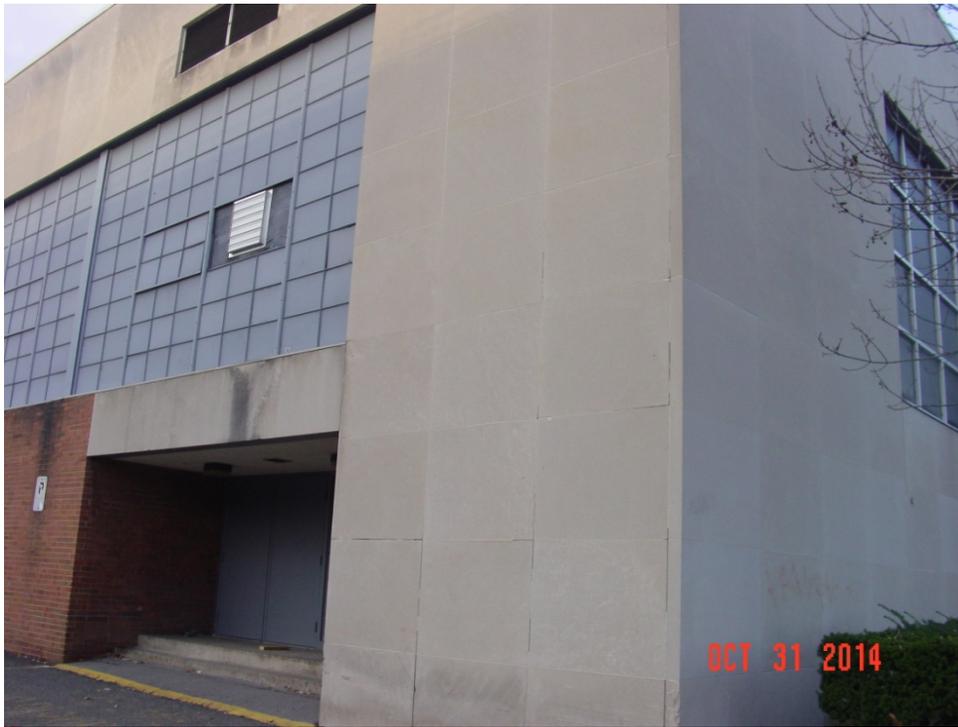
**Southeast corner of Annex (Gymnasium). Note the loss of mortar is numerous stone panel joints.**

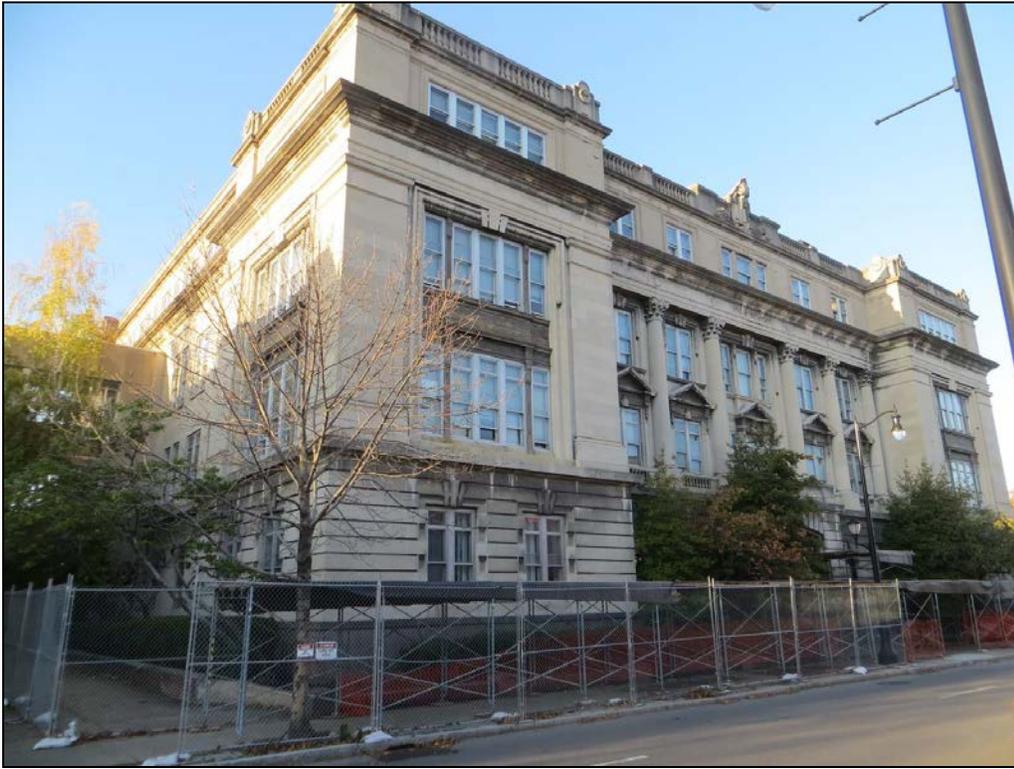
**Photograph 1:**  
Overview of the east (front) elevation of the building. Note the fencing and overhead protection in place.

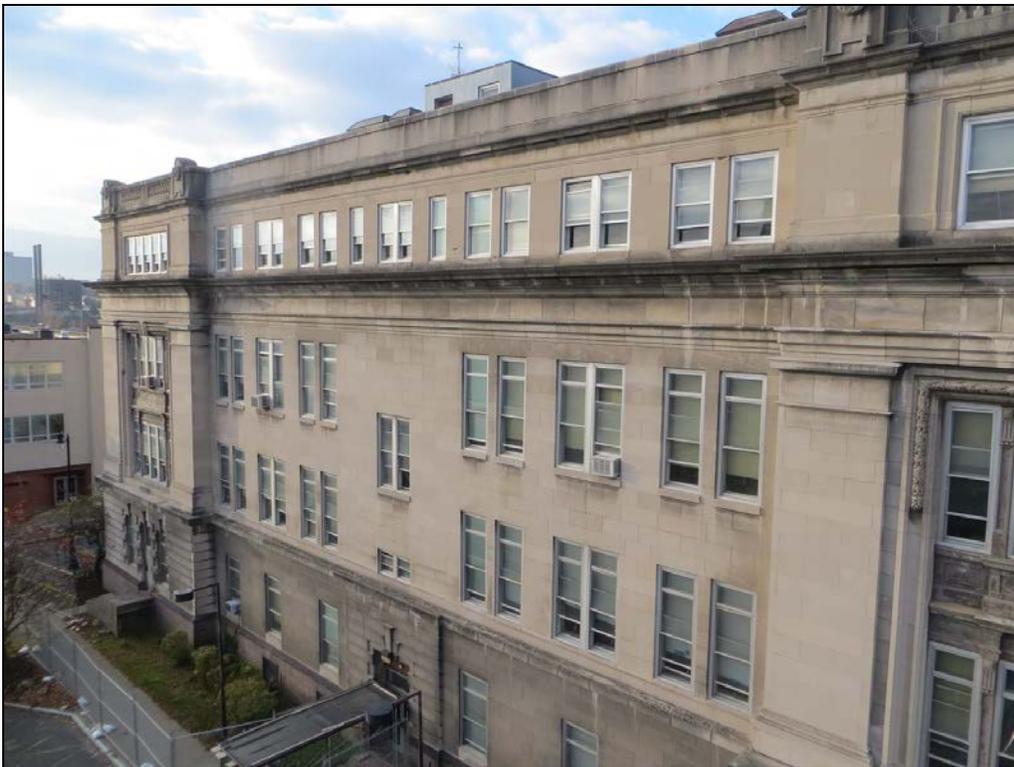
**Photograph 2:**  
Overview of the north (side) elevation of the building.

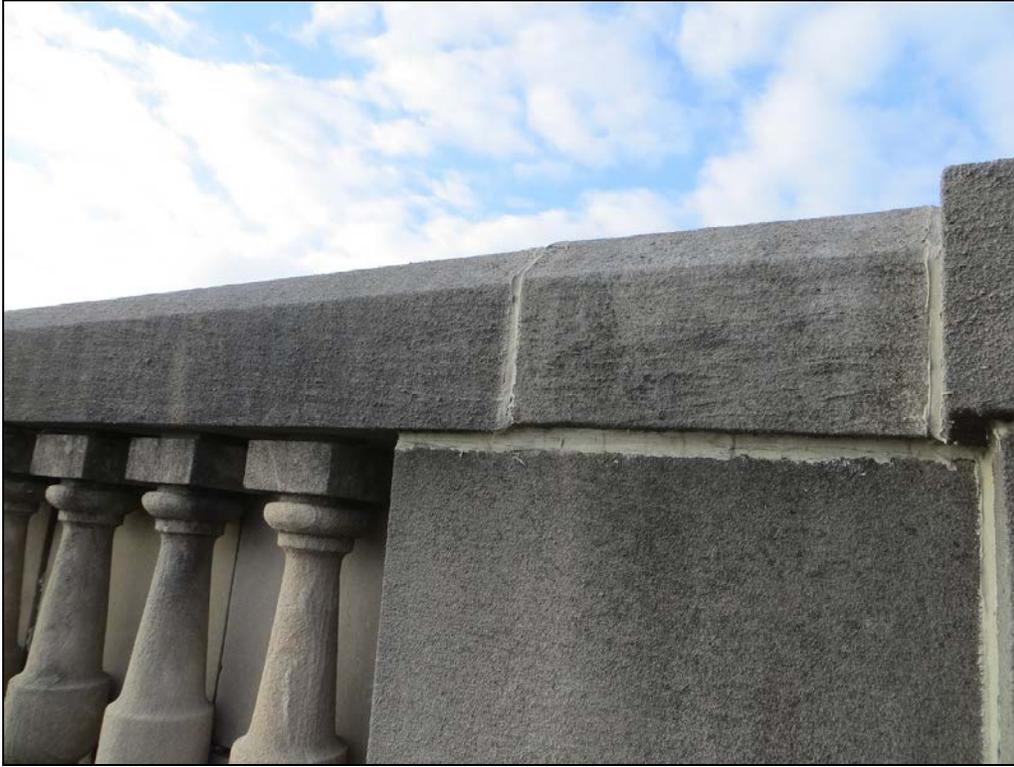
**Photograph 13:**

There was no evidence of flashing below the copings. Without proper flashing, large quantities of bulk rain water can enter the wall assembly.

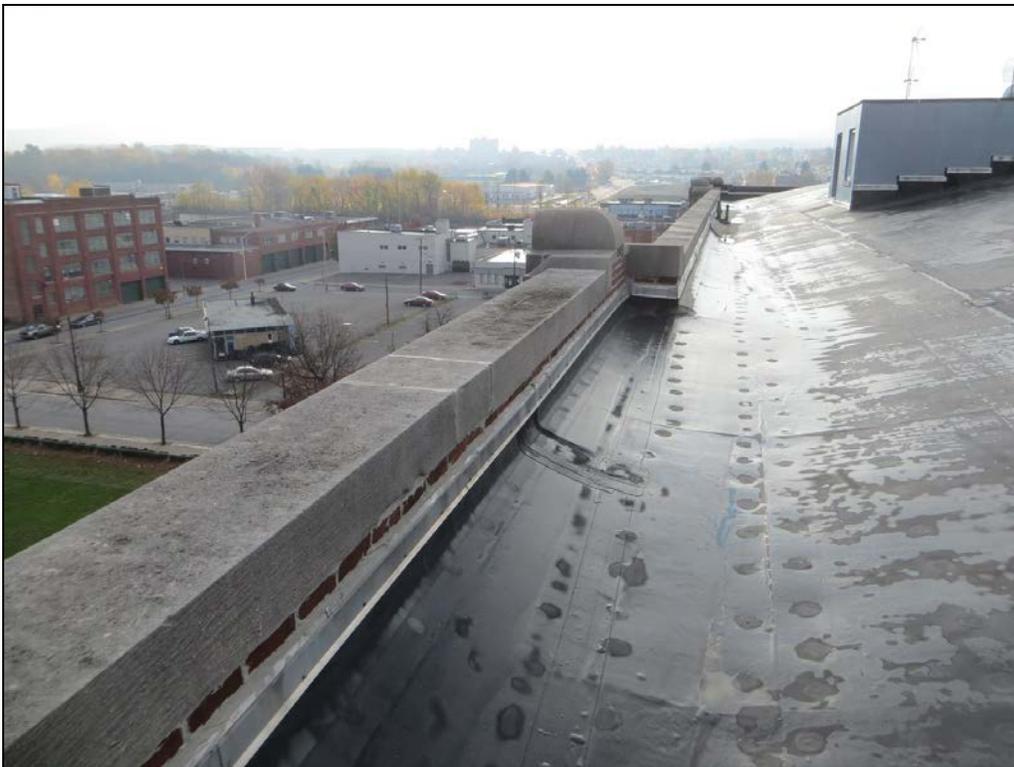
**Photograph 14:**

The roof counterflashing on the rear elevation of the parapet extends into the masonry less than one inch.

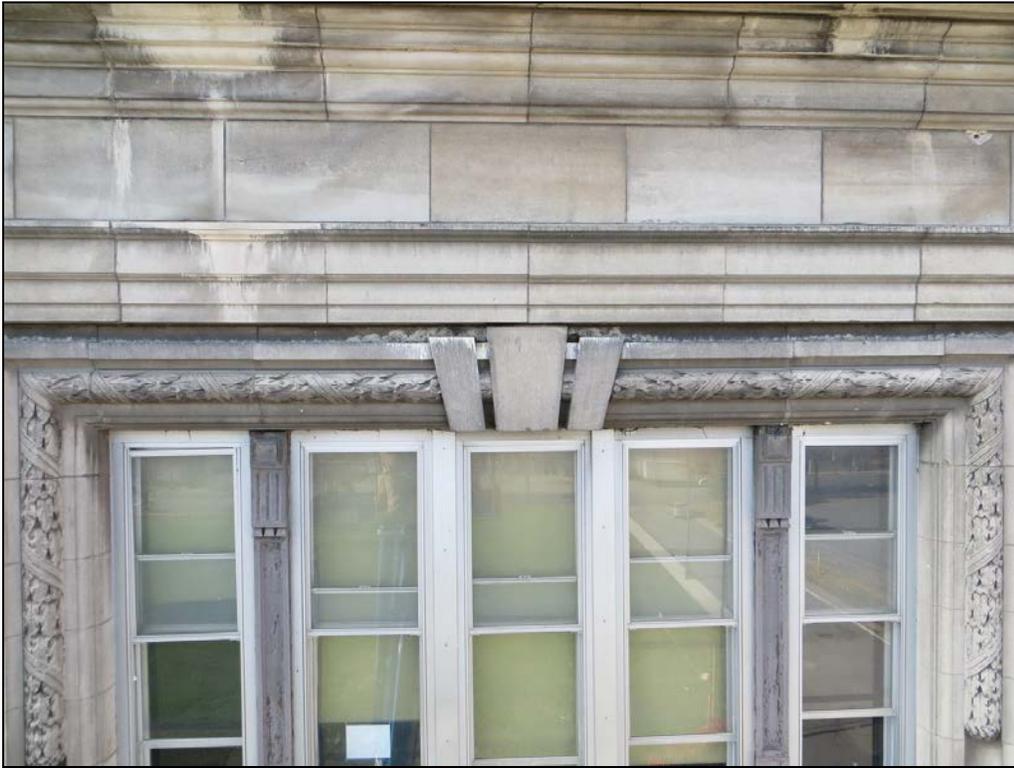
**Photograph 21:** All of the stone at the window heads was supported by a steel member, even the massive pieces above the large window openings at the ends of each elevation.

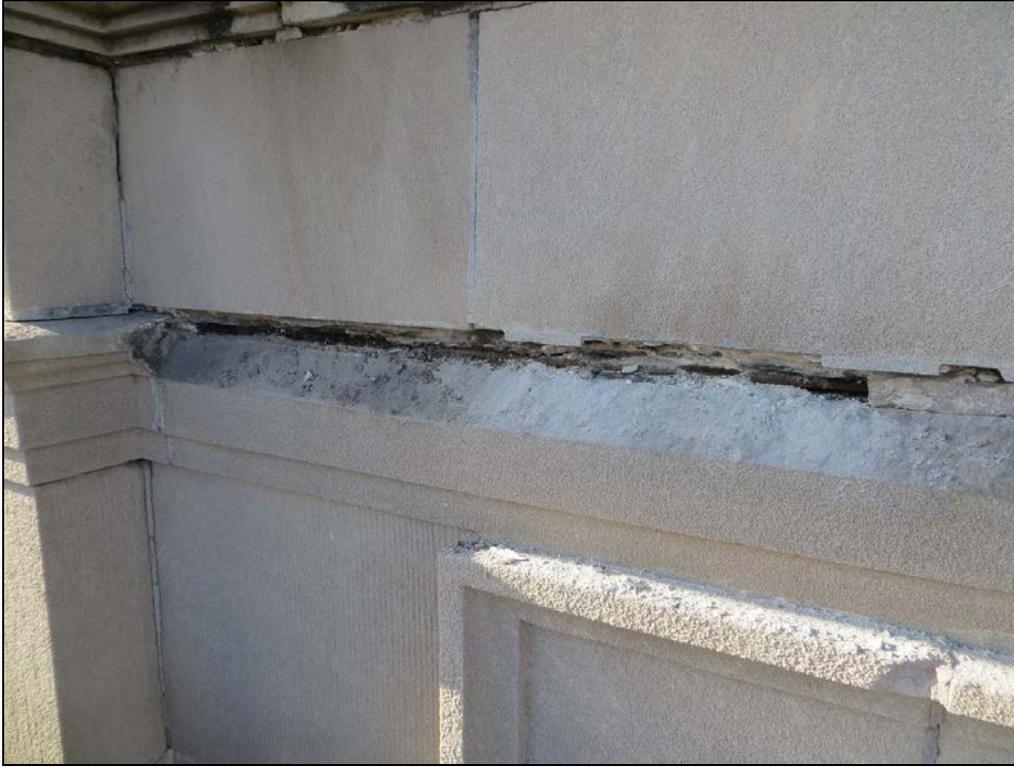
**Photograph 29:**  
The entire molding piece was removed by hand without the use of any tools.

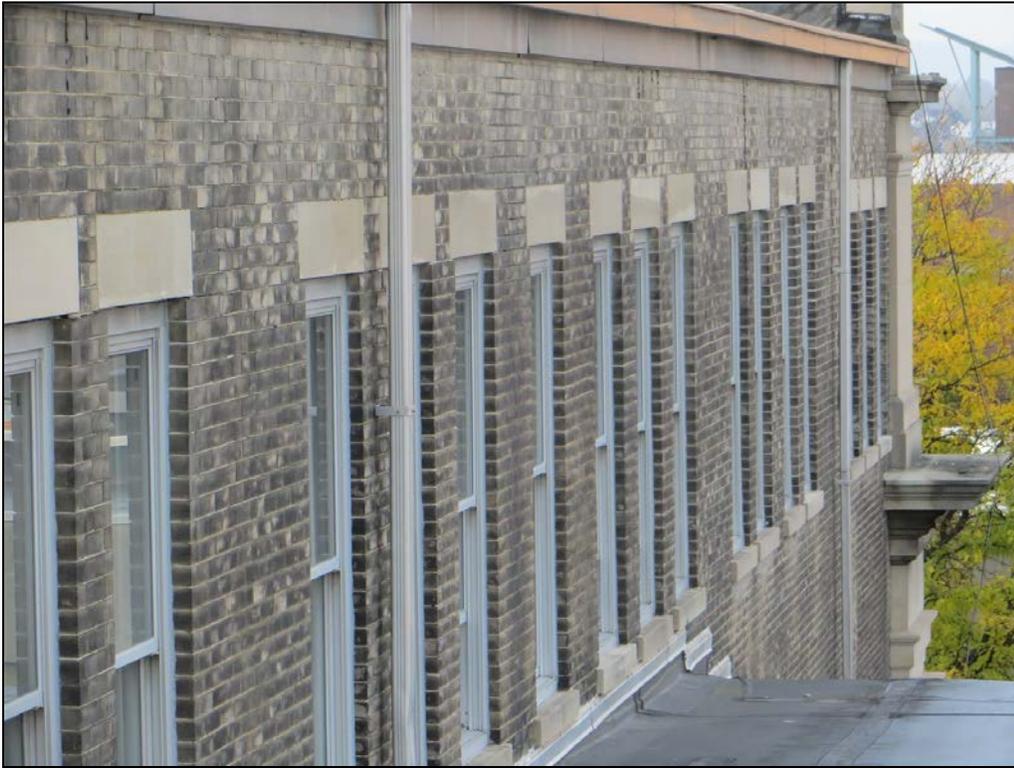
**Photograph 31:**  
View of the rear elevation of the building. Note the stone lintels over the window openings.

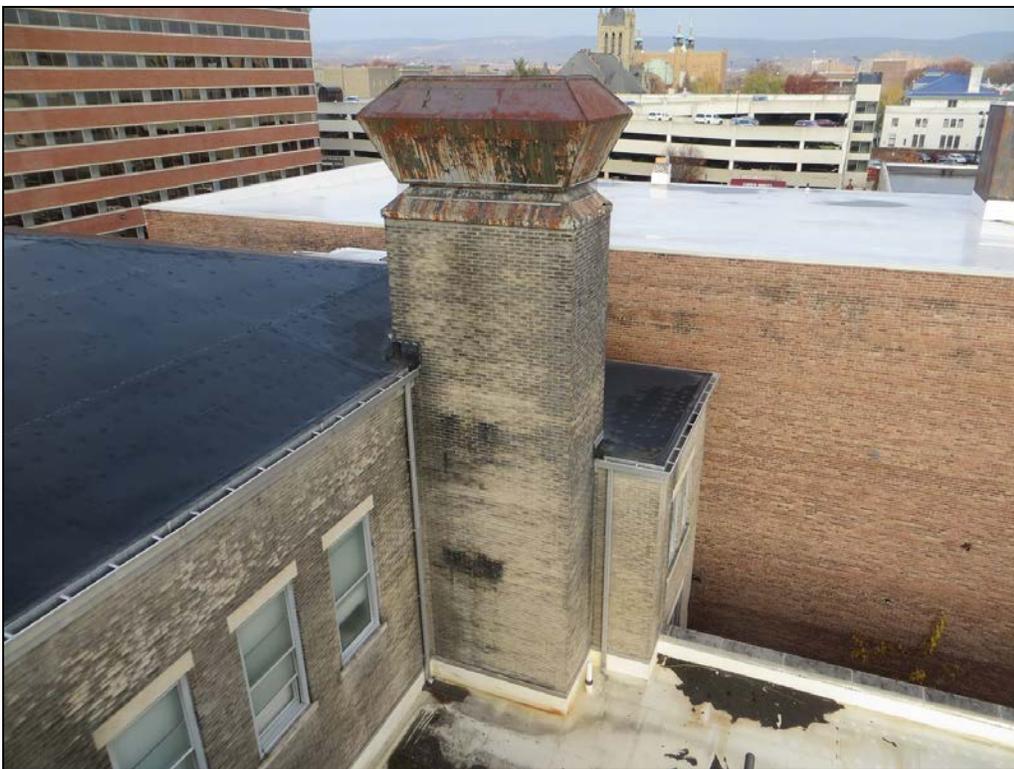
**Photograph 32:**  
View of a one of the chimneys on a lower level at the rear of the building.

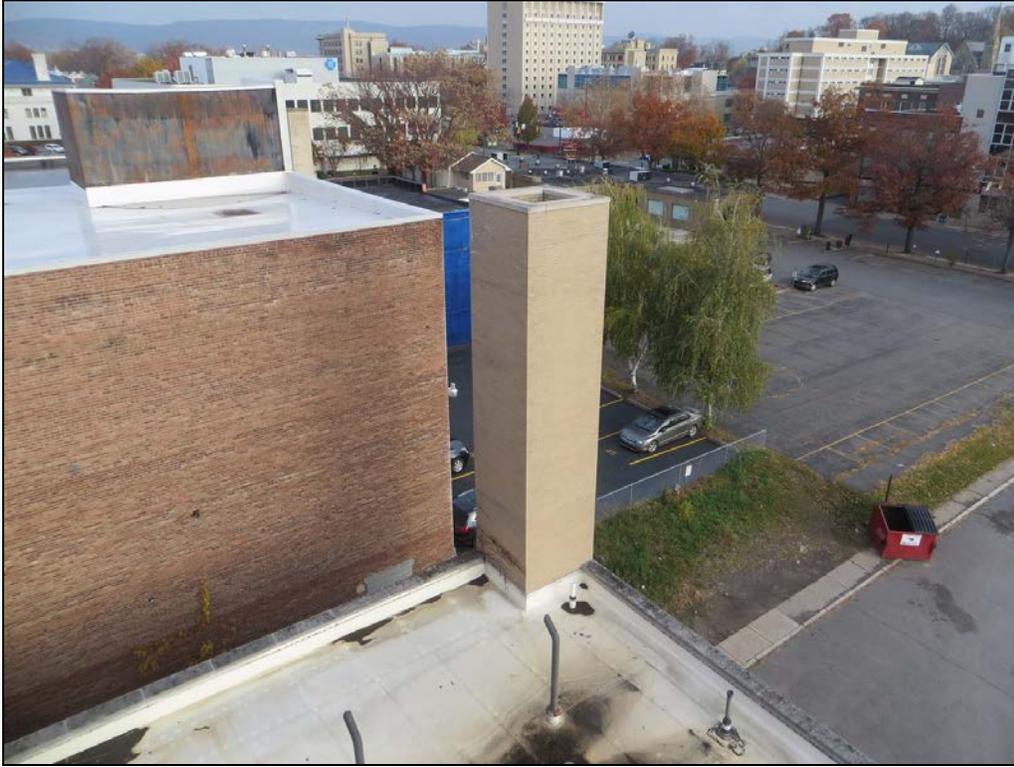
**Photograph 33:**  
Chimney at an addition to the building.

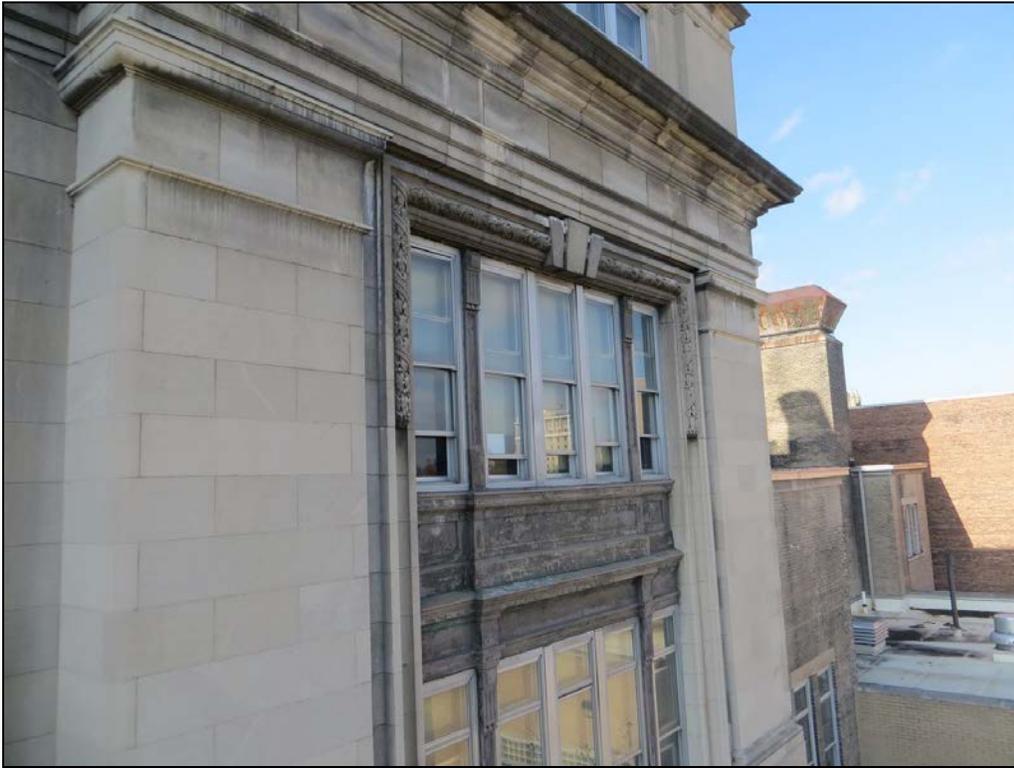
**Photograph 43:**  
Copper sheet metal over wood framing was used at the large windows at the end of each elevation.

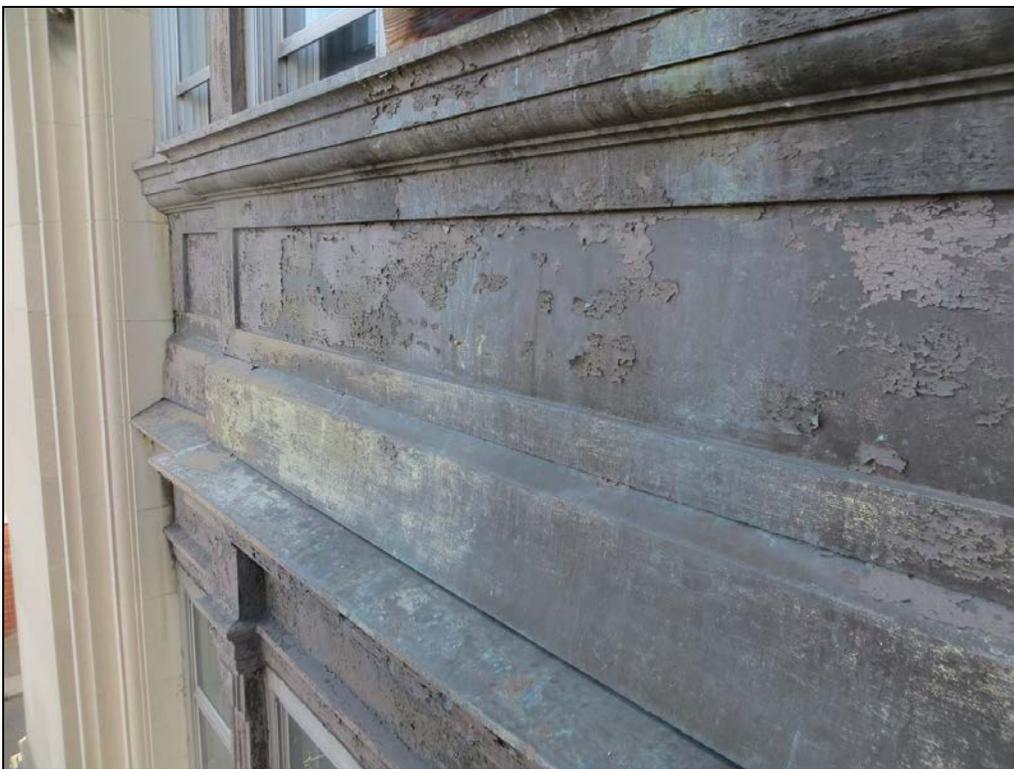
**Photograph 44:**  
The copper sheet metal was painted. The paint is now peeling at most locations.

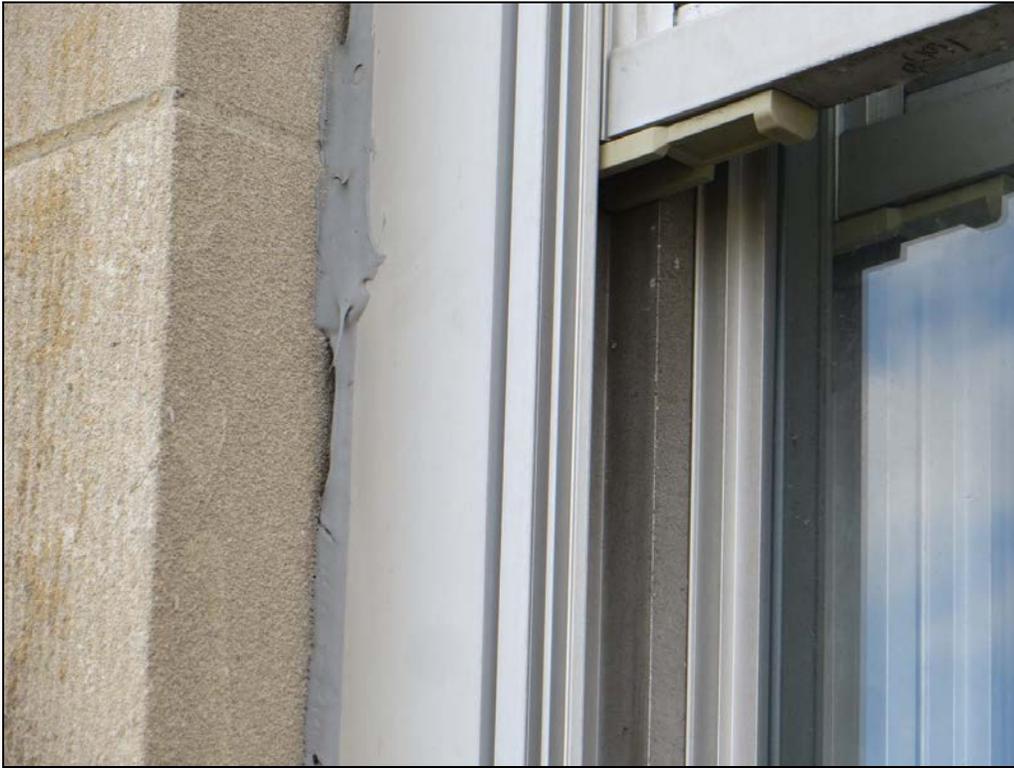
**Photograph 47:**  
Poorly installed sealant has lost adhesion to the stone.

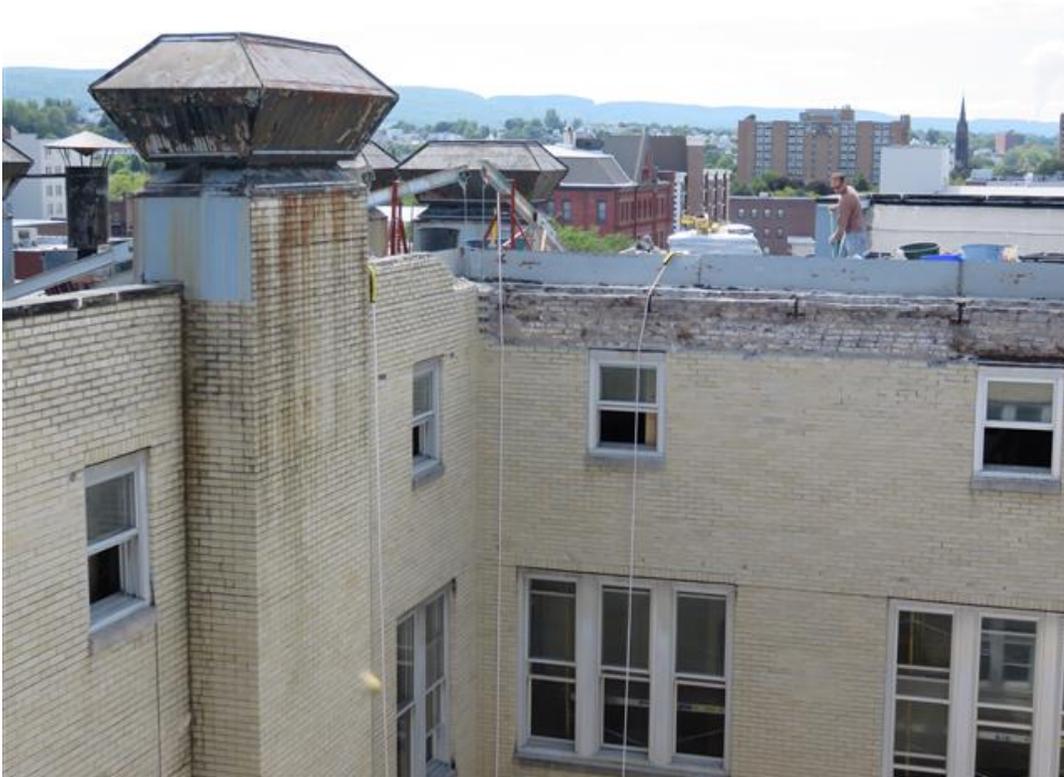
**Photograph 1:**

- MPS was on-site to review masonry stabilization, demolition and containment efforts underway.
- a) Brick parapet demolition had started along the south and intersecting east parapets. Reportedly, only hand tools were required to remove the brick masonry components. Refer to Photograph 1.

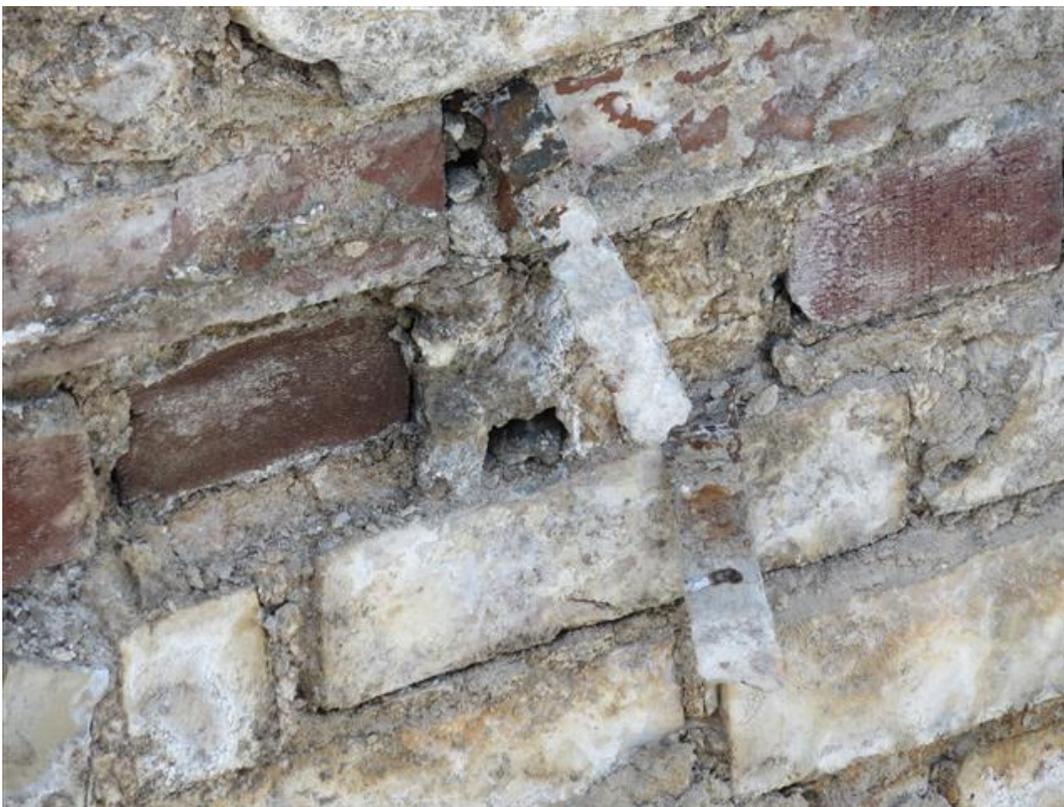
**Photograph 2:**

- b) A majority of the masonry brick ties were consumed by rust. Refer to Photograph 2.
- c) The attic level window relief angle exhibited advanced oxide jacking and/or was consumed by rust contributing to vertical displacement of the parapet’s outer wythe of brick. Refer to Photograph 3.

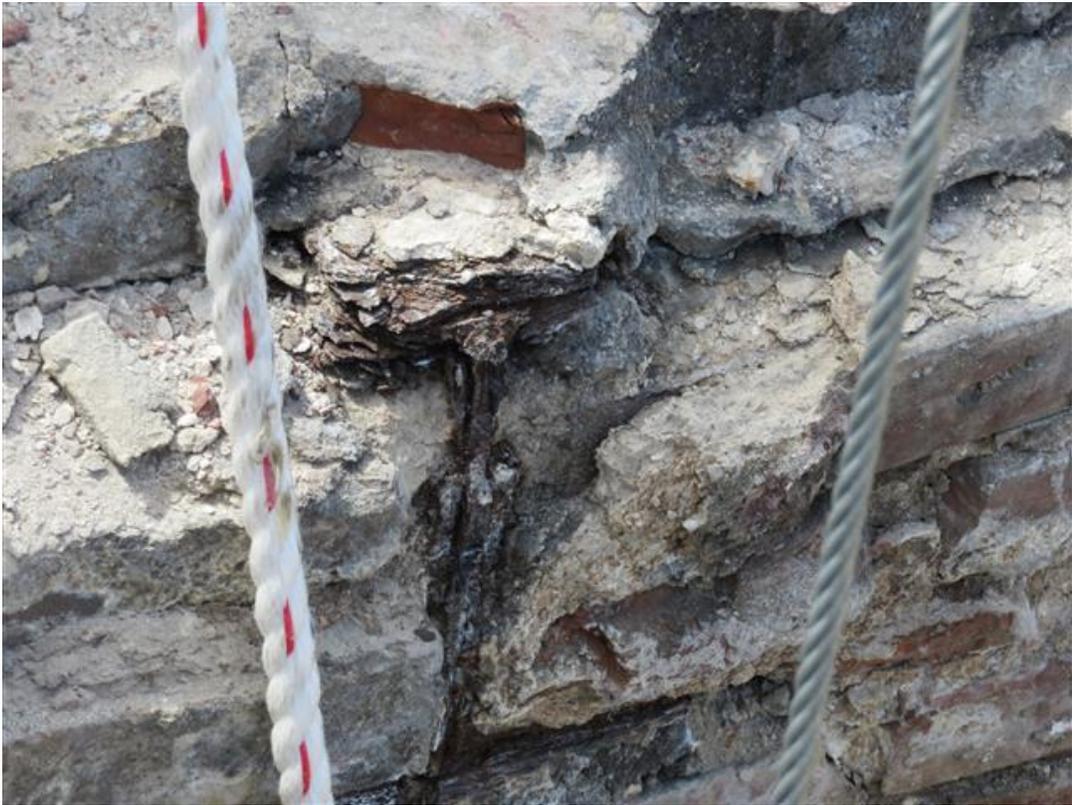
**Photograph 4:**

- d) The 7” X 3 5/8” roof slab support beam end exhibited complete section loss at its interface with the parapet’s outer brick wythe. The corroded section (beam flange) measured in excess of 2½” which is approximately 7 times its original thickness of 3/8”. This expansion displaced the parapet masonry both vertically and horizontally. Refer to Photograph 4.

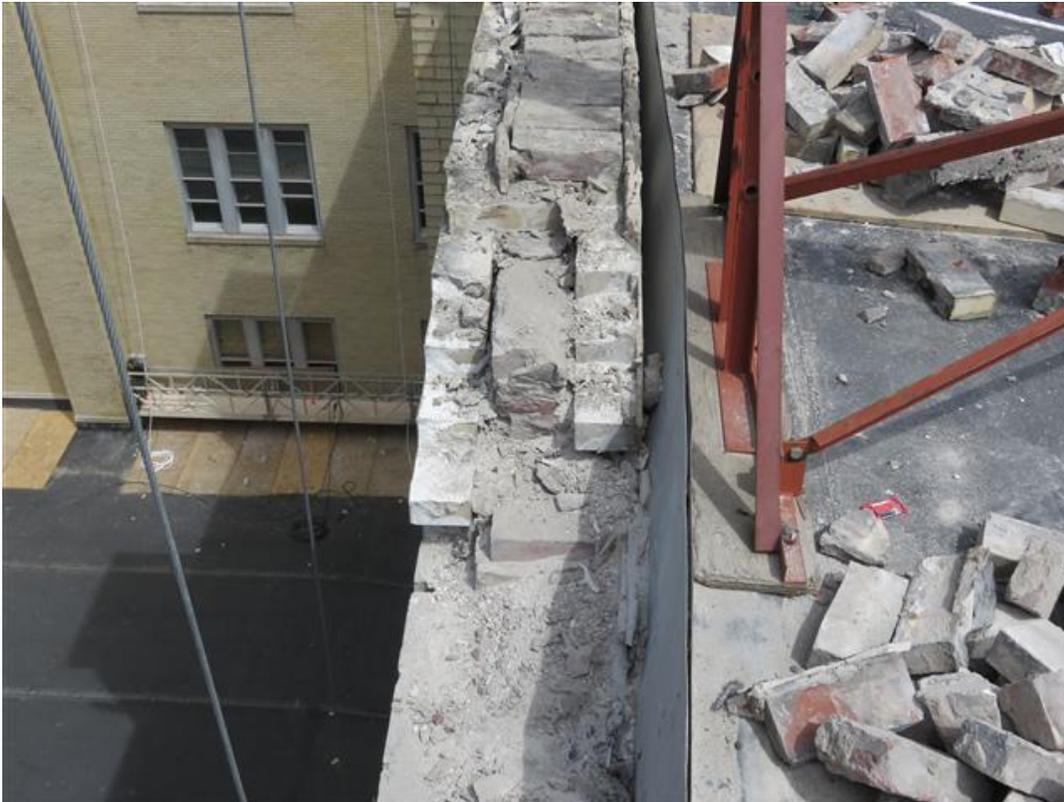
**Photograph 5:**

- e) The original parapet coursing included headers from both the exterior and interior wythes directly below the coping, along with additional interior headers below. Refer to Photograph 5.

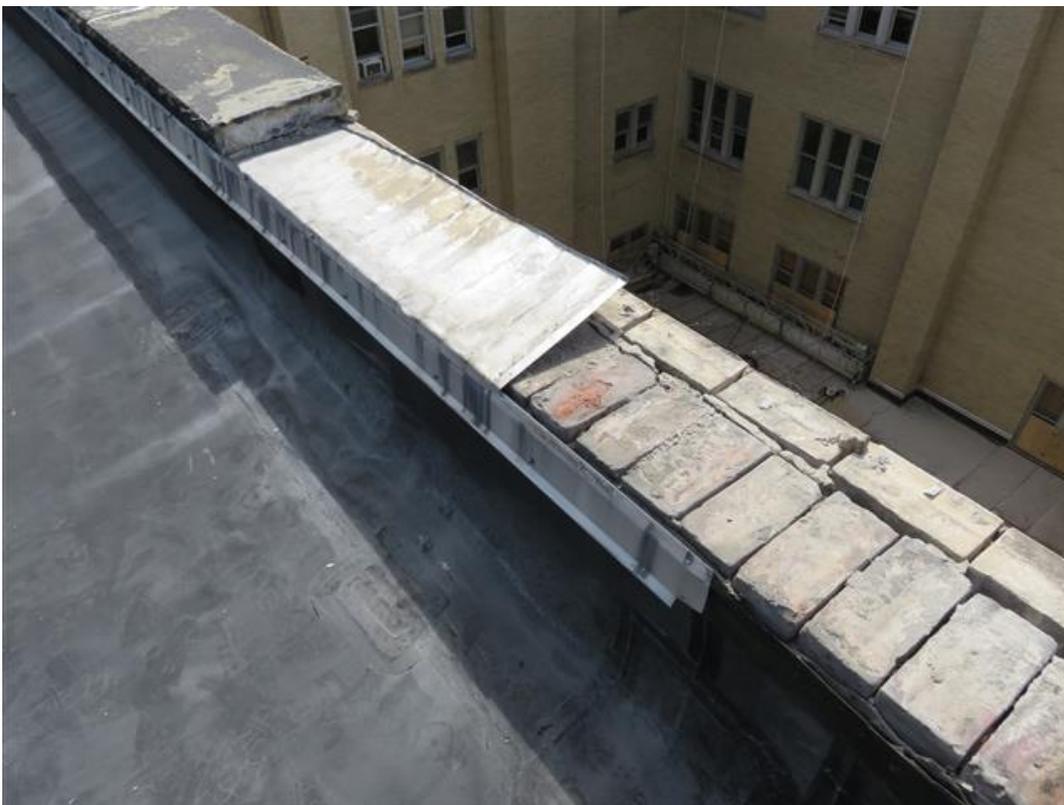
**Photograph 6:**

- f) The coping stones were removed along the north and intersecting west parapets. Remedial flashing and interior counterflashing was observed. Refer to Photograph 6.

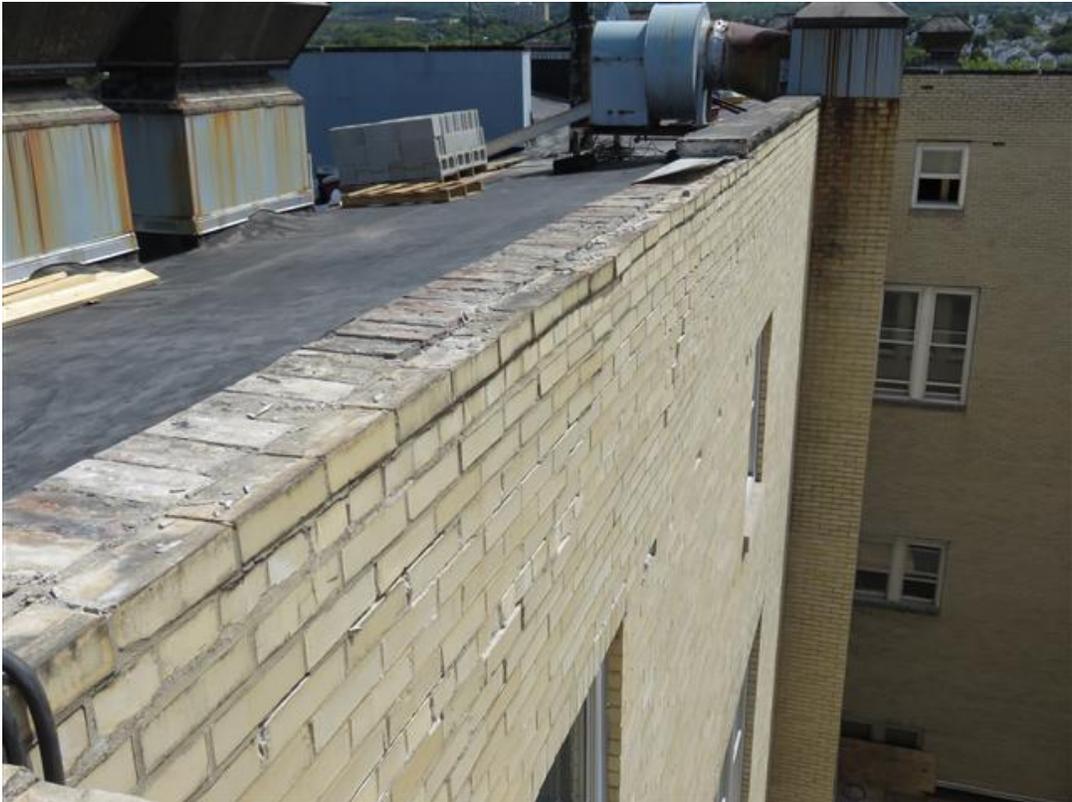
**Photograph 7:**

- g) Again, as observed on the southeast corner, the northwest corner parapet is unbonded, vertically and horizontally displaced and can be removed by hand. This indicates complete loss of mortar/cementitious bond which is required for masonry assemblies to act as a monolithic wall. Refer to Photograph 7.

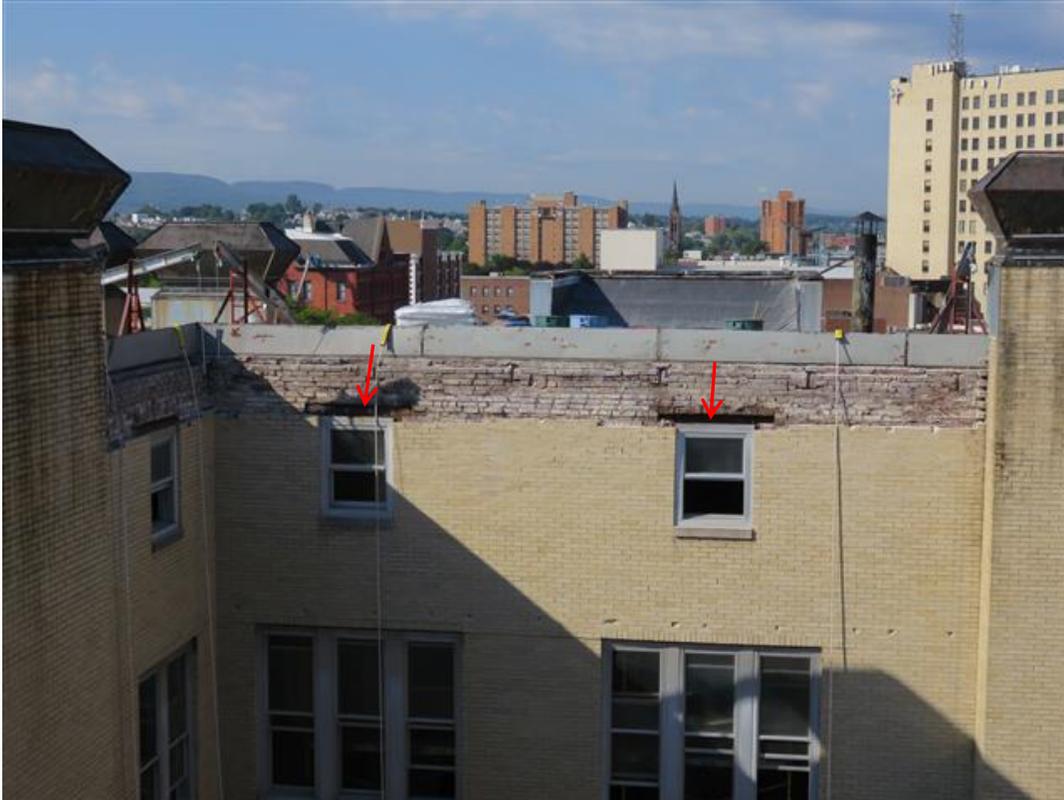
**Photograph 1:**

- a) Portions of the steel channel/lintel attic floor window head support steel were removed during demolition. Refer to Photograph 1.
  - b) The relief angles had lost significant original section and in some cases, were completely consumed by corrosion. Refer to Photograph 2.

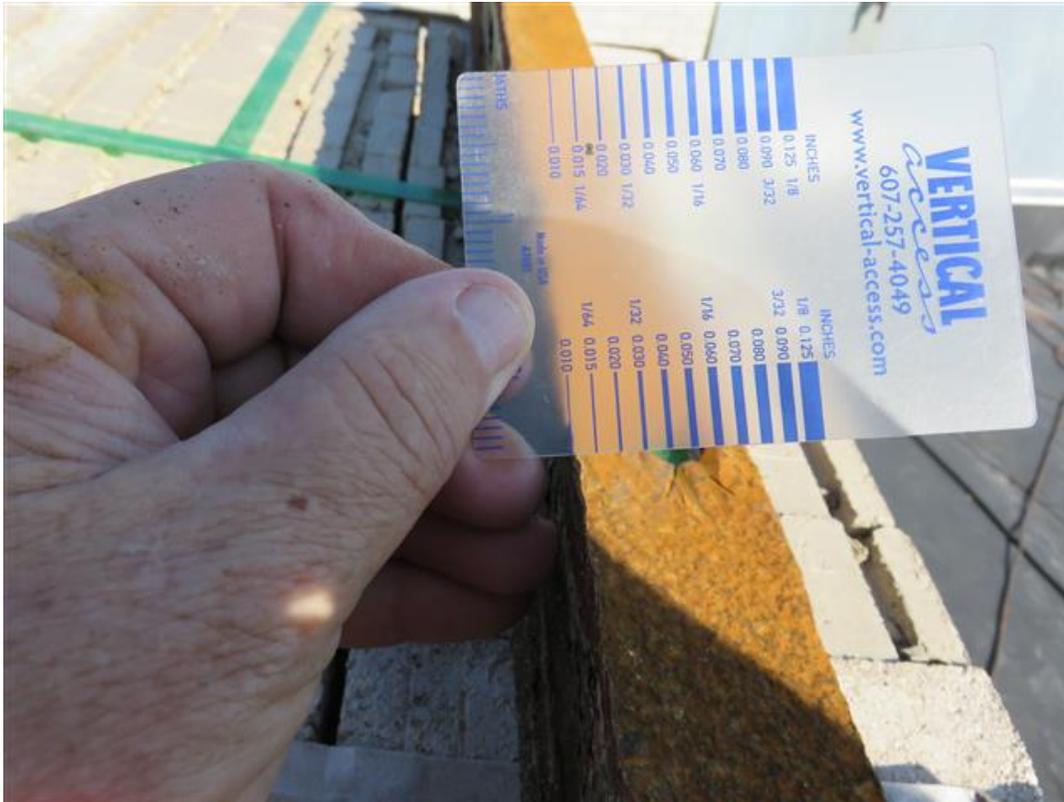
**Photograph 3:**

- c) Portions of the angle’s horizontal leg exhibited complete section loss (a phenomenon known as knifing). Refer to Photograph 3.
  - d) Overview of the area reviewed via swing stage including floors 2, 3, 4 and attic. Refer to Photograph 4.

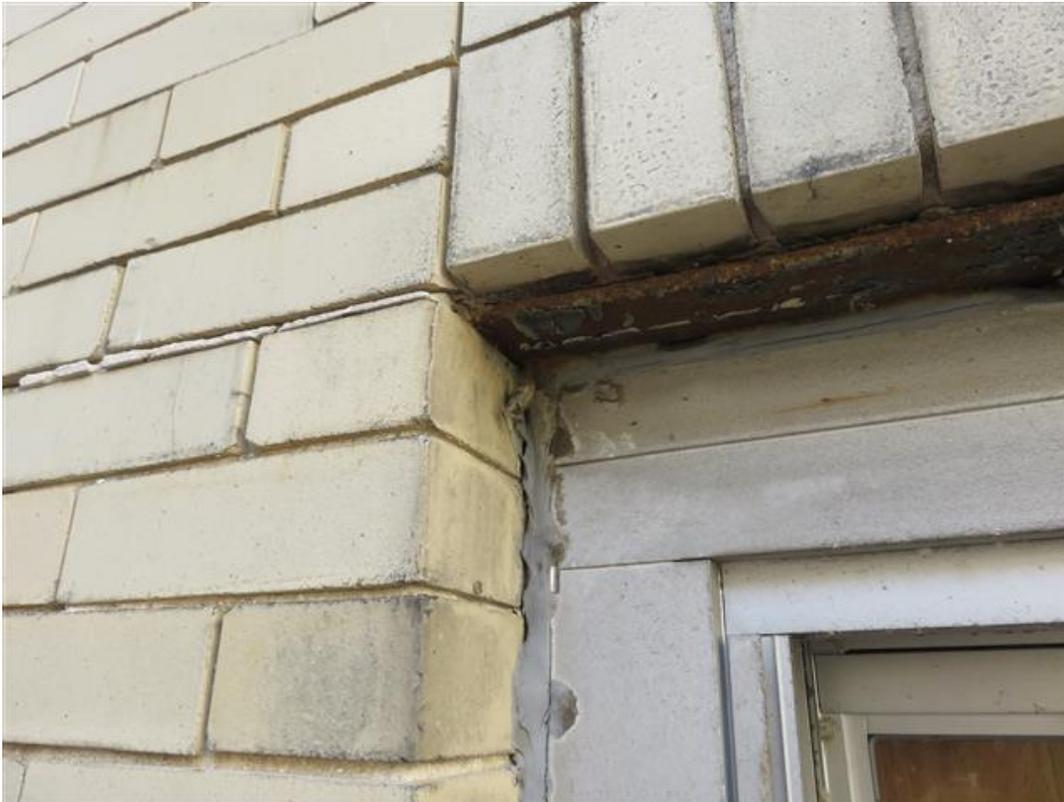
**Photograph 5:**

- e) The 2<sup>nd</sup> floor window head exhibited corrosion build-up (oxide jacking) above the window head relief angle and compressive displacement of masonry above and below the lintel at bearing areas. Refer to Photograph 5.

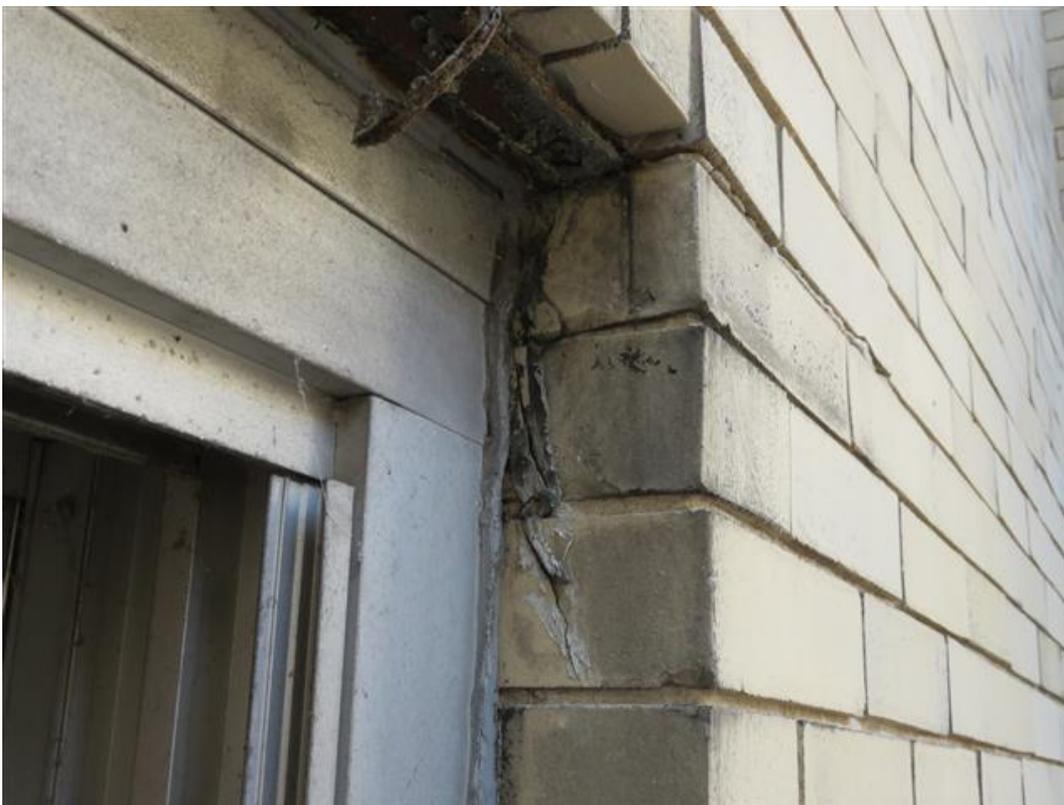
**Photograph 6:**

- f) More severe oxide jacking was noted at the 3<sup>rd</sup> floor window head including crushing of jamb brick beneath the lintel’s bearing area. Refer to Photograph 6.

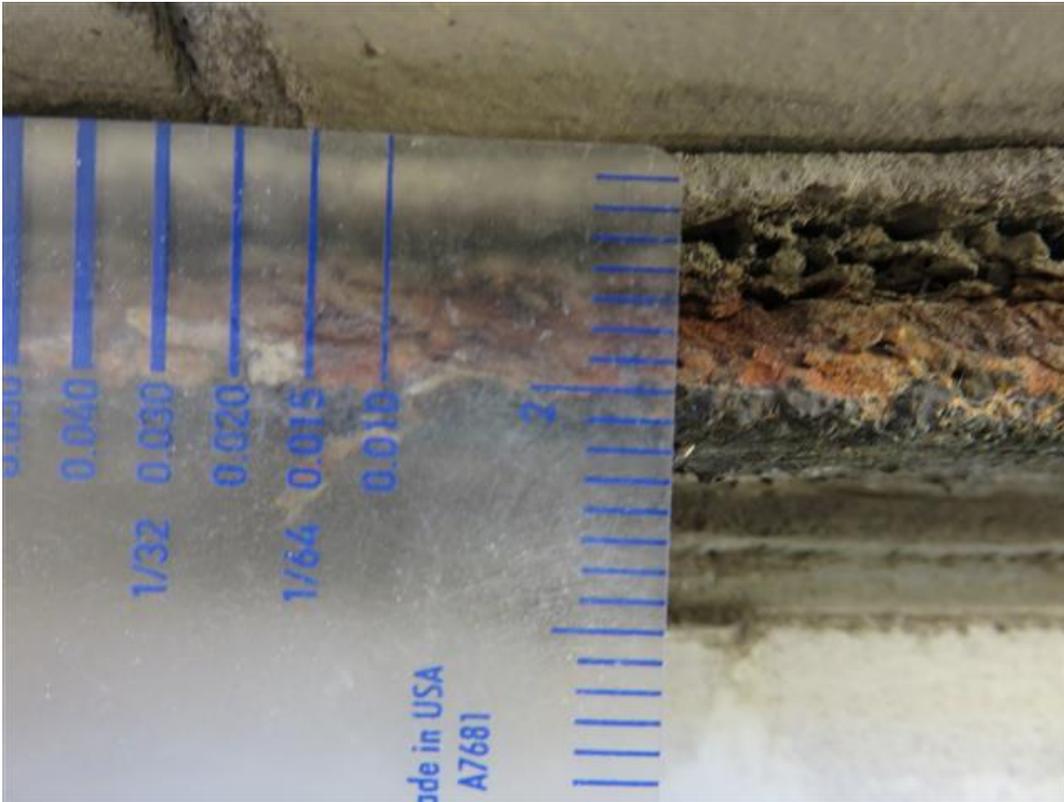
**Photograph 7:**

- g) Corrosion build-up exceeding ½” was noted at the 3<sup>rd</sup> floor. Refer to Photograph 7.
  - h) Masonry displacement, both vertical and horizontal, along with exasperated brick spalling was noted at the 4<sup>th</sup> floor masonry window heads. Refer to Photograph 8.
