## WILKES-BARRE AREA SCHOOL DISTRICT STRUCTURAL EVALUATION OF JAMES M COUGHLIN HIGH SCHOOL

**Re: Structural Evaluation of Coughlin High School**

# Coughlin High School Structural Evaluation

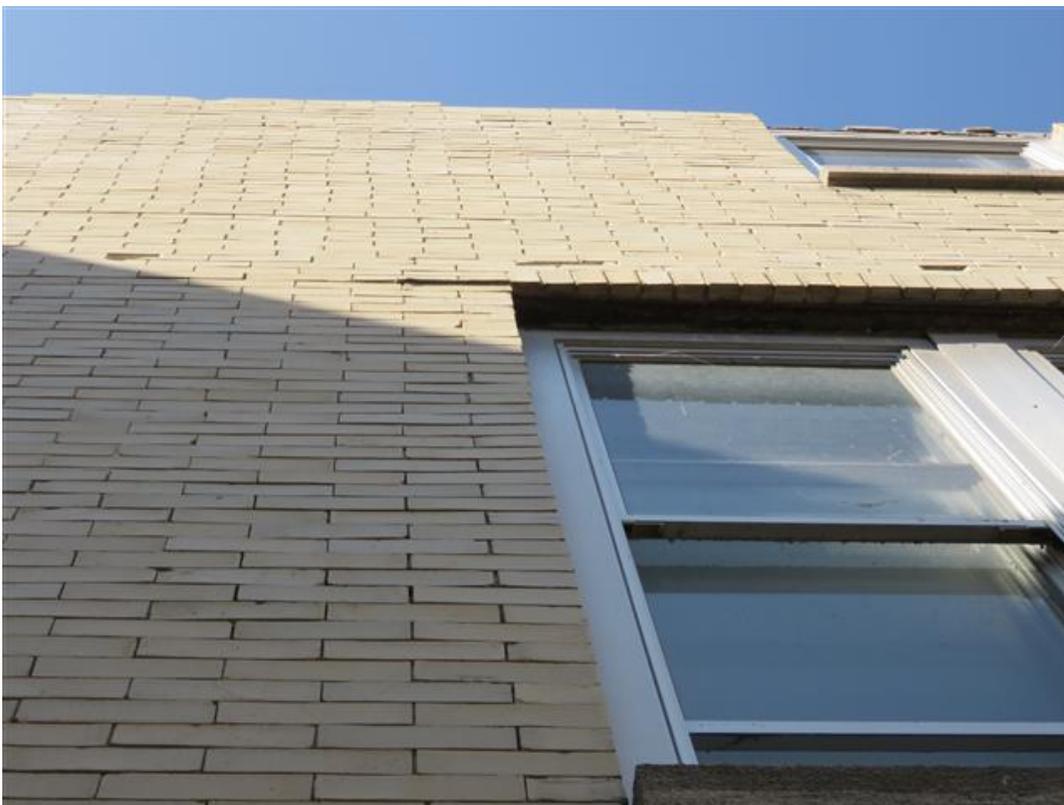
**Photograph 8:**

- g) Corrosion build-up exceeding ½” was noted at the 3<sup>rd</sup> floor. Refer to Photograph 7.
  - h) Masonry displacement, both vertical and horizontal, along with exasperated brick spalling was noted at the 4<sup>th</sup> floor masonry window heads. Refer to Photograph 8.

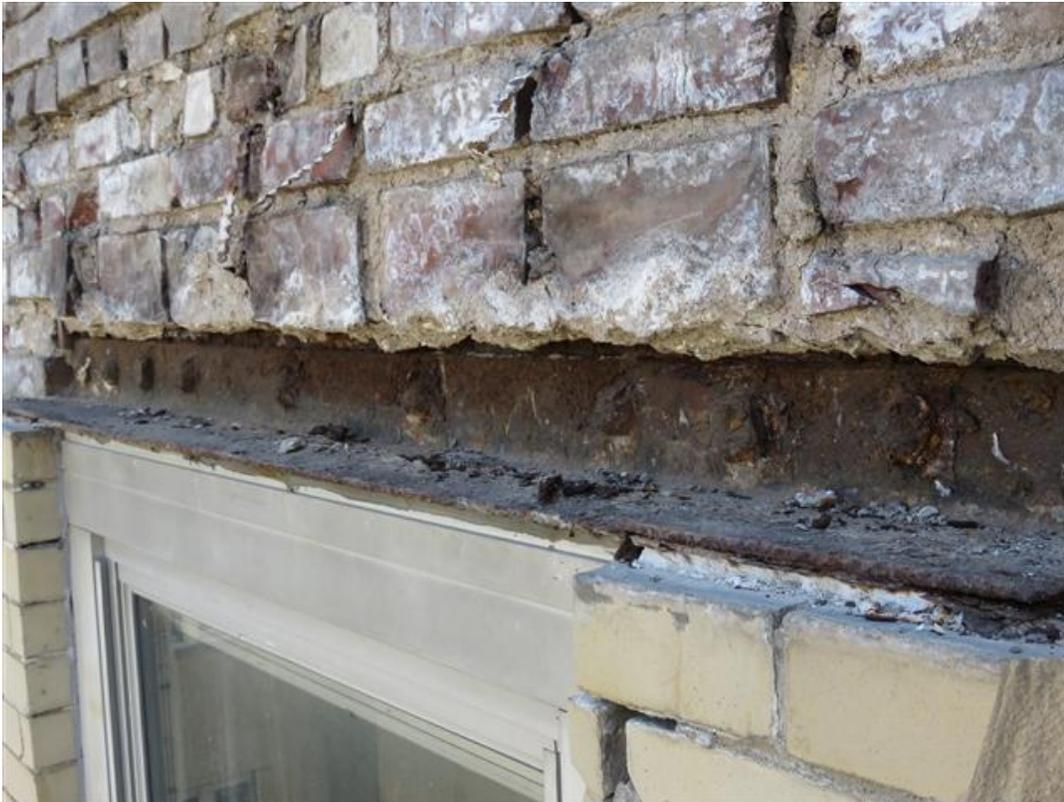
**Photograph 11:**

- k) The attic level window head along the east elevation while corroded did not require removal. Also note the corroded brick anchors and poor condition of back-up common brick wythes beneath the removed face brick. See Photograph 11.

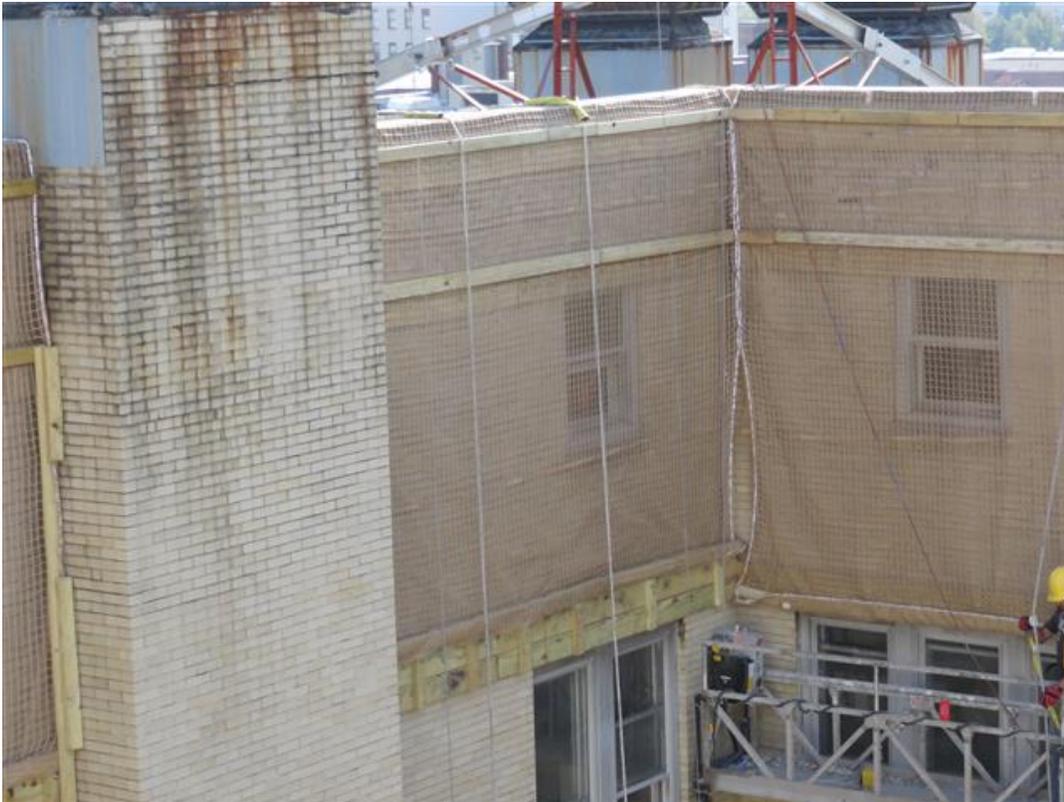
**Photograph 1:**

- MPS was on-site to inspect ongoing netting installation, wire mesh installation and masonry parapet rebuilding.
- a) Netting installation was completed or being finished except for the northwest corner where masonry parapets were being rebuilt. Refer to Photograph 1.

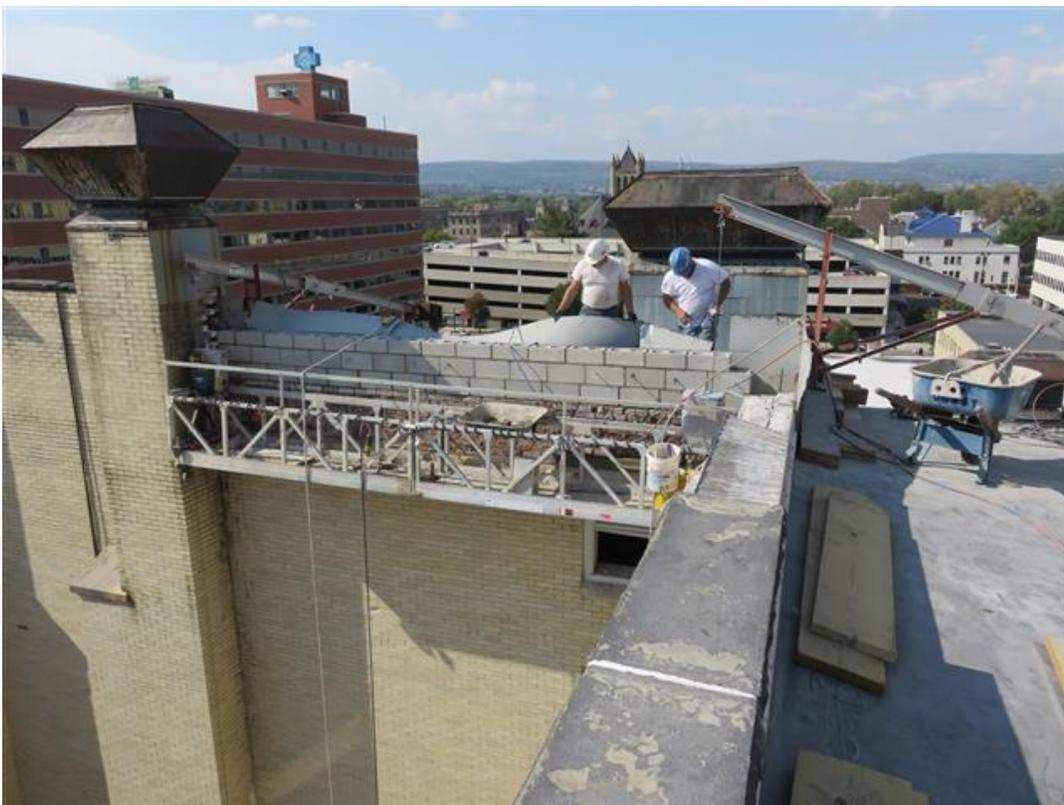
**Photograph 2:**

- b) The parapet west elevation north end was rebuilt including CMU back-up. Refer to Photograph 2.
- c) The back-up parapet masonry included through wall stainless steel all thread and adjustable veneer anchors. Refer to Photograph 3.

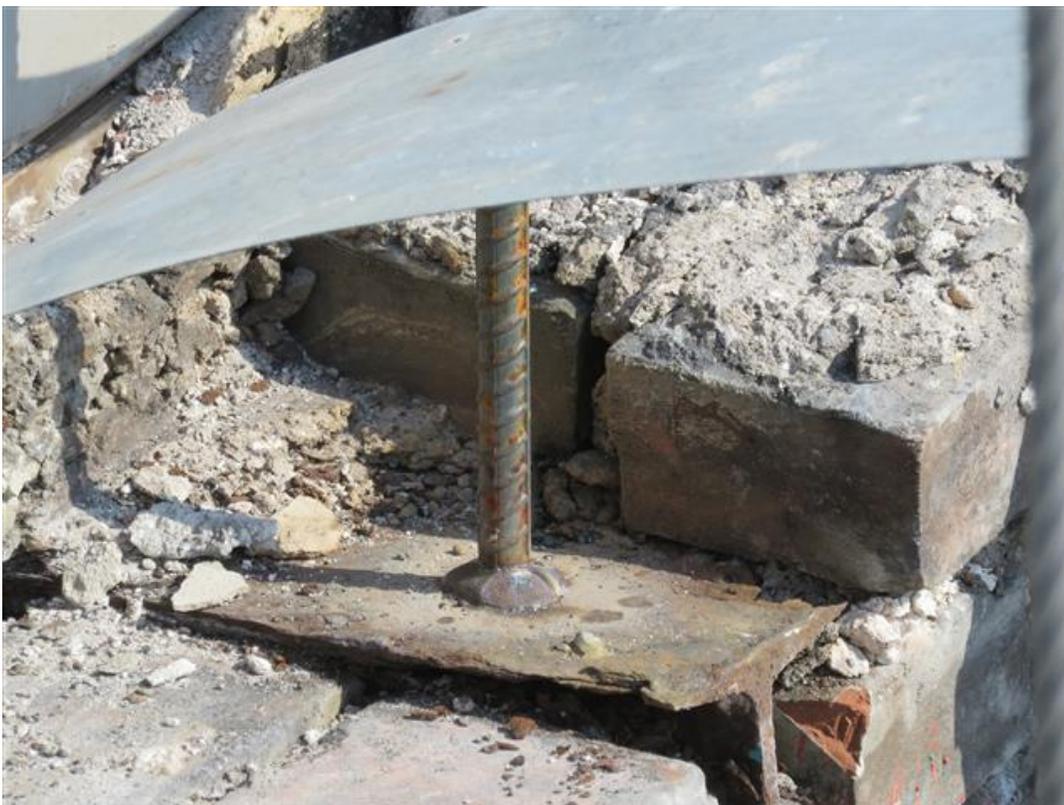
**Photograph 4:**

- d) Reinforcing bar had been welded onto the projecting roof support beam end along the north elevation where masonry demolition and rebuilding is scheduled to continue this week. Refer to Photograph 4.

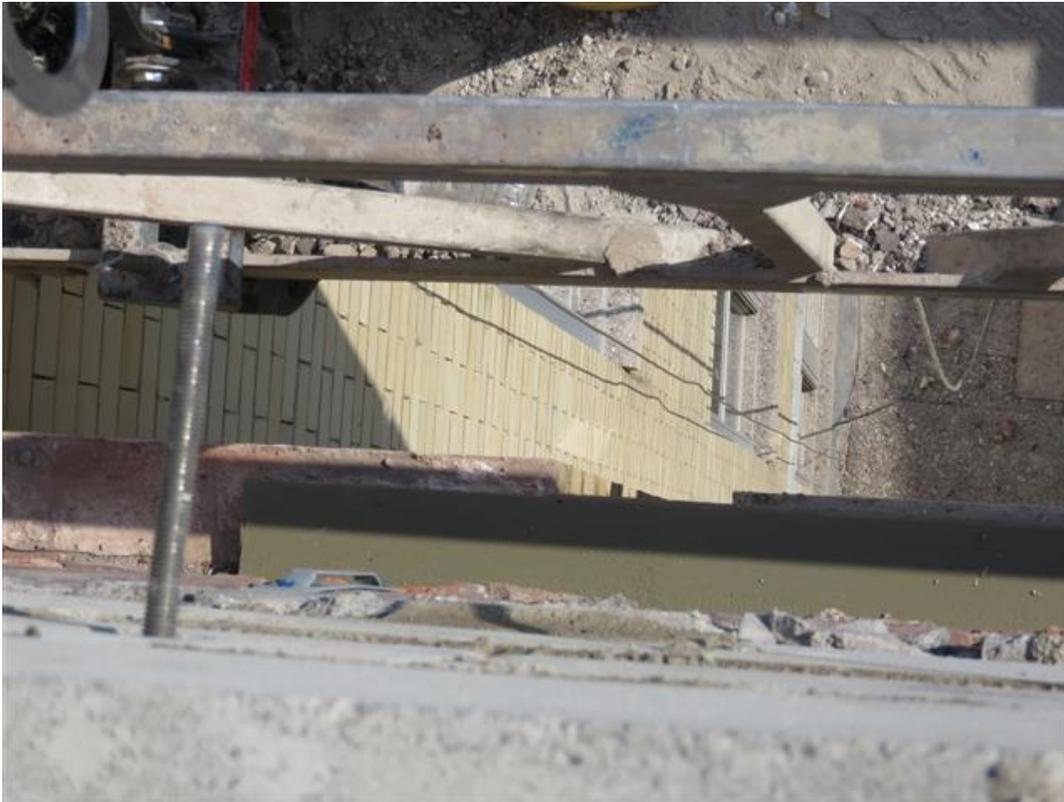
**Photograph 5:**

- e) A new steel window head lintel had been installed along the west elevation in preparation for the installation of the face brick. Refer to Photograph 5.

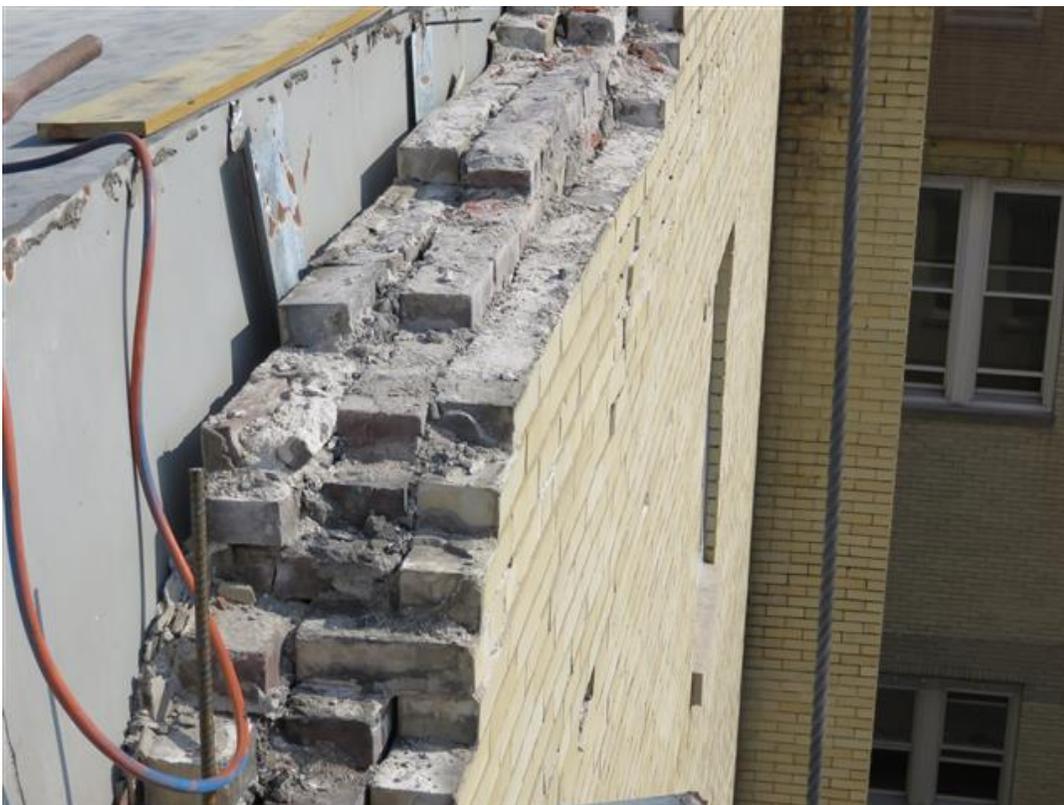
**Photograph 6:**

- f) A discussion regarding the parapet rebuild area included measurements to extend the rebuild to engage the 3<sup>rd</sup> projecting steel beam east of the northwest parapet intersection so the end CMU will engage a projecting welded vertical rebar. Refer to Photograph 6.

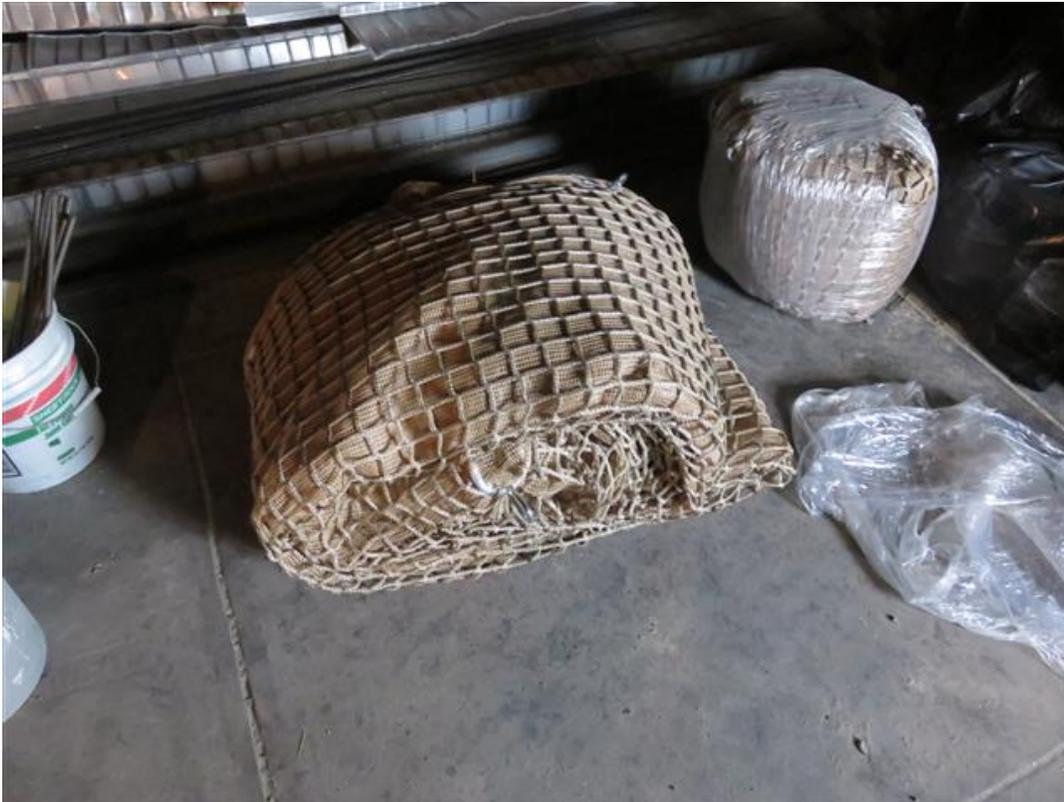
**Photograph 7:**

- g) Photograph of the structural netting prior to installation. Refer to Photograph 7.
- h) The rebuild parapet's heights were reduced to accommodate the netting securement requirements and lower the parapets to work with CMU coursing. The contractor will infill the parapet ends where projecting original masonry interfaced with the old parapet. Refer to Photograph 8.

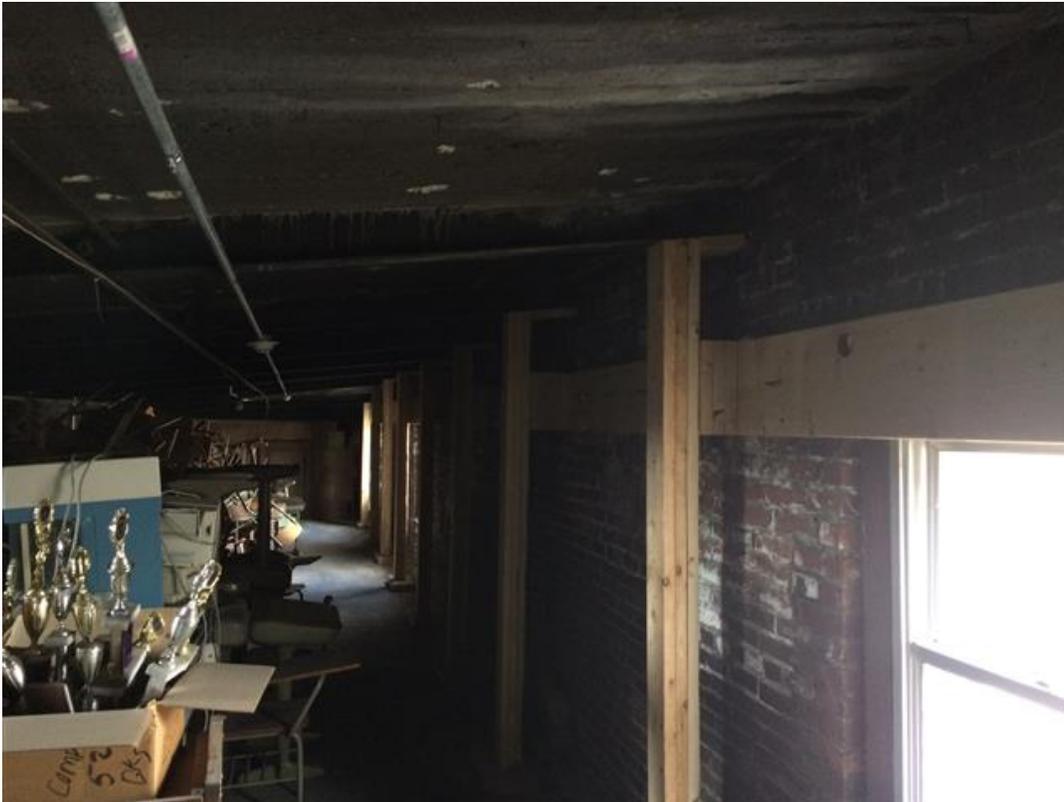
**Photograph 1:**

- a) Interior shoring posts located beneath roof slab support beams were in place. At most locations, the shoring posts were erected to interface with the attic window 2” X 12” interior bracing timber diaphragms. Refer to Photograph 1.

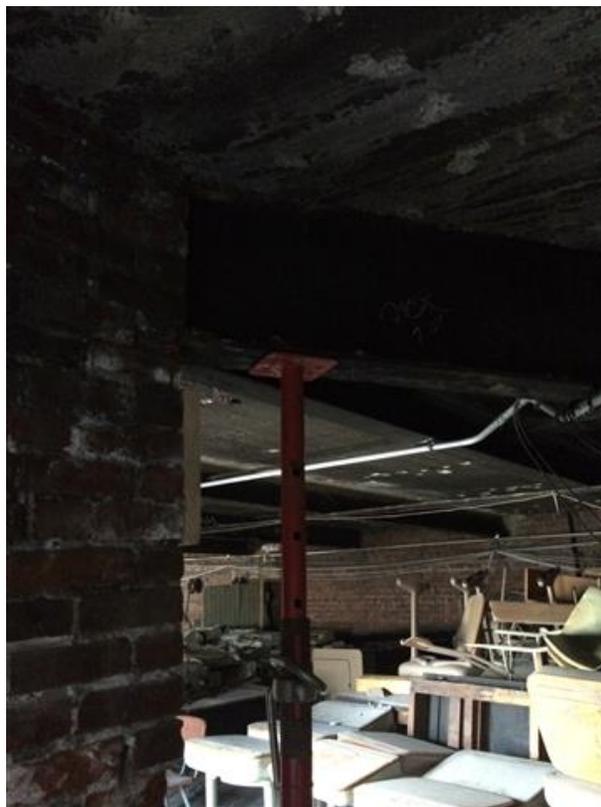
**Photograph 2:**

- b) At angled corner girders, steel shoring posts were added after extensive steel section loss was identified during exterior wythe brick demolition. This additional bracing was intended to augment loss of bearing surface noted during exterior demolition. Refer to Photograph 2.

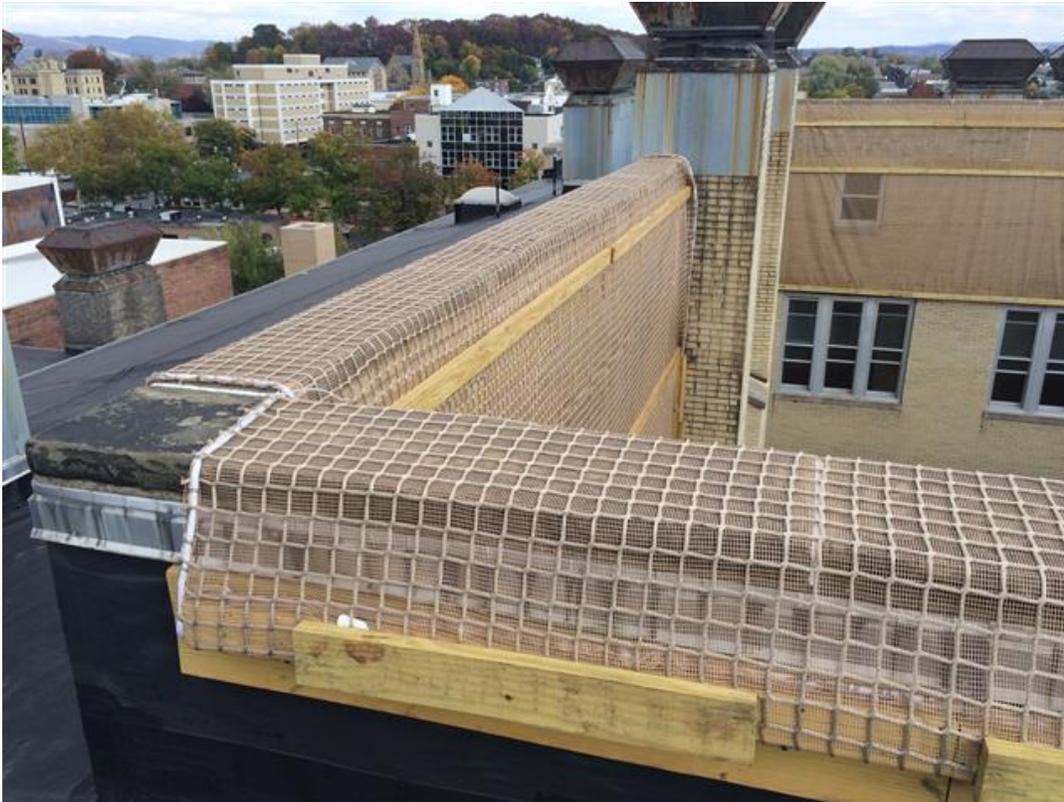
**Photograph 3:**

- c) Around the perimeter of the light well, 2” X 12” or 2” X 10” lumber was placed continuously and thru bolted at the existing or rebuilt masonry parapets. This diaphragm was compressed by placing thru bolts at 36” centers to brace the masonry assembly. Refer to Photograph 3.

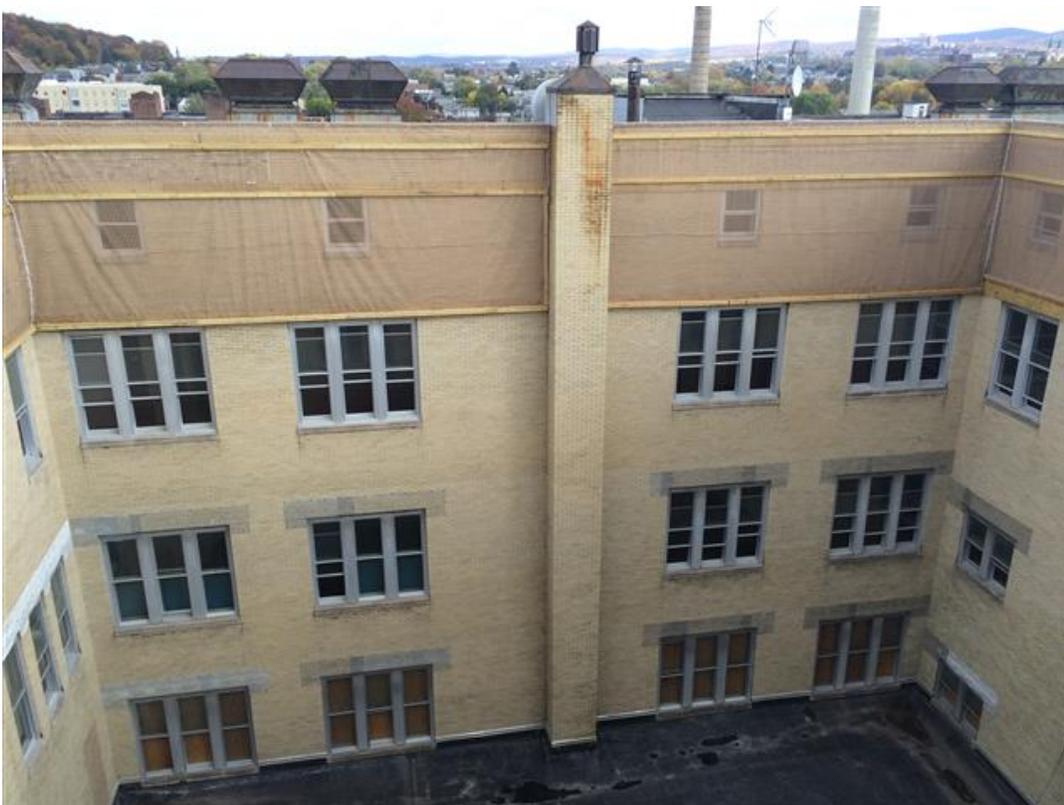
**Photograph 4:**

- d) At both the attic level window head and 4<sup>th</sup> floor window head elevations, continuous lumber diaphragms were installed and thru bolted to capture deteriorated and/or displaced masonry adjacent to steel lintel/girder assemblies built into the masonry walls to span the masonry openings. Refer to Photograph 4.

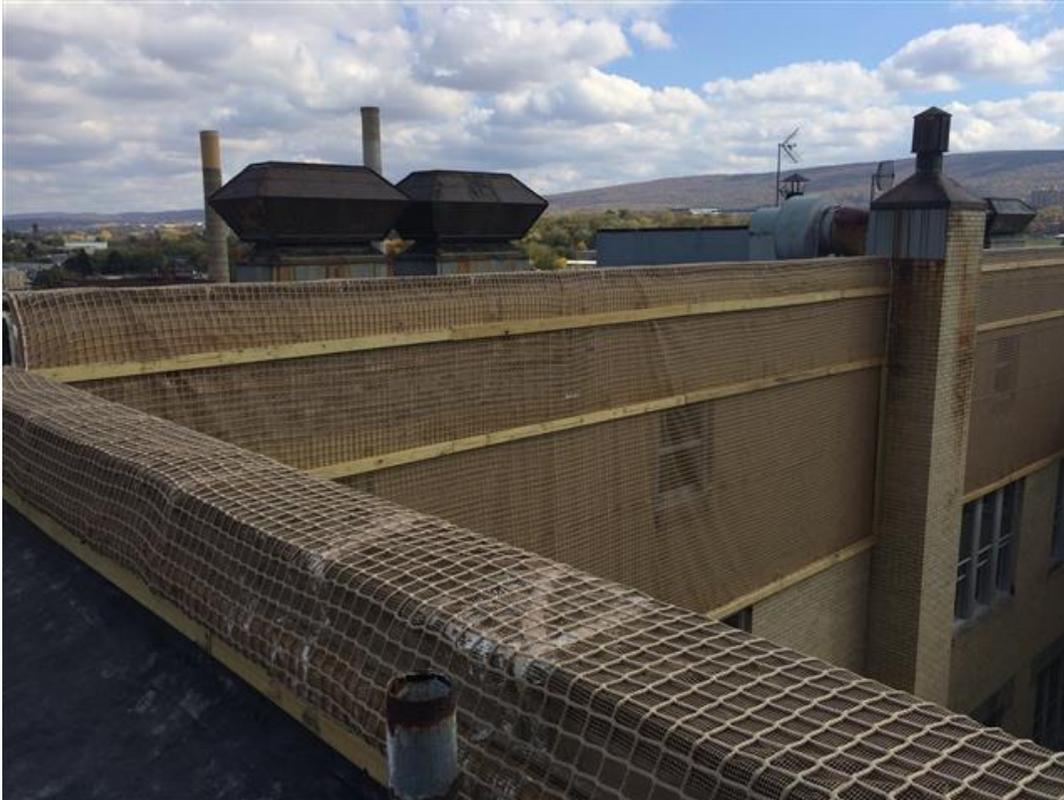
**Photograph 5:**

- e) Sections of the parapets intersecting north/west and south/east corners were demolished and rebuilt prior to installation of the timber compression diaphragms. Refer to Photograph 5.

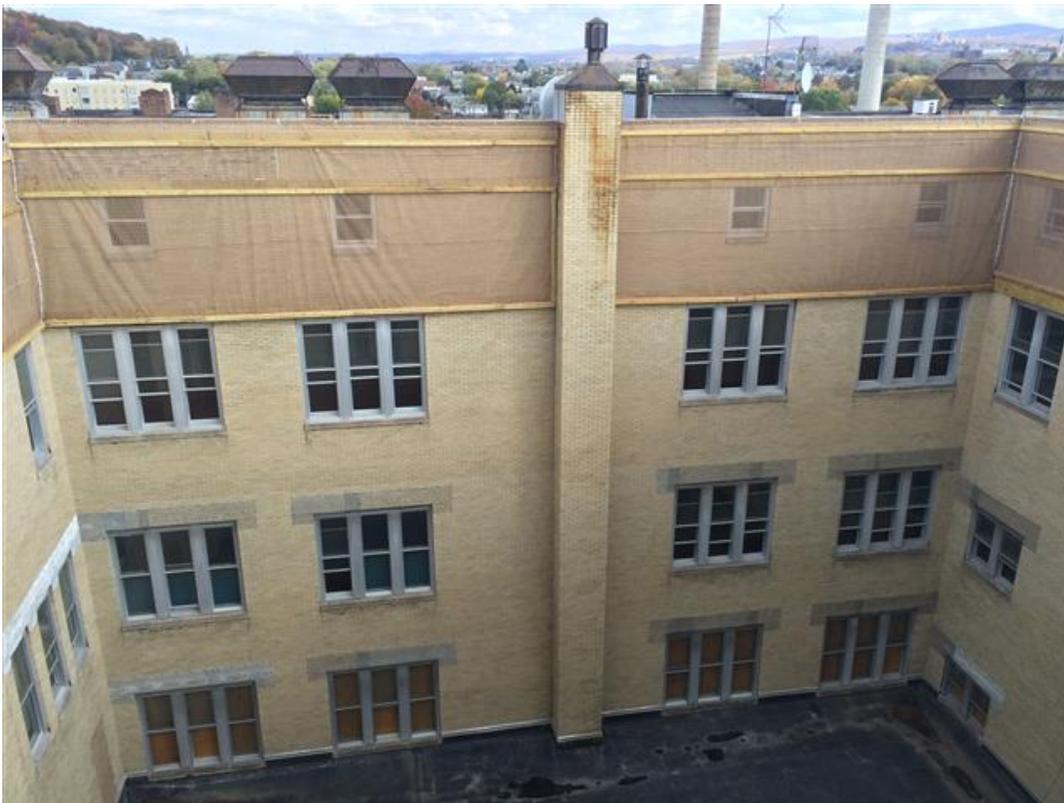
**Photograph 6:**

- f) After the parapets, attic and 4<sup>th</sup> floor window level diaphragms were installed, double level structural debris netting was attached. The netting was installed along the rear of the parapet and continued uninterrupted over the coping down to the 4<sup>th</sup> floor window heads. All netting was attached to the thru bolted timber diaphragms at three levels. Refer to Photograph 6.

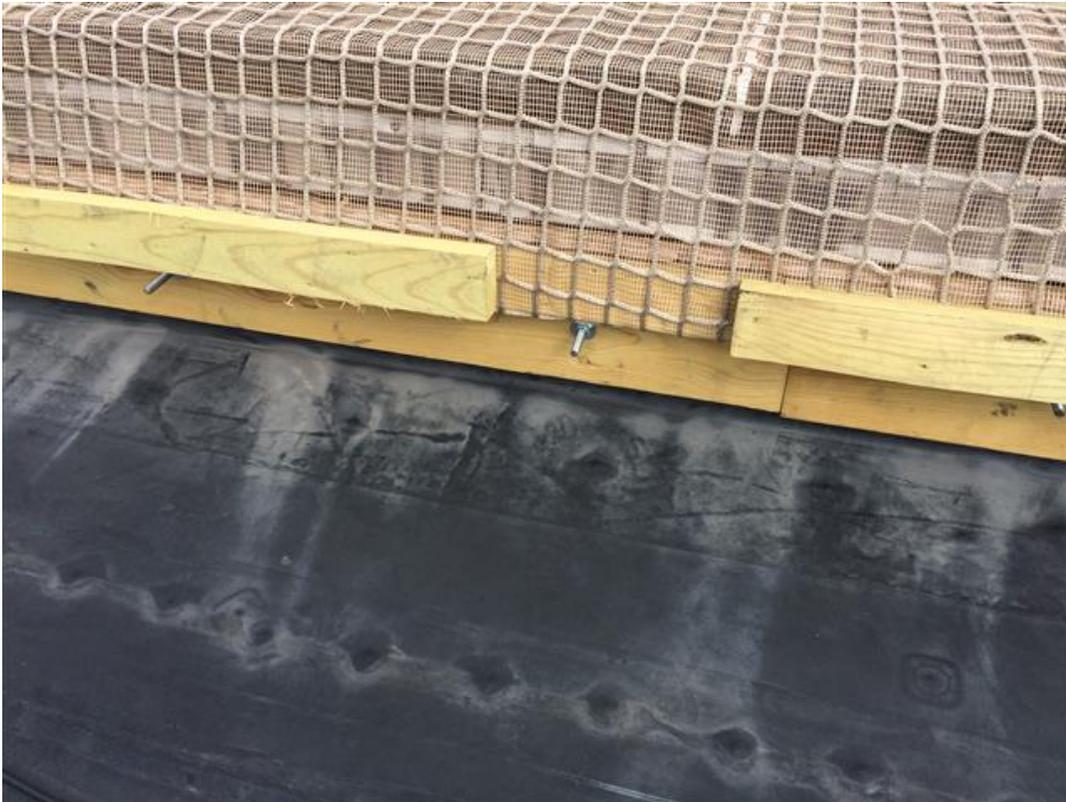
**Photograph 7:**

- g) The timber diaphragms were compressed using ½” diameter stainless steel all thread with washers and nuts located at the maximum spacing of 36” on center. Refer to Photograph 7.
