## WILKES-BARRE AREA SCHOOL DISTRICT STRUCTURAL EVALUATION OF ELMER L. MEYERS HIGH SCHOOL

December 8, 2014

**Re: Structural Evaluation of Meyers High School**

# Meyers High School Structural Evaluation

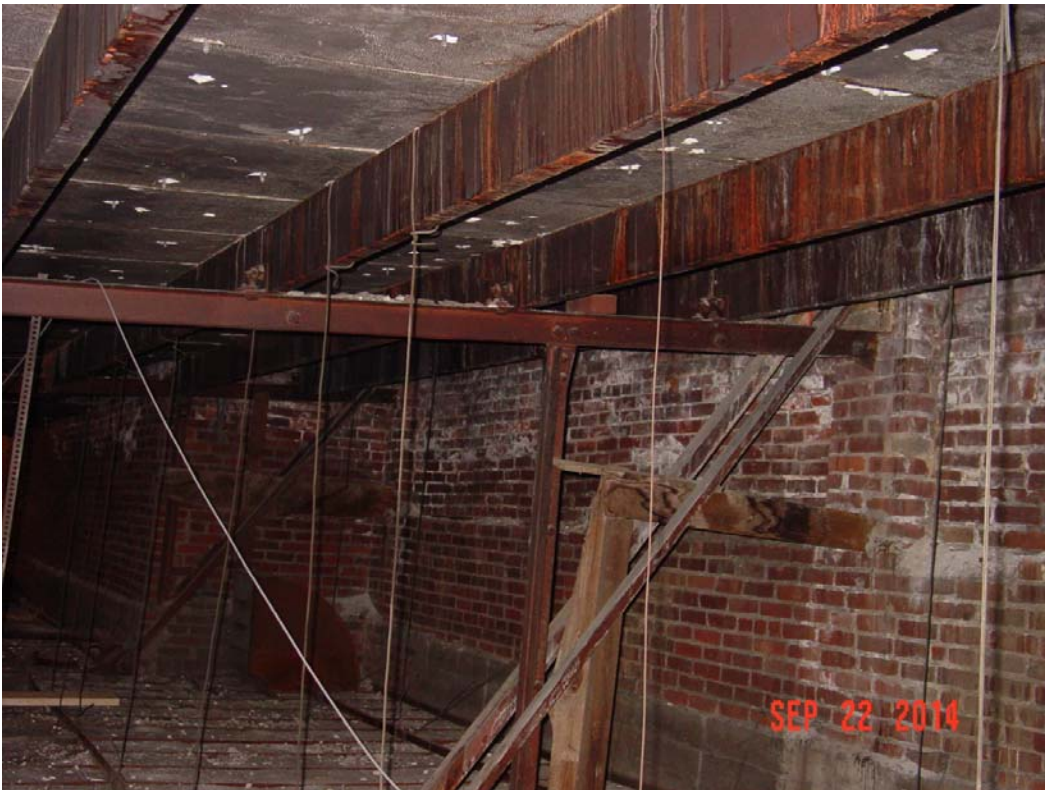
Main Building roof framing visible in attic above Hanover Street

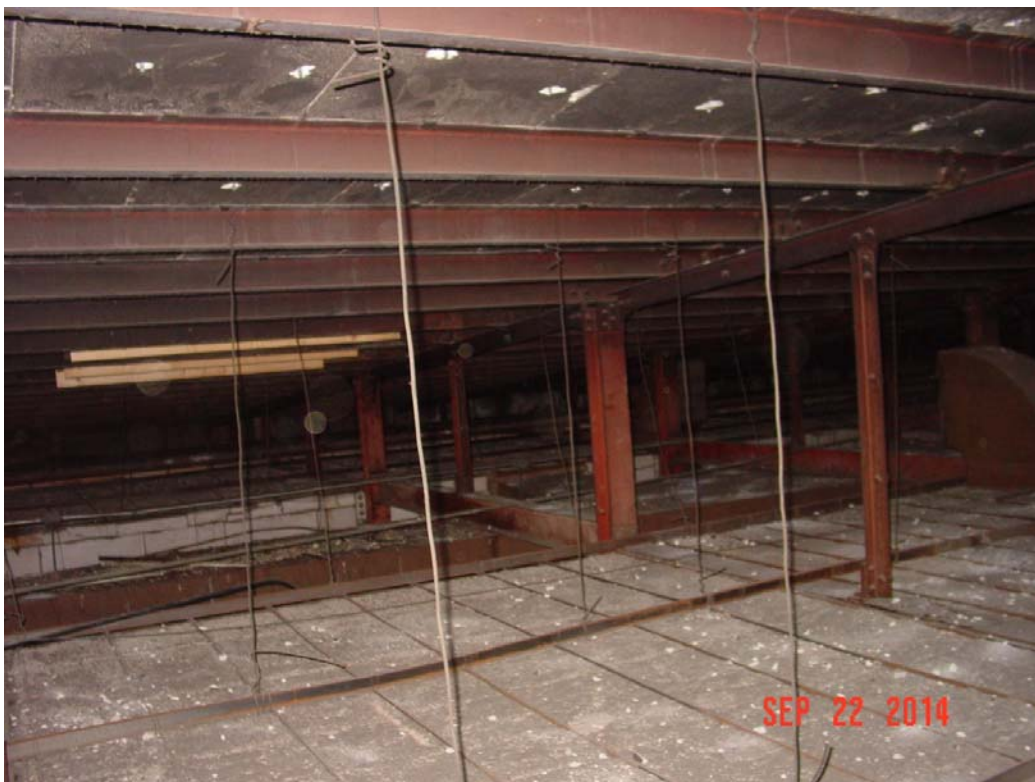
Main Building roof framing visible in attic above Hanover Street side.

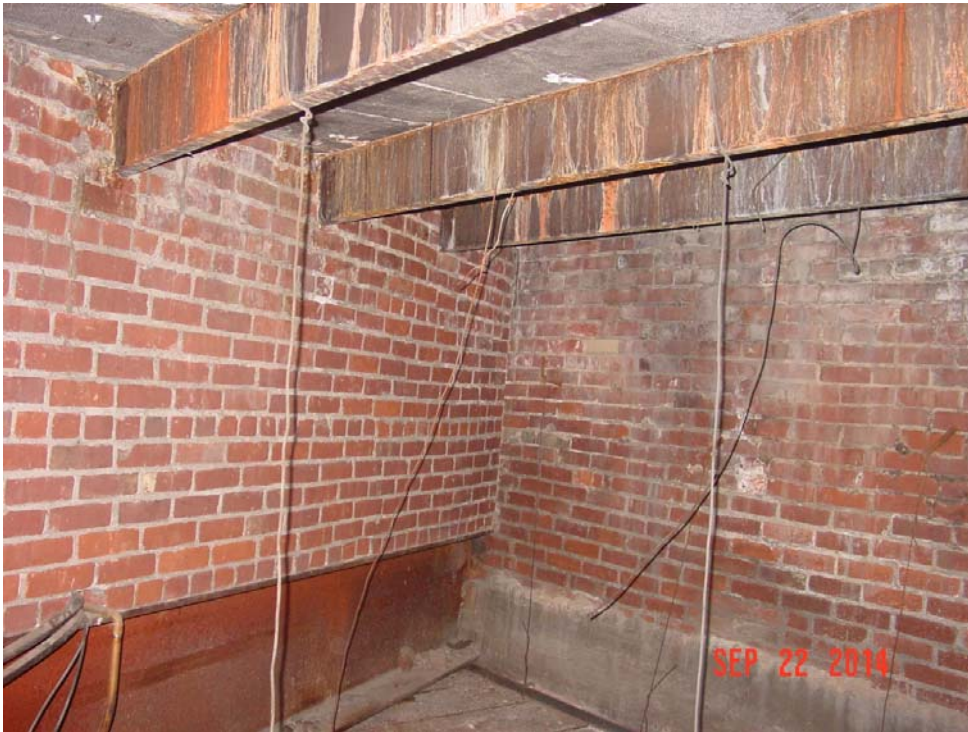
Tie-in of Hanover Street classroom wing to main entrance

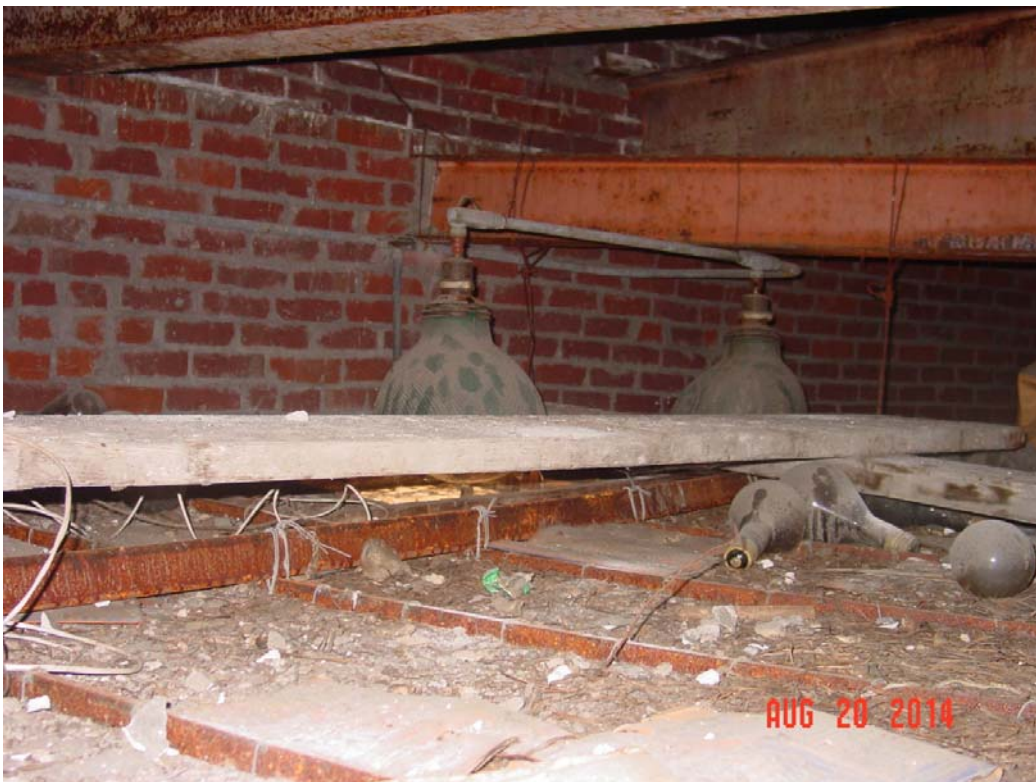
Ceiling and roof in architrave above main entrance

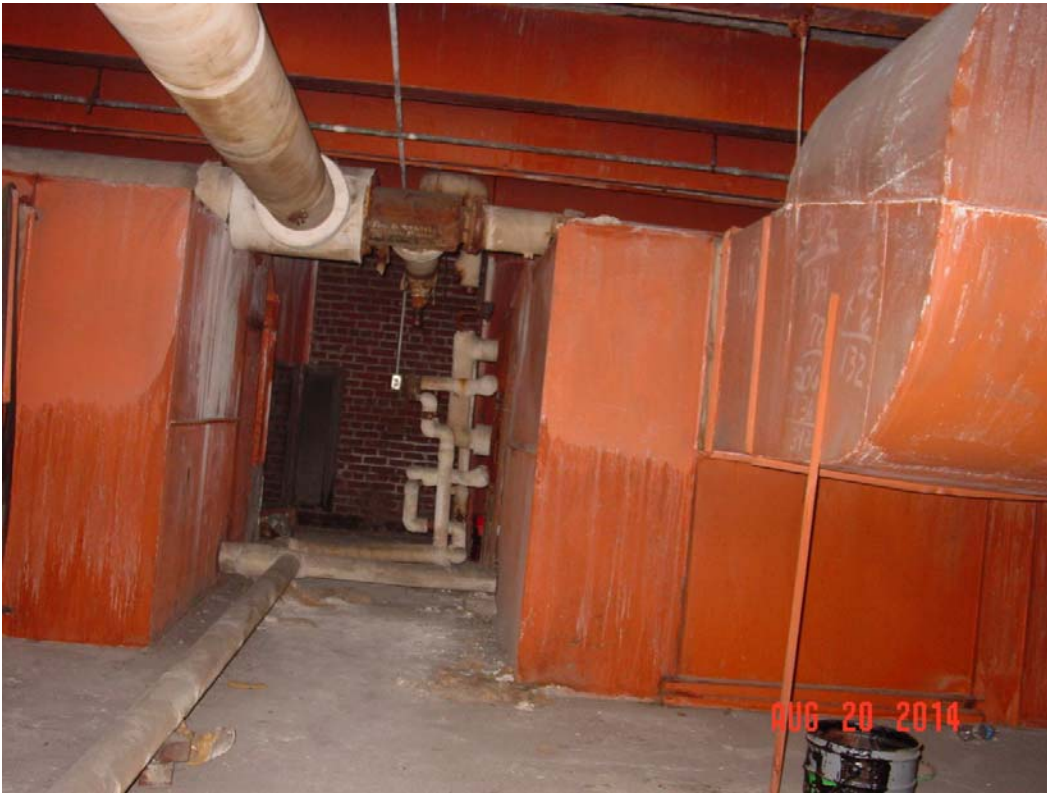
The 2014 survey also included shots in the mechanical (4th) floor above the main entry and the results were similar to the floors below, with the mechanical slab sloping approximately 12" from front to rear. No cracking was noted in the unfinished mechanical room concrete floor slab.

Old mechanical equipment in Mechanical room above Main Building staircase. Floor slopes down 12" to brick wall beyond.

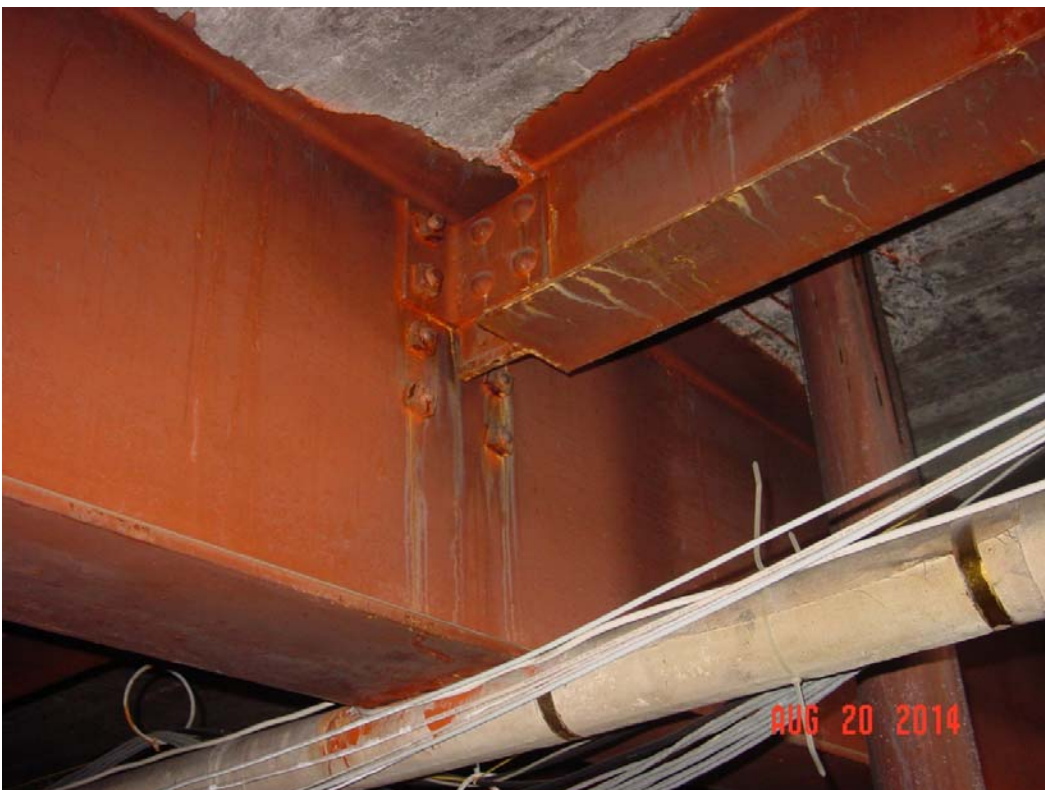
Steel roof beam to girder connection in mechanical room above Main Building staircase

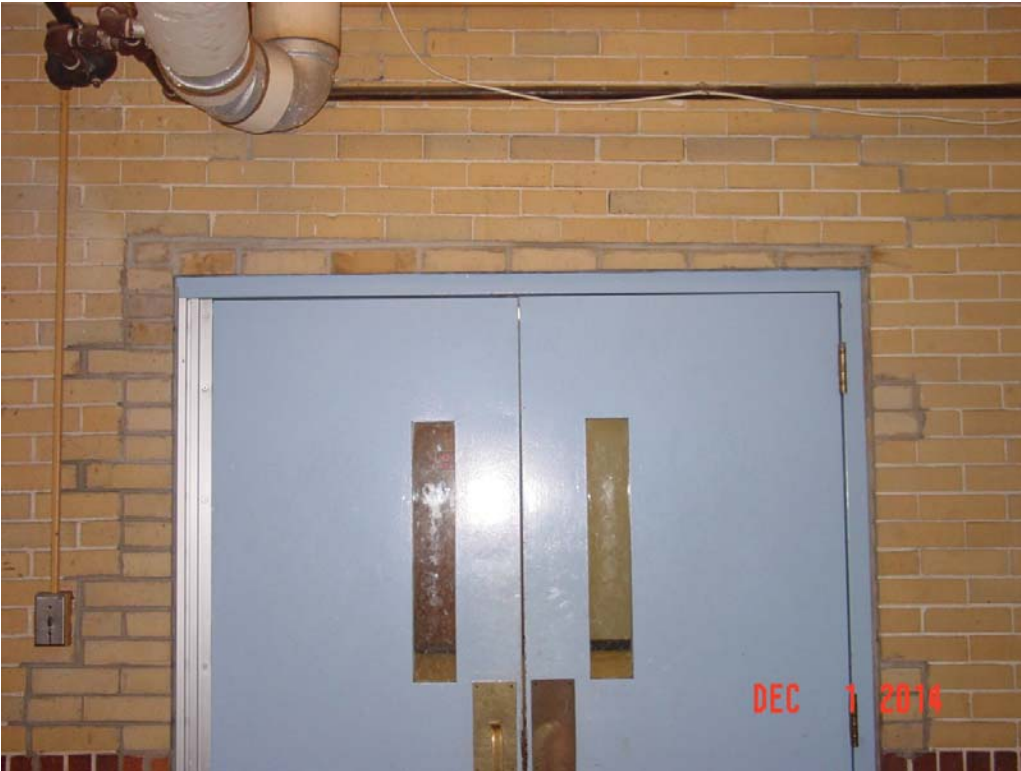
Door leading into basement level of Main Building staircase. Note the slope of the brick above door.

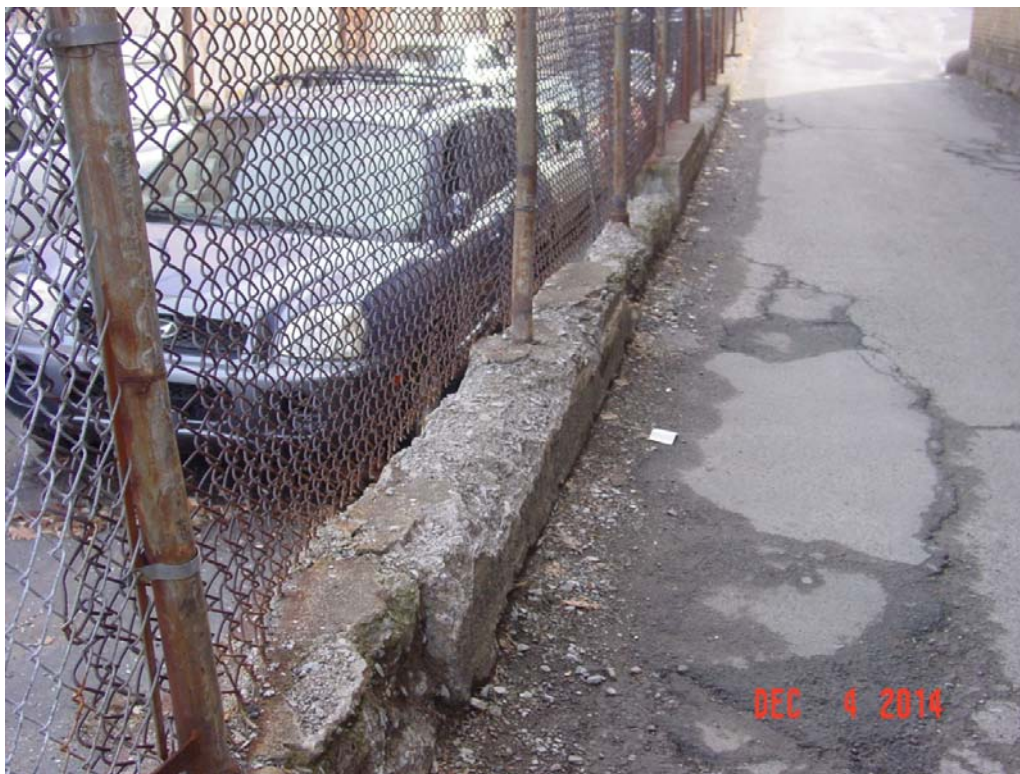
Retaining wall at driveway adjacent to Heating Plant

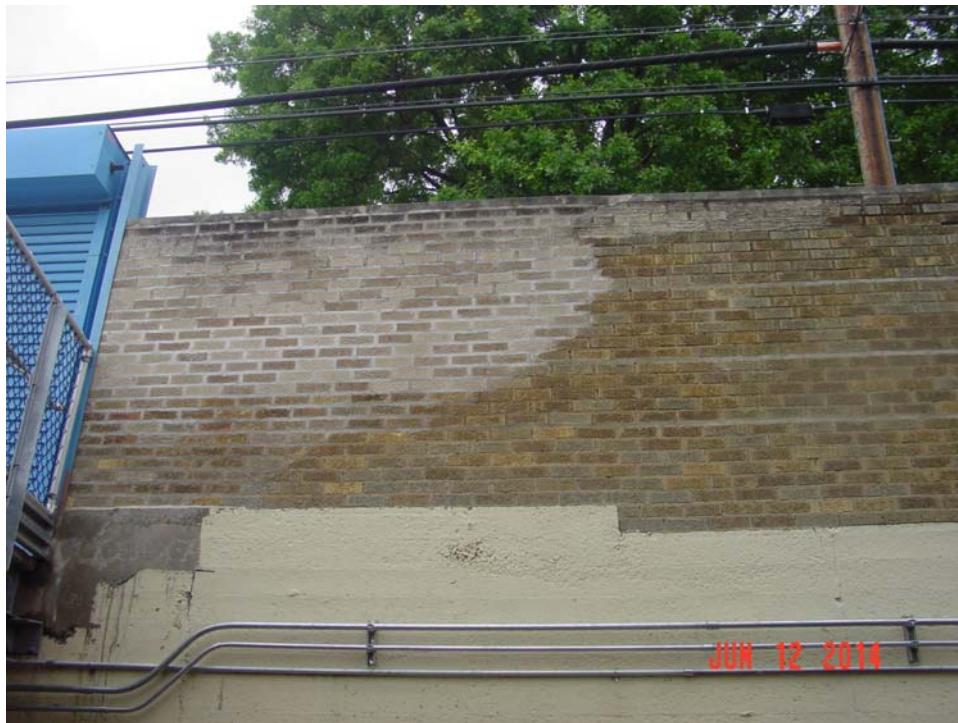
Deteriorated section of brick wall adjacent to Old River Road stadium entrance prior to removal in Summer of 2014

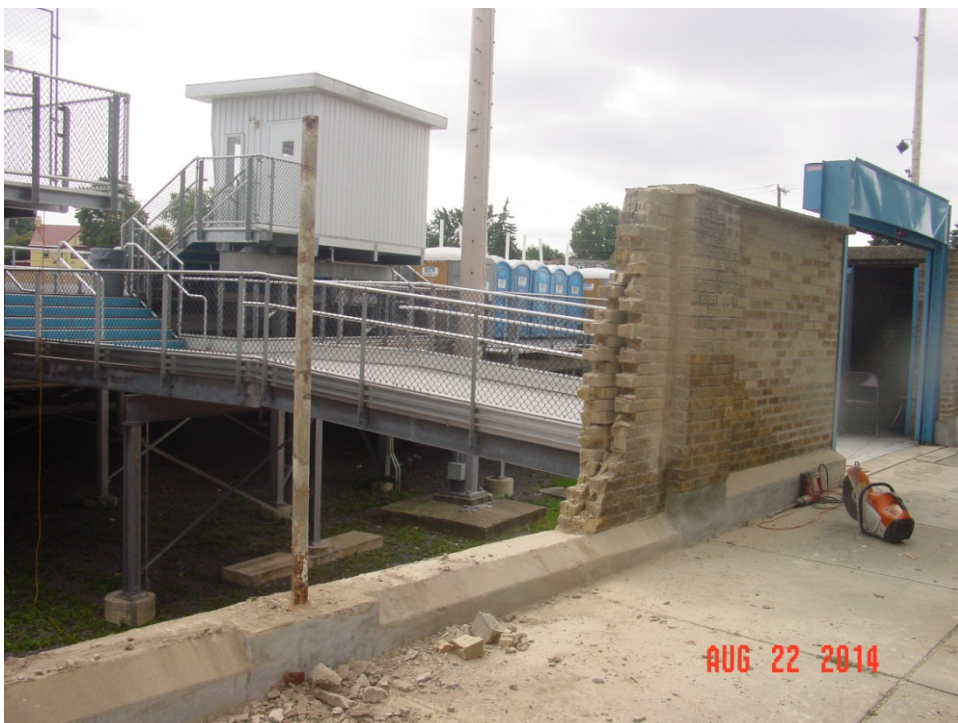
Deteriorated brick wall removal near Old River Road stadium entrance. The section was replaced with chain link fencing.

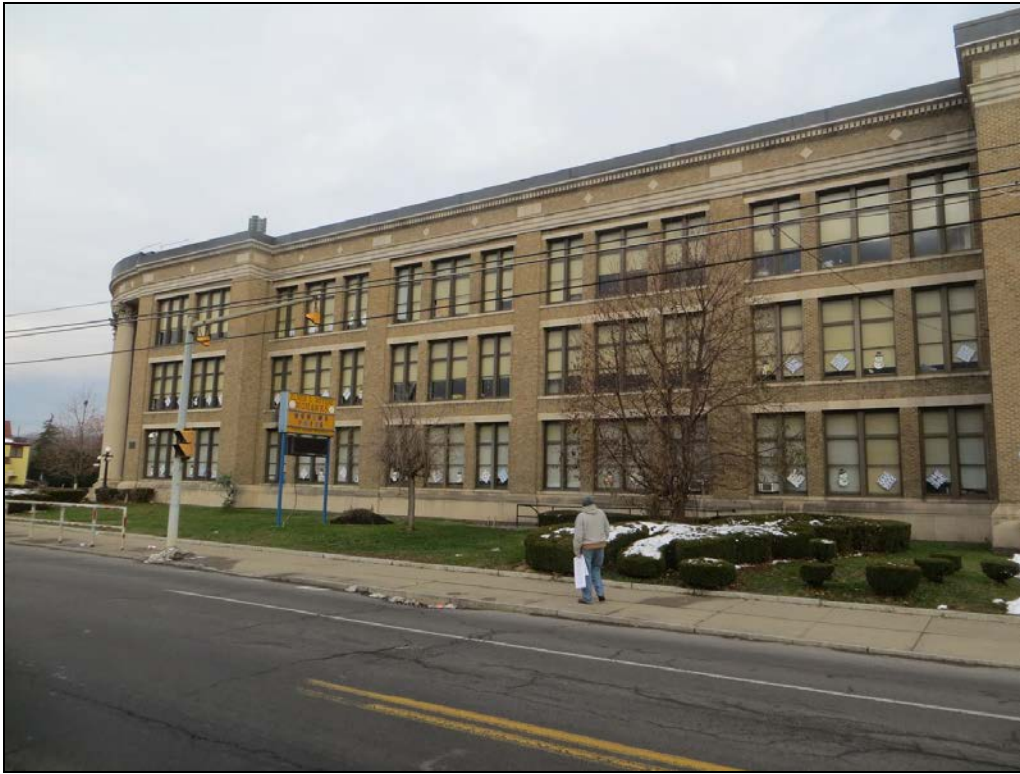
**Photograph 1:**  
Overview of the  
east side of the  
front elevation of  
the building.

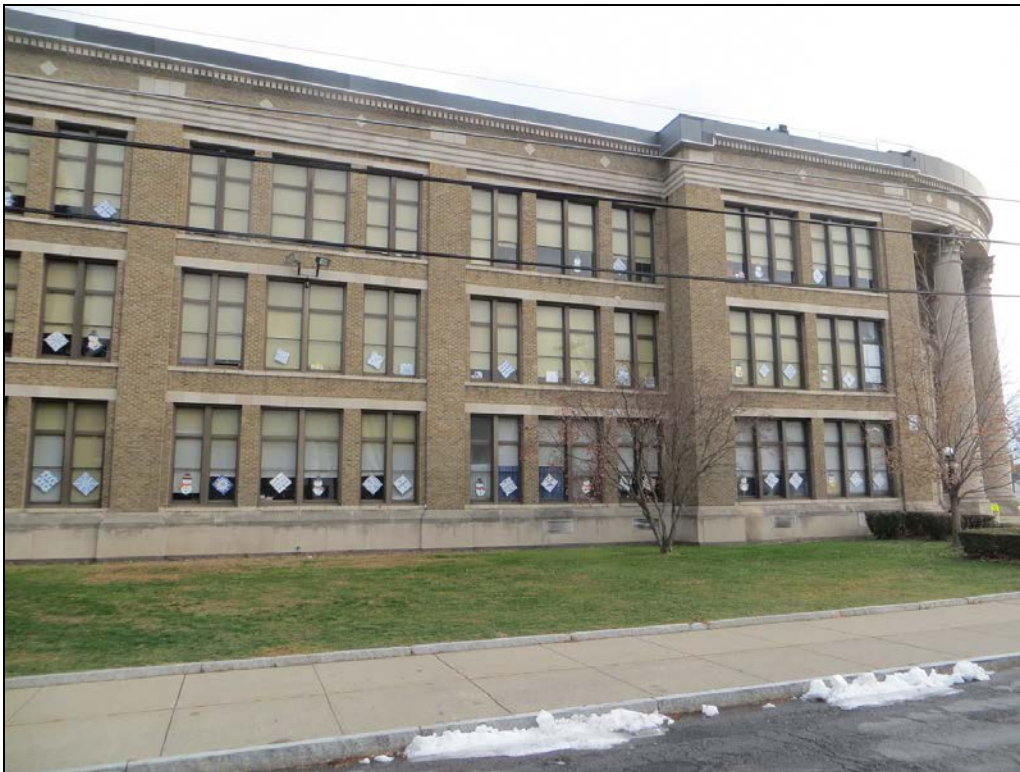
**Photograph 2:**  
Overview of the  
south side of the  
front elevation of  
the building.

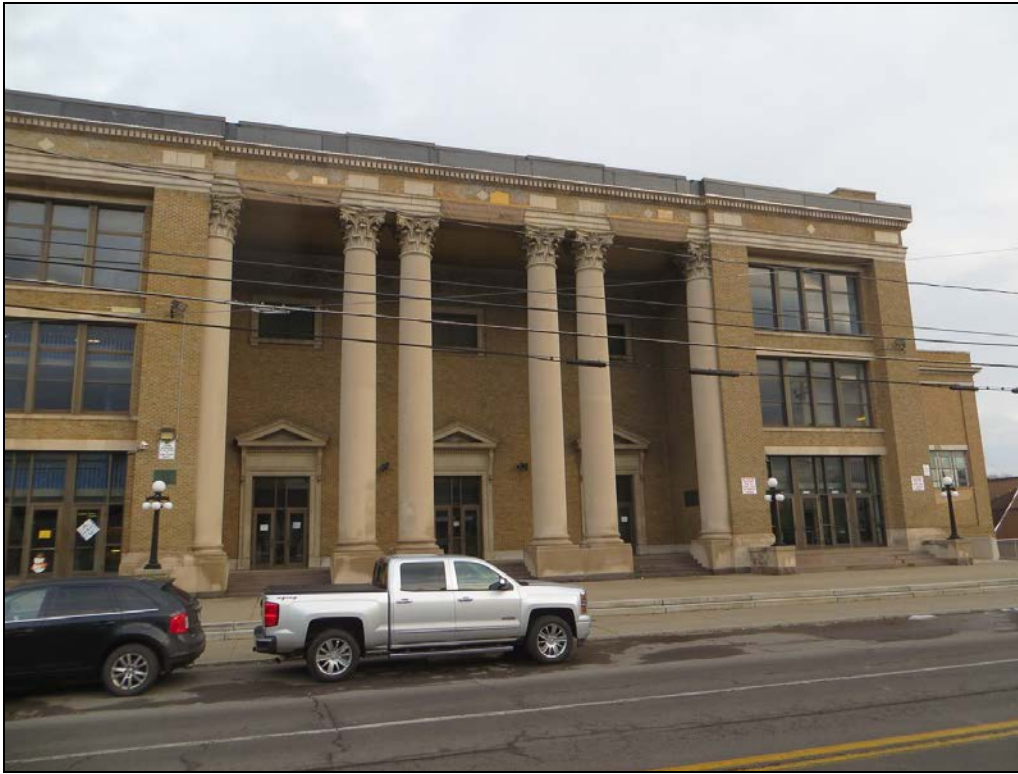
**Photograph 3:**  
Overview of the  
architrave at the  
north end of the  
east elevation.

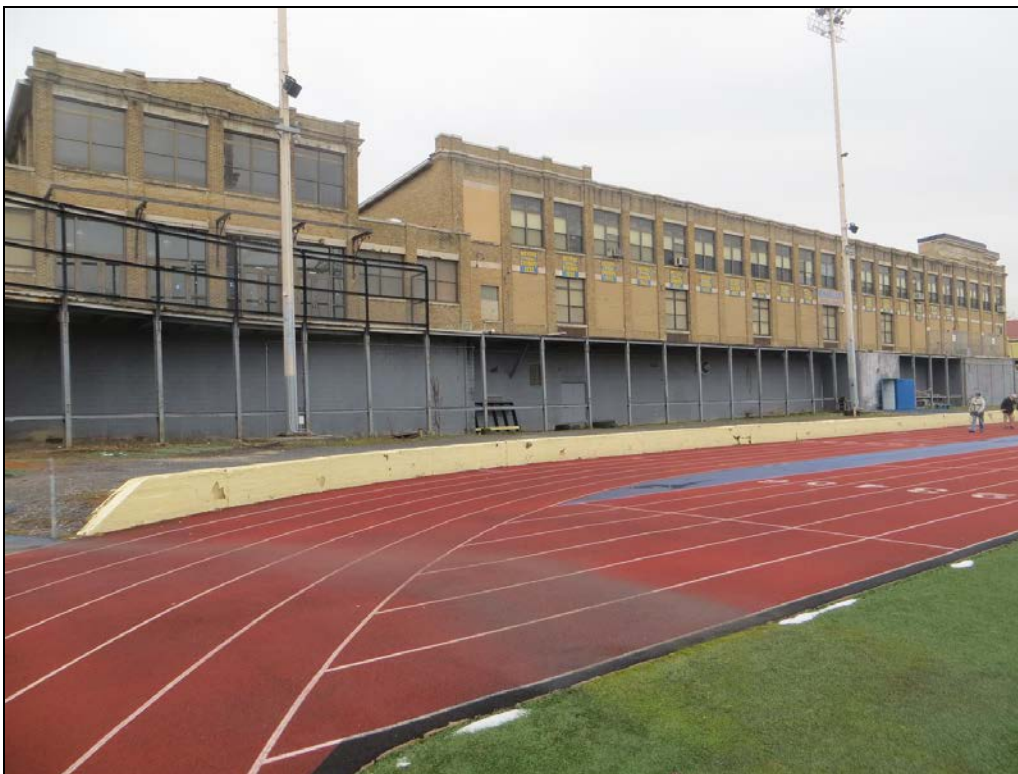
**Photograph 4:**  
Overview of the  
rear elevation that  
faces the stadium.

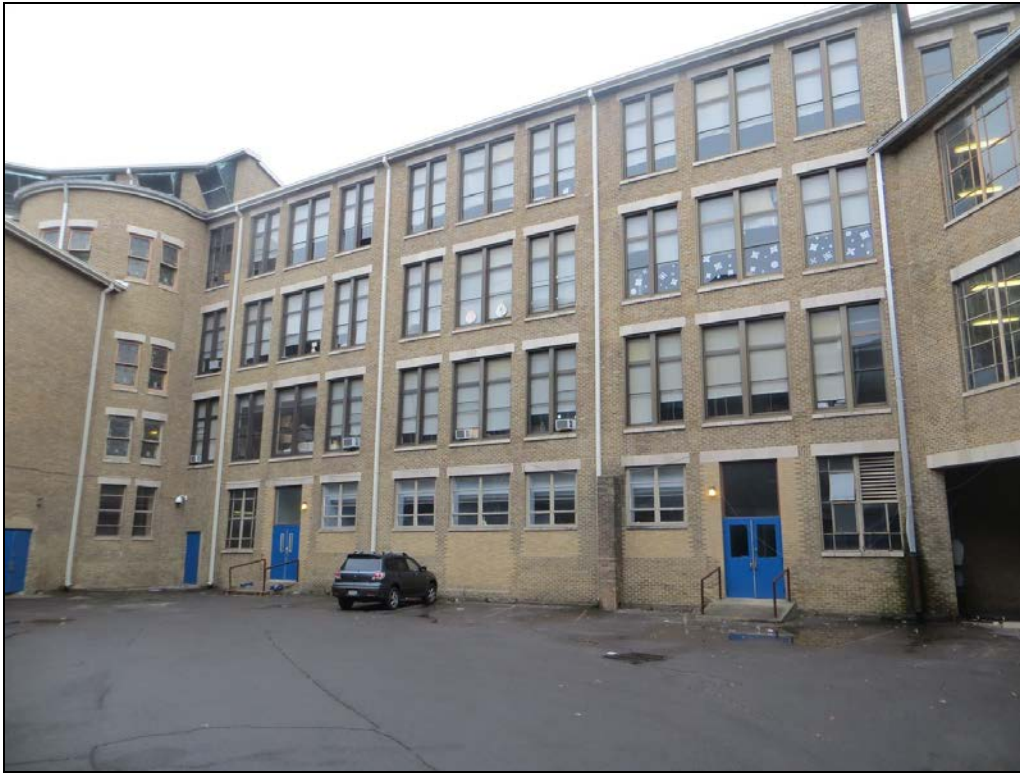
**Photograph 5:**  
Typical courtyard  
elevation that  
comes to grade.

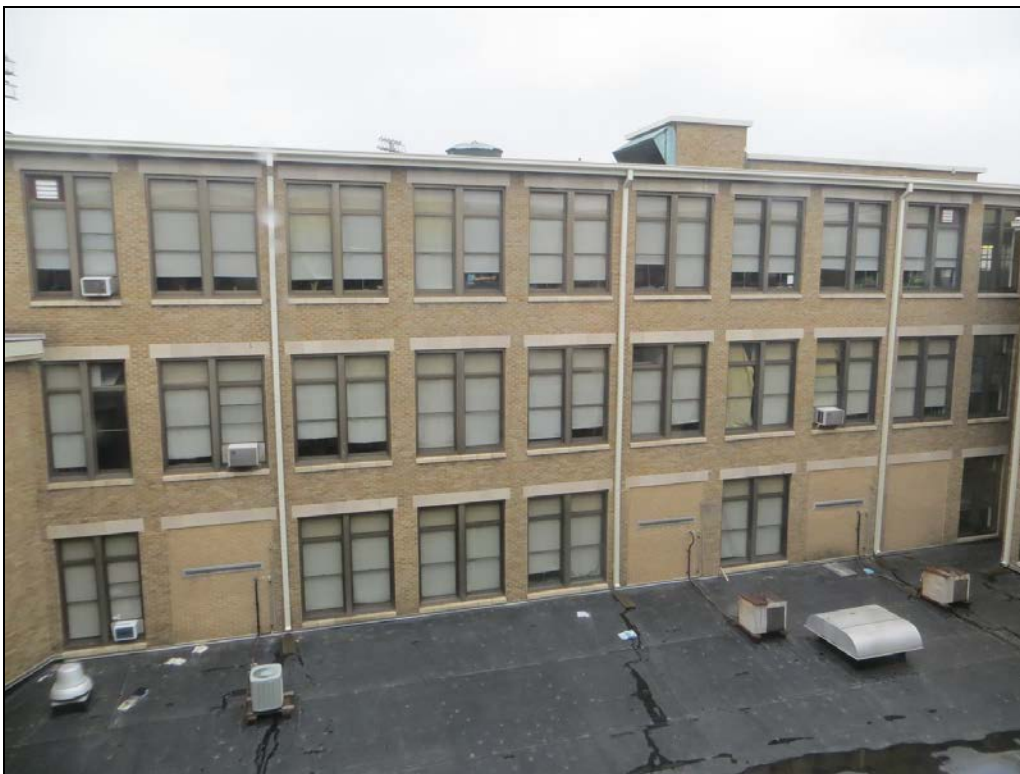
**Photograph 6:**  
Typical courtyard  
elevation that  
interfaces with a  
lower roof.

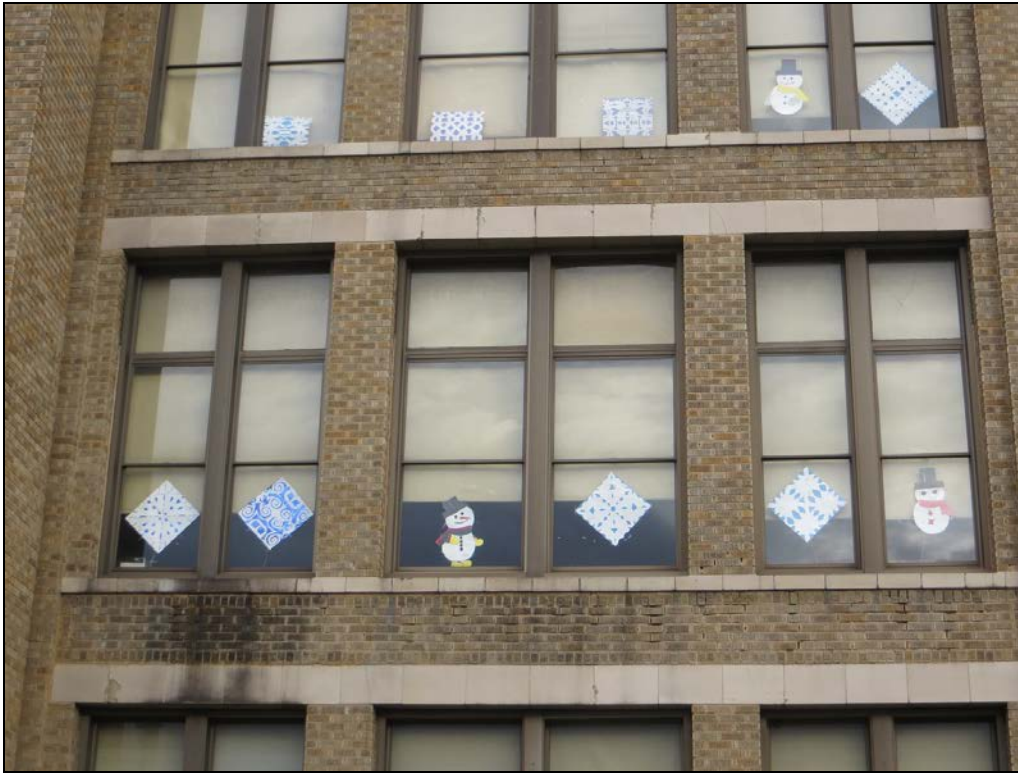
**Photograph 7:**  
Typical punched  
window opening  
with terra cotta  
header and sill  
pieces.

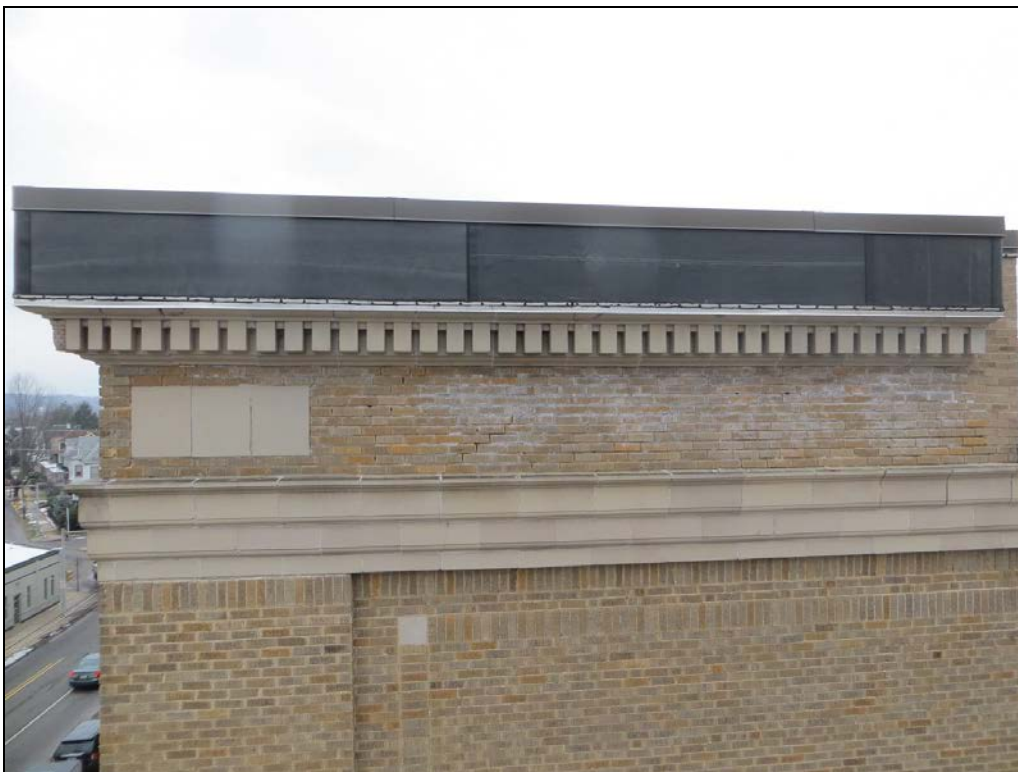
**Photograph 8:**  
View of a section  
of the removed  
parapet and cornice  
and the new  
roofing detail.

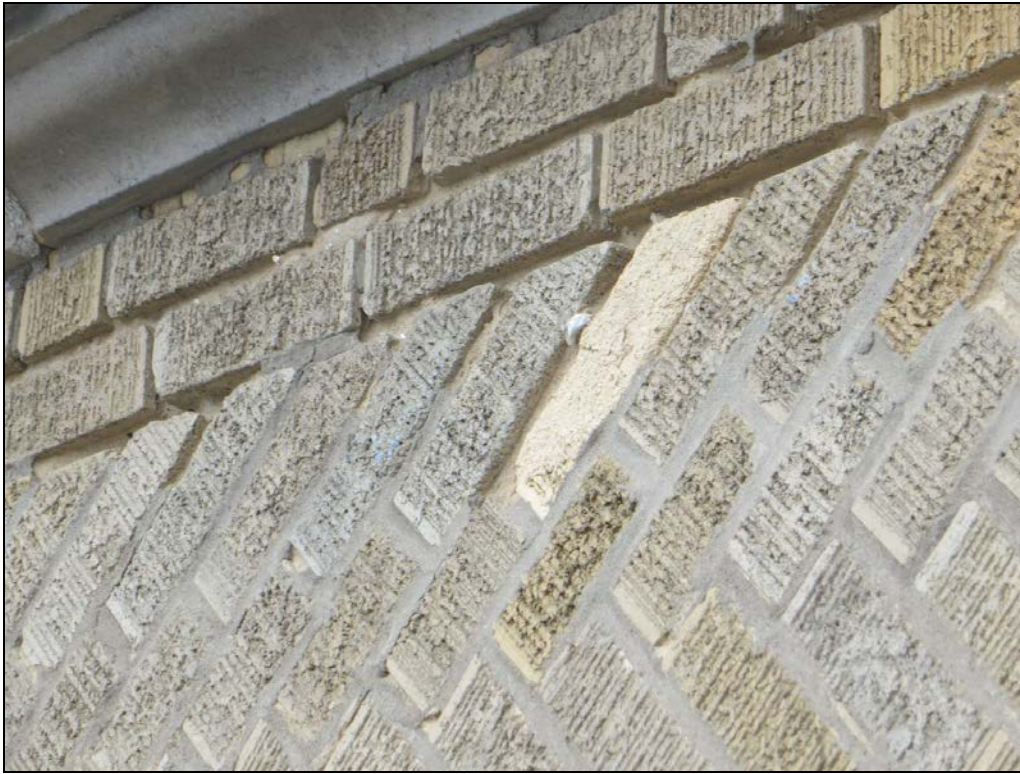
**Photograph 13:**  
Open mortar joints  
at the top of an  
elevation.

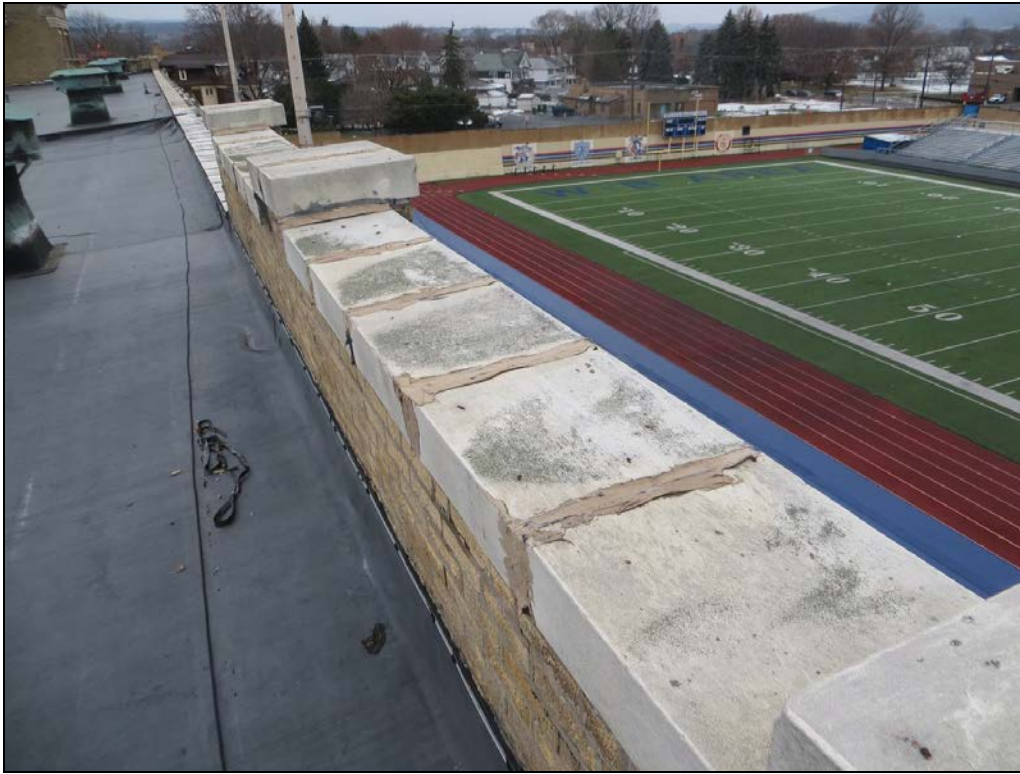
**Photograph 29:**  
There was no  
evidence of  
flashing under the  
copings.

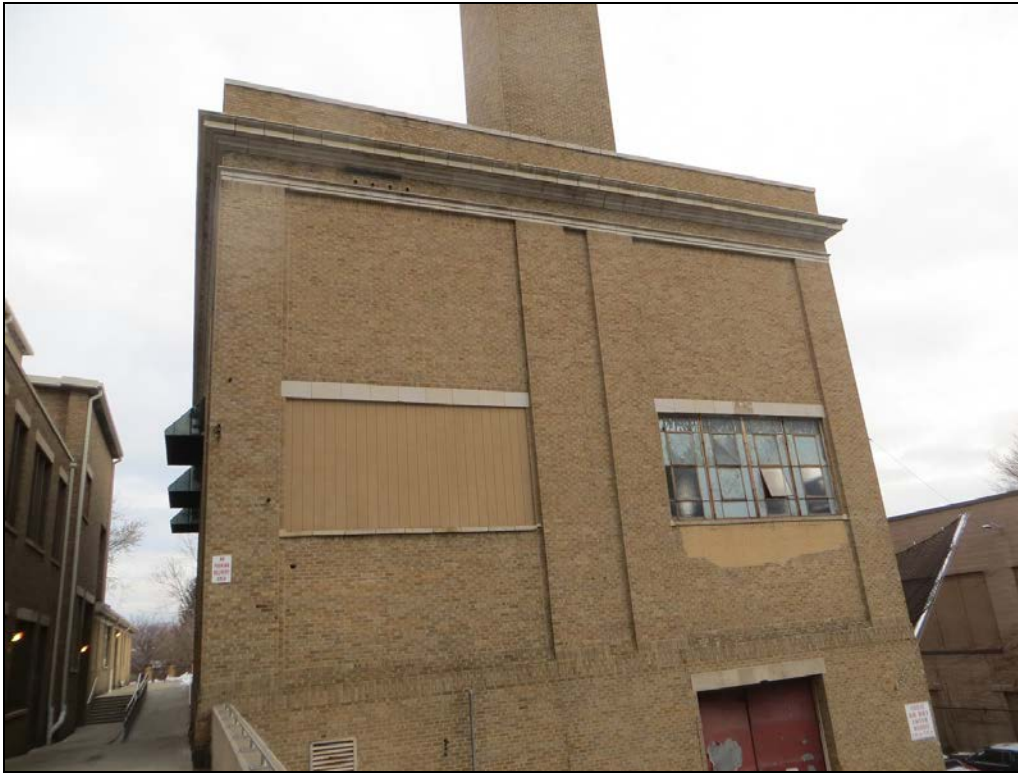
**Photograph 51:**  
Overview of the  
front elevation of  
the building that  
houses the  
mechanical  
equipment.

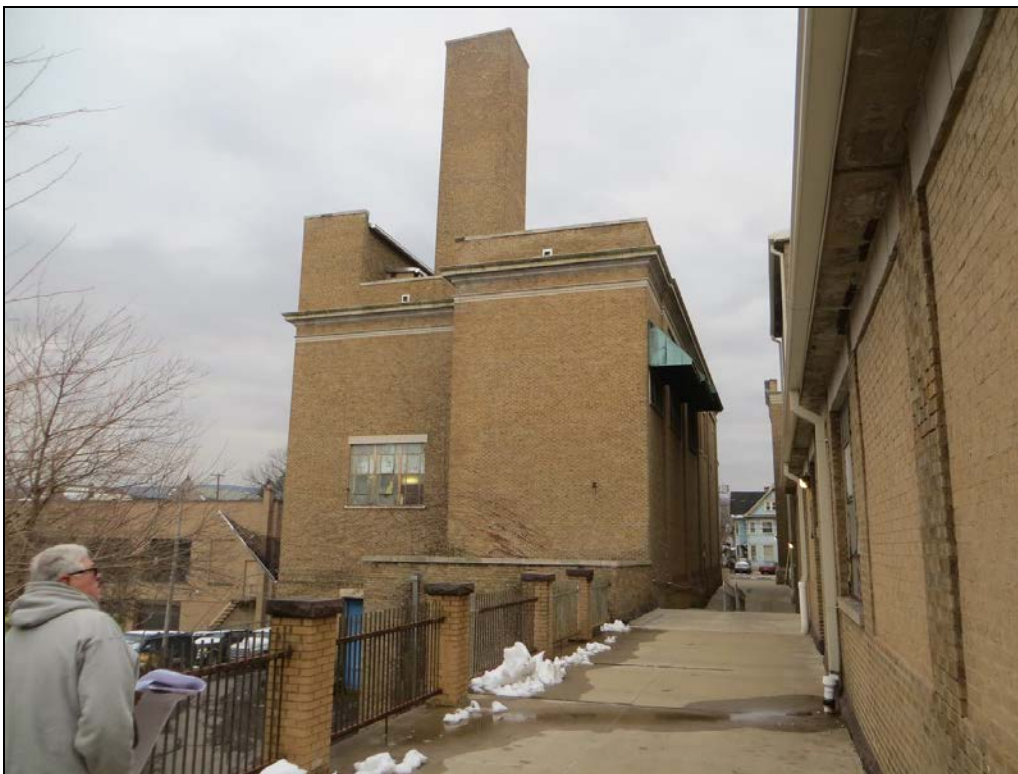
**Photograph 52:**  
Overview of the  
rear elevation of  
the mechanical  
building.

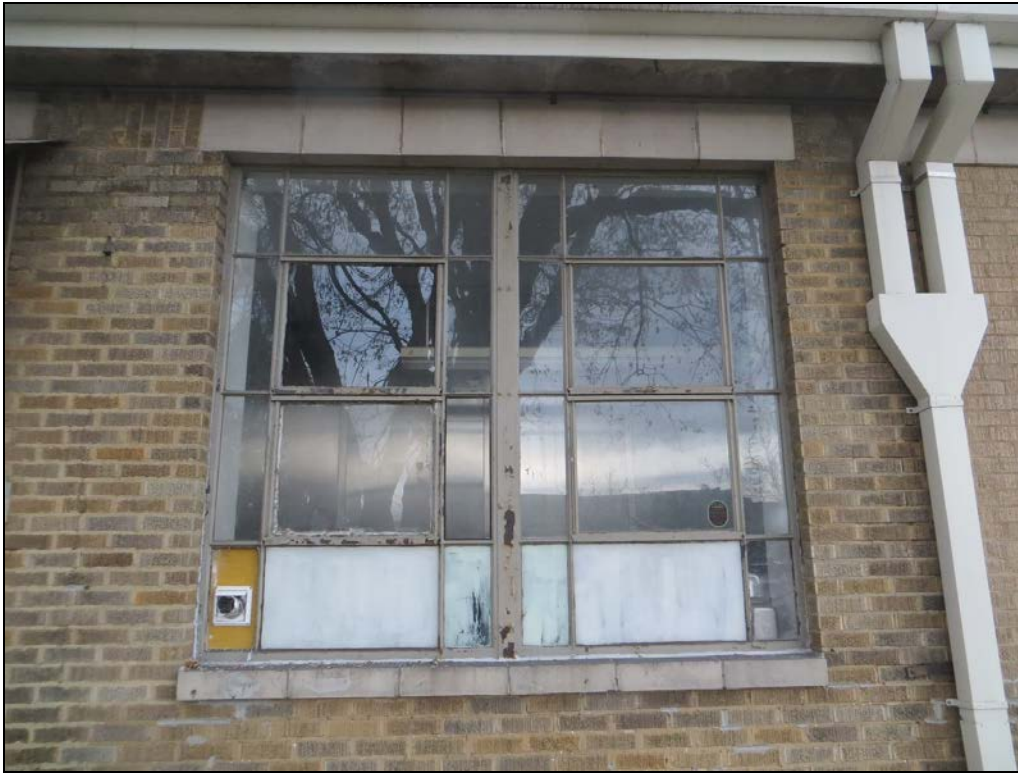
**Photograph 55:**  
The original windows on the building are steel framed. These windows are still present at many of the rear elevations.

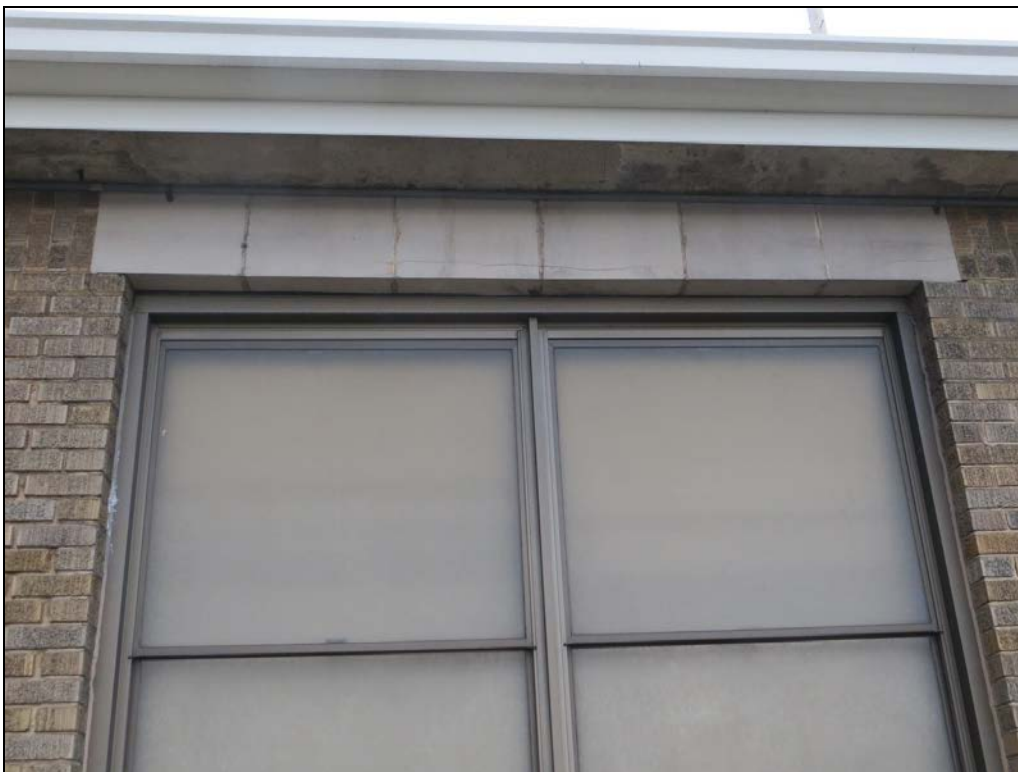
**Photograph 56:**  
New retrofit windows were installed over the original steel frames at many locations.

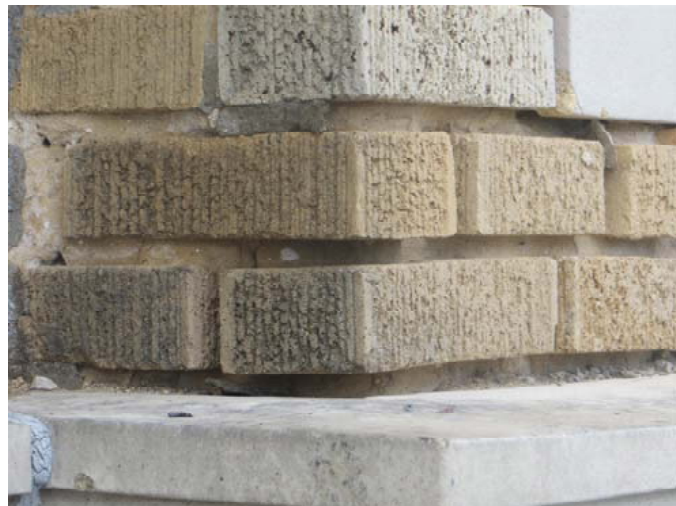
Continued failure of the mortar will eventually compromise the stability of the brick.

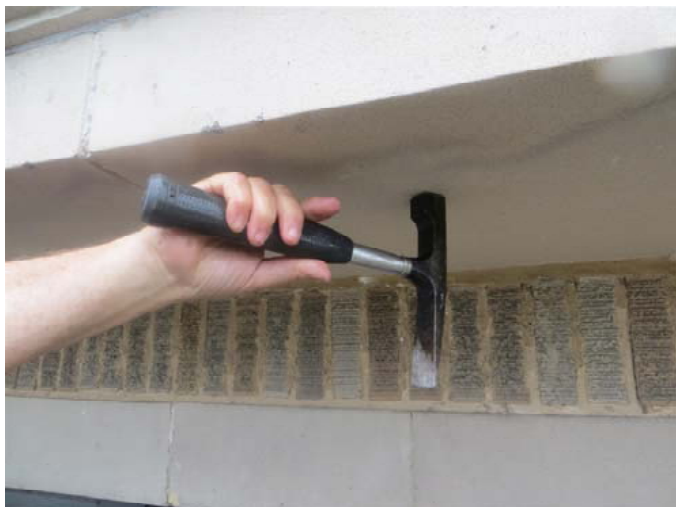
All of the terra cotta pieces were sounded. We did not find any pieces that were unstable or significantly displaced

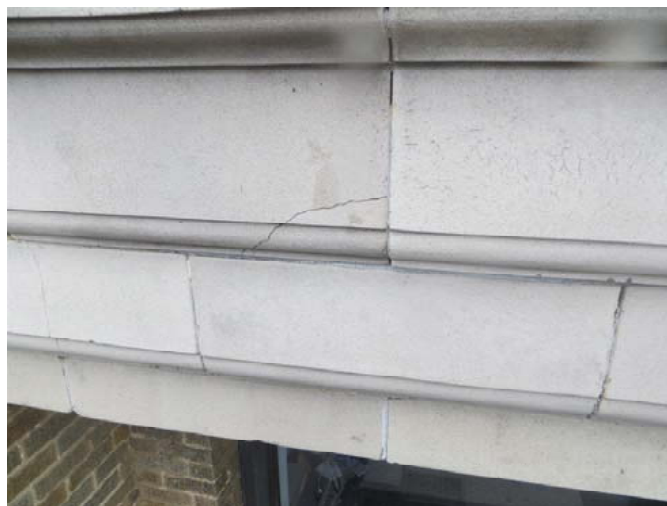
A minor crack in the face of the terra cotta panel.

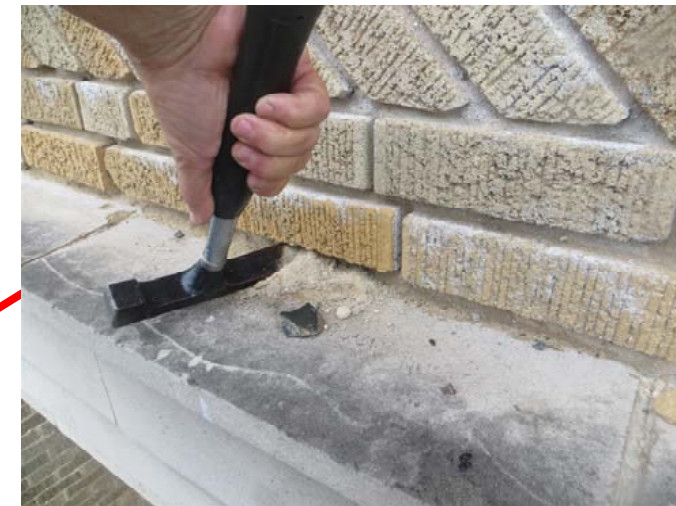
The mortar in the brick above the terra cotta was in poor condition. Previous attempts to repoint the mortar were unsuccessful and have already failed.

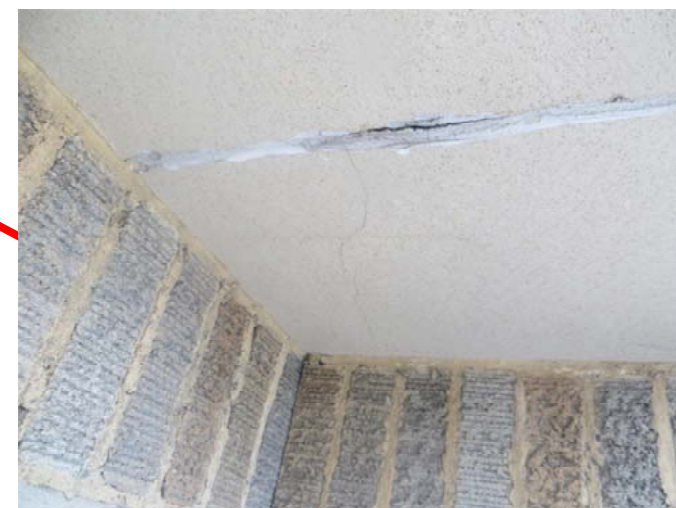
Sealant was installed over the majority of the terra cotta mortar joints. The sealant and mortar had failed at most locations.

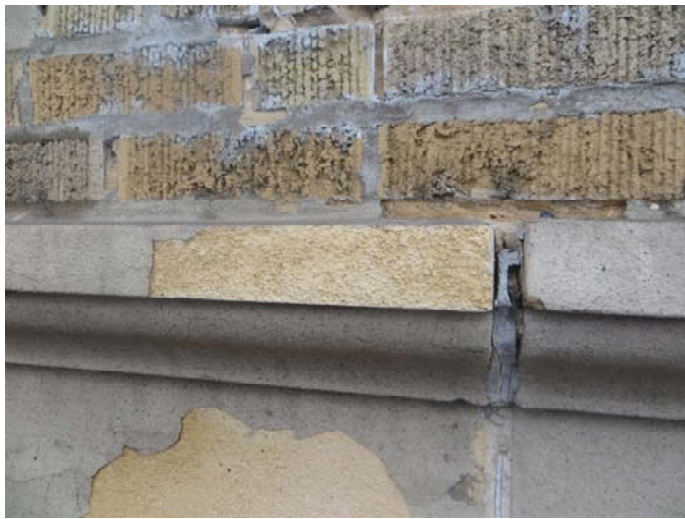
Spalling of the glaze was present at many locations.

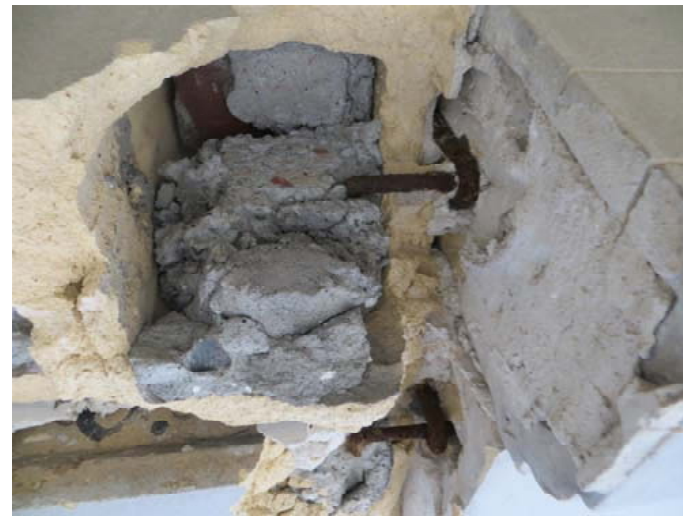
Some heavy surface corrosion was noted on the steel supports, but little loss of cross sectional area was observed.

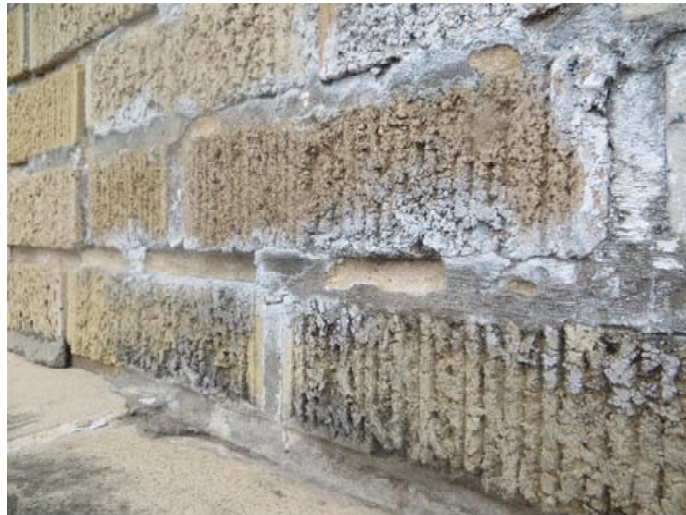
Many of the brick mortar joints had failed, allowing excessive water infiltration.

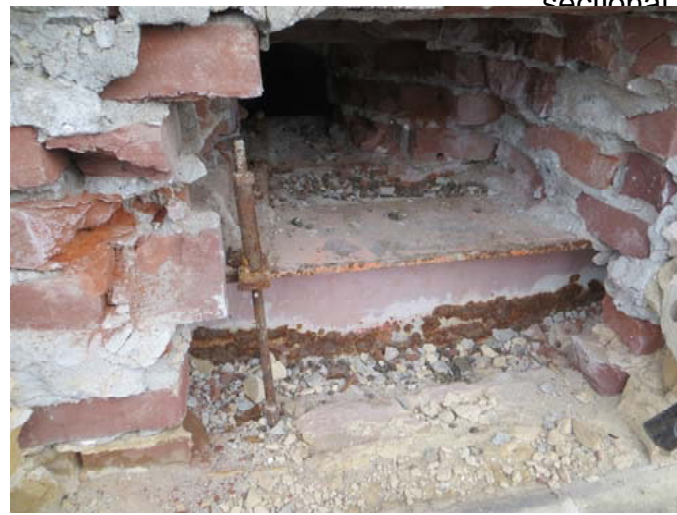
Beam had some surface corrosion but was in good condition.

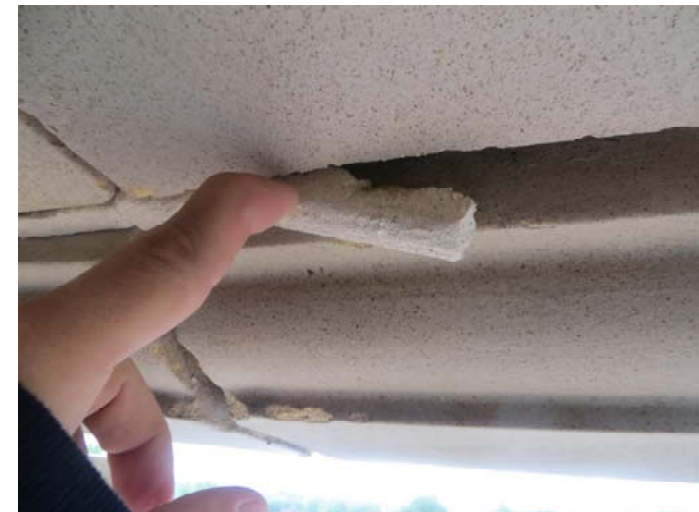
A piece of mortar that was removed by hand with little force used.
