## WILKES-BARRE AREA SCHOOL DISTRICT STRUCTURAL EVALUATION OF ELMER L. MEYERS HIGH SCHOOL

December 8, 2014

**Re: Structural Evaluation of Meyers High School**

# Meyers High School Structural Evaluation

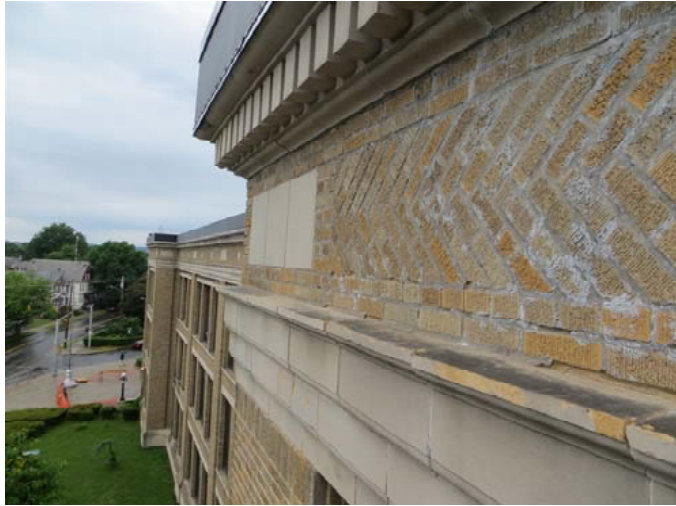
Efflorescence (white staining) was present at several sections of brick, a sign that the masonry is drying out.

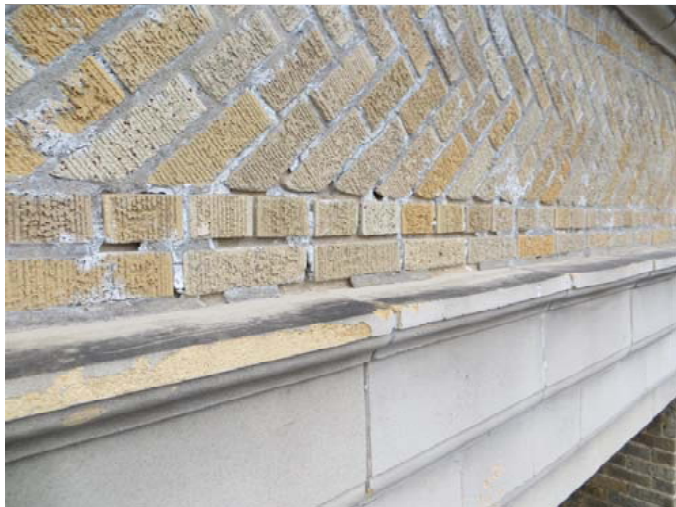
There were numerous failed brick mortar joints.

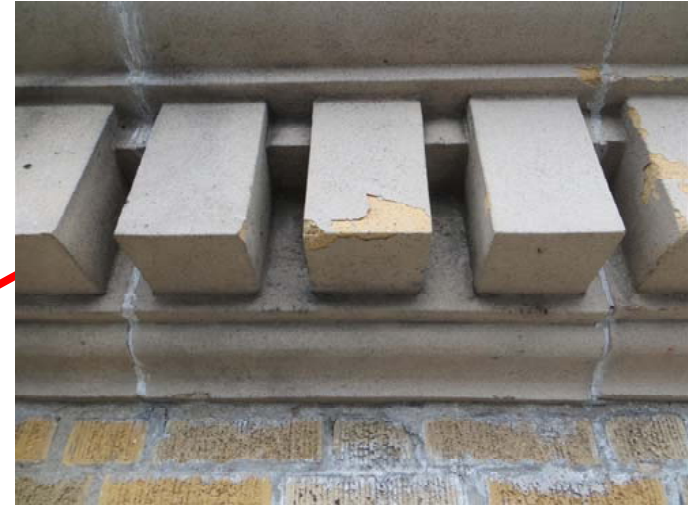
Spalling of the glazing was present at a few locations in this area.

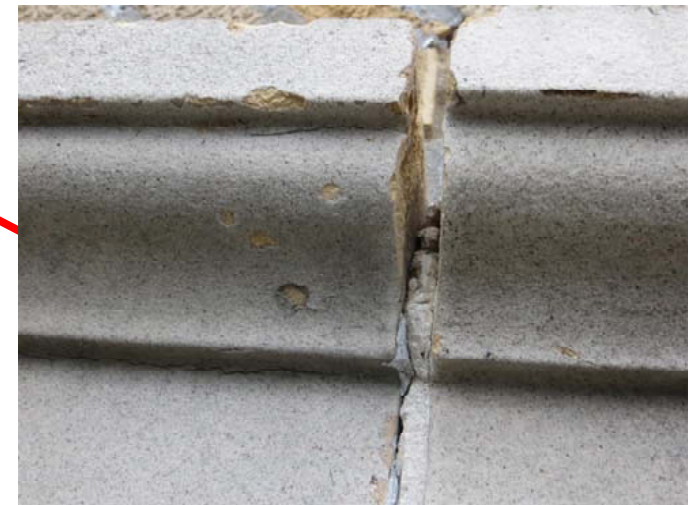
Sealant was installed over the majority of the terra cotta mortar joints. The sealant and mortar had failed at most locations.

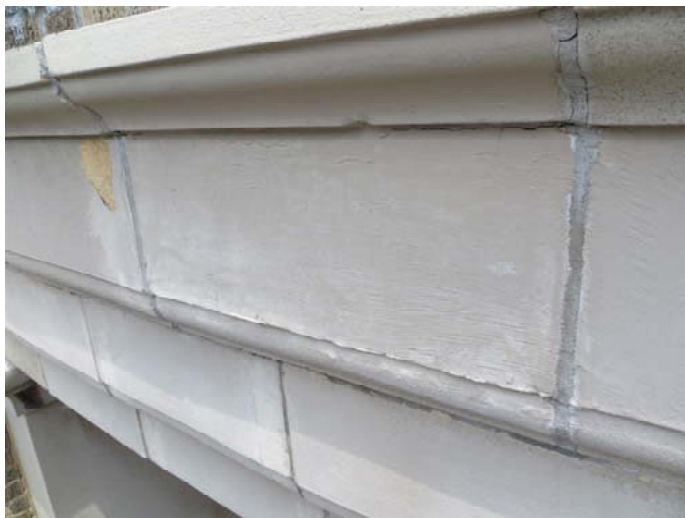
Terra cotta repair mortar appears to be well-bonded to the surrounding substrates.

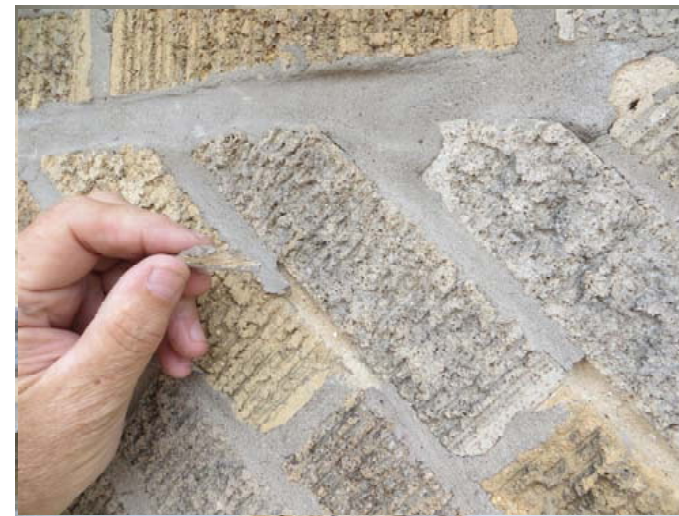
Several attempts to repoint the mortar were improperly completed and have failed.

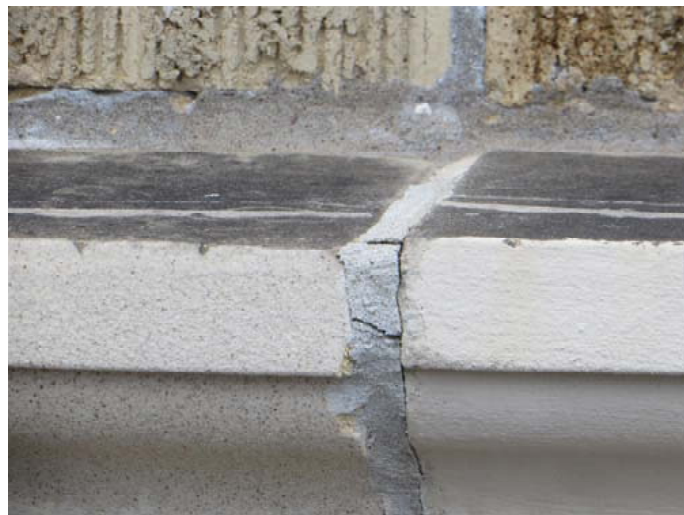
Failed mortar joint adjacent to patched terra cotta piece.

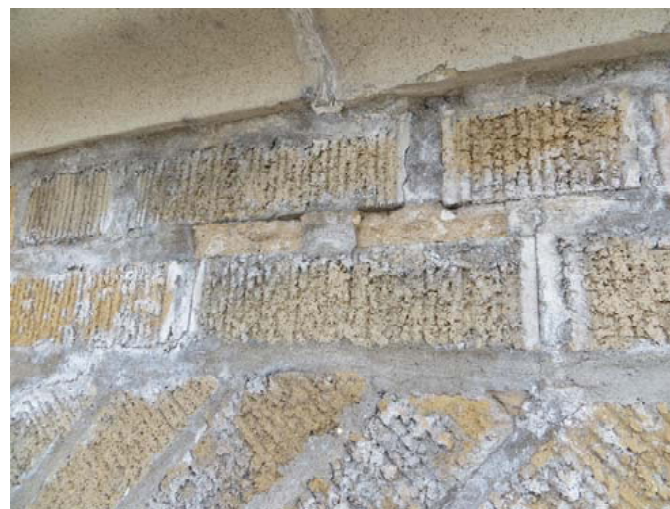
Failed mortar joints directly below the terra cotta dentil.

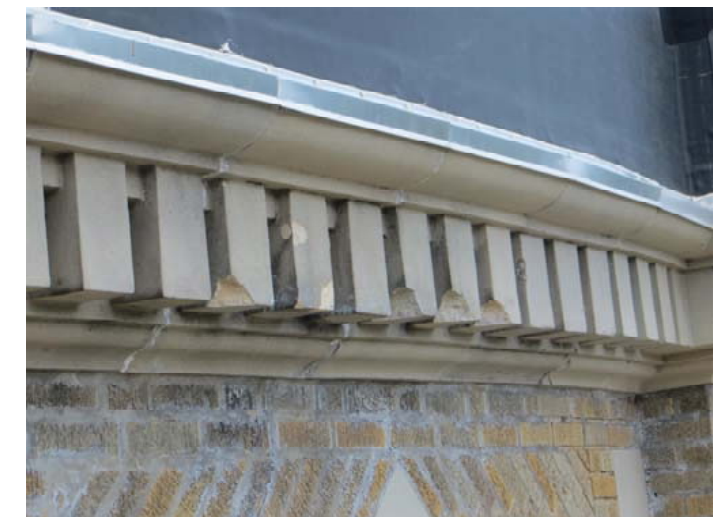
Some small spalls were noted on the dentil above the architrave.
